EDGEWOOD CREEK  
WATERSHED ASSESSMENT

TECH MEMO II  
**FINAL DRAFT**

December 12, 2002  
Revised April 23, 2003  
Revised June 10, 2003

**EDGEWOOD CREEK INTEGRATED WATERSHED ASSESSMENT TEAM**

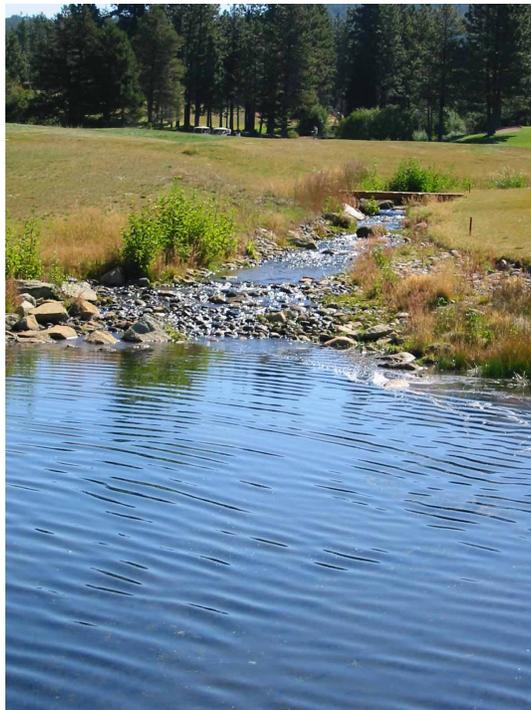
Reconstructed stream channel entering a pond on Edgewood Golf Course.

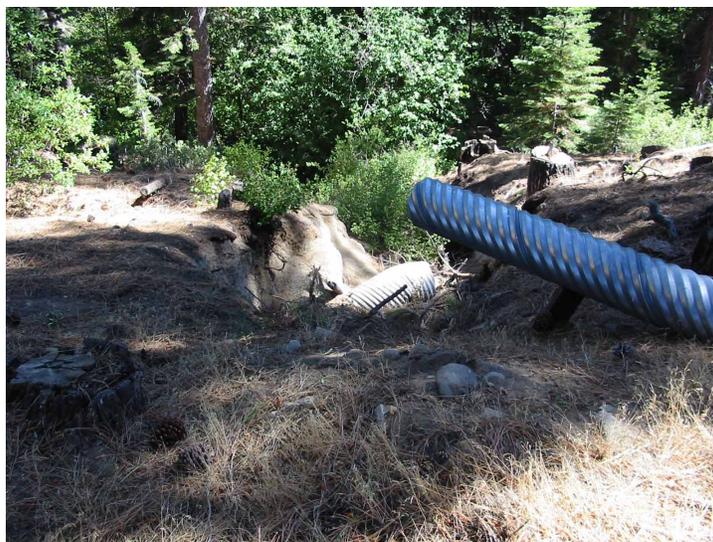
Just upstream of the pond, irrigation drainage from the meadow to the south has formed several large gullies in the south slope above Edgewood Creek. An old flume diversion is found on the south bank of the creek in this area. The gullies cut across the flume, which probably supplied water to the station. Past attempts have been made to arrest the erosion through drainage modification with little success. The gullies continue to be a problematic sediment source.

Gullies forming due to concentrated surface flow just upstream of Friday Station Pond.

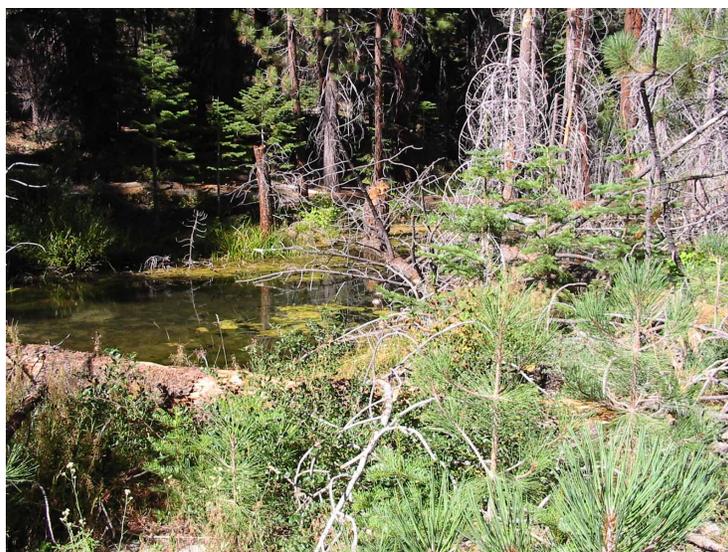
Approximately ¼ mile downstream of Palisades/Crestview Drive there is a large pond on the north side of the creek. We were unable to locate the source of water for the pond. It is extensively bermed along the south side to separate the pond from Edgewood Creek. The berm is constructed of sandy material and is actively eroding. Immediately downstream of Palisades/Crestview Drive there is a USGS gauging station. Frantz (1982) noted that this portion of the channel had been highly disturbed by development activity. Some of this disturbance was still visible during our visit. Although the stream has obviously been channelized, subsequent colonization by riparian vegetation has stabilized it. Some minor bank erosion is apparent.

Pond adjacent to Edgewood Creek located approximately ¼ mile downstream of Palisades/Crestview Road. A levee separates the pond from the stream channel. The levee toe is actively eroding, contributing sediment directly to the channel.

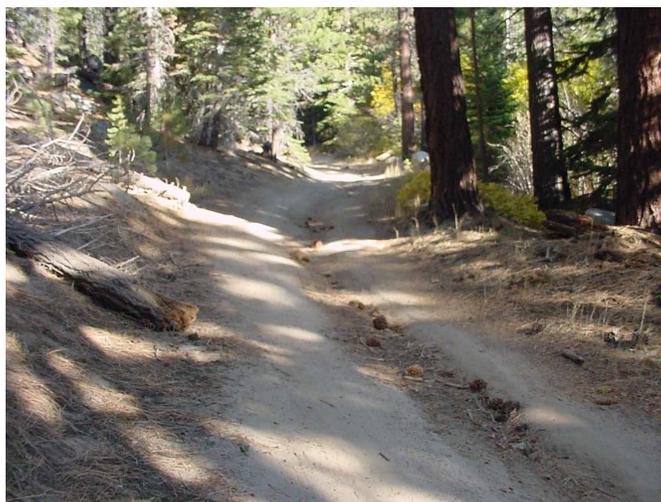
Access road along Reach 2 of Edgewood Creek. The road impinges on the creek and captures drainage, resulting in gully formation and direct delivery of sediment to the stream channel. Probably a sewer utility road on USFS and others property.

impinges directly on the channel in some locations and is a source of direct sediment input into Edgewood Creek. The Forest Service road is in need of maintenance and installation of road BMPs to reduce visible gullying and flow concentration. There does not appear to be any drainage control associated with the road. Spur roads and shortcutting have caused extensive erosion, especially in the upper portions of the road near the Boulder Parking Lot.

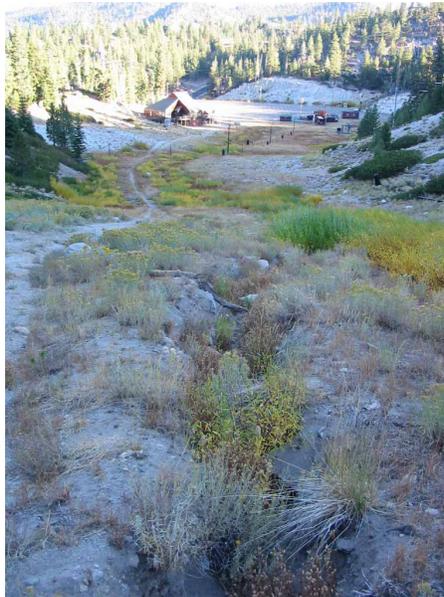
Upstream of the Boulder Parking Lot, Edgewood Creek has been highly modified. It appears that the valley has been completely modified through a cut and fill process that has flattened out the ski run area. The stream channel and banks have been unable to recover from these impacts due to a policy of riparian vegetation removal that appears to occur annually as part of a special use permit with the Forest Service. Without mature riparian vegetation to support banks, the channel has become braided with a series of headcuts propagating upstream. The result is an unstable channel with extensive downcutting and bank erosion. This area is a significant source of sediment to Edgewood Creek. Two riparian zone wells directly adjacent to the creek are also present. The discharge pipes from these wells are in the SEZ and are probably affecting water quality and recruitment of riparian vegetation.

Edgewood Creek has been highly modified through Reach 10. Cut and fill of the valley and annual removal of riparian vegetation has resulted in the formation of localized gullies. During spring snowmelt, it is likely that high sediment loads are delivered downstream

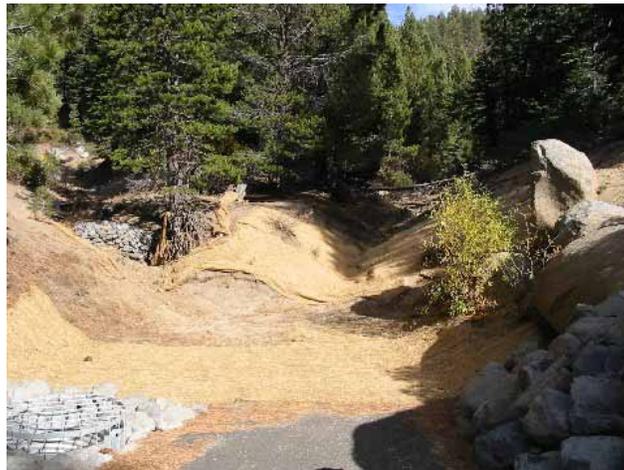
The North Fork tributary, entering from the east, is a small, ephemeral drainage. The tributary runs along residential streets and through sediment traps and ponds before reaching the North Fork. Upstream of the residential area, a newly constructed sediment basin collects drainage from two heavily eroding gullies. These gullies were monumented and surveyed as part of the USGS study. Previous attempts to stabilize these gullies through the use of gabion check dams have only been temporary solutions. The gullies appear to be actively eroding, though how often they carry flowing water is unknown. Recreational use in this area may be exacerbating the problem. Future repairs of these gullies should consider the hydrologic regime, upstream and downstream impacts and the possibility of an installed grade control structure or energy dissipater being outflanked as a result of bank erosion or woody debris input.

Two gullies on a tributary to the North Fork. A sediment basin has recently been constructed to reduce sediment delivery downstream. Though this is a step in the right direction, this approach will not reduce erosion occurring at the head of each gully and will require long-term maintenance of the sediment basin

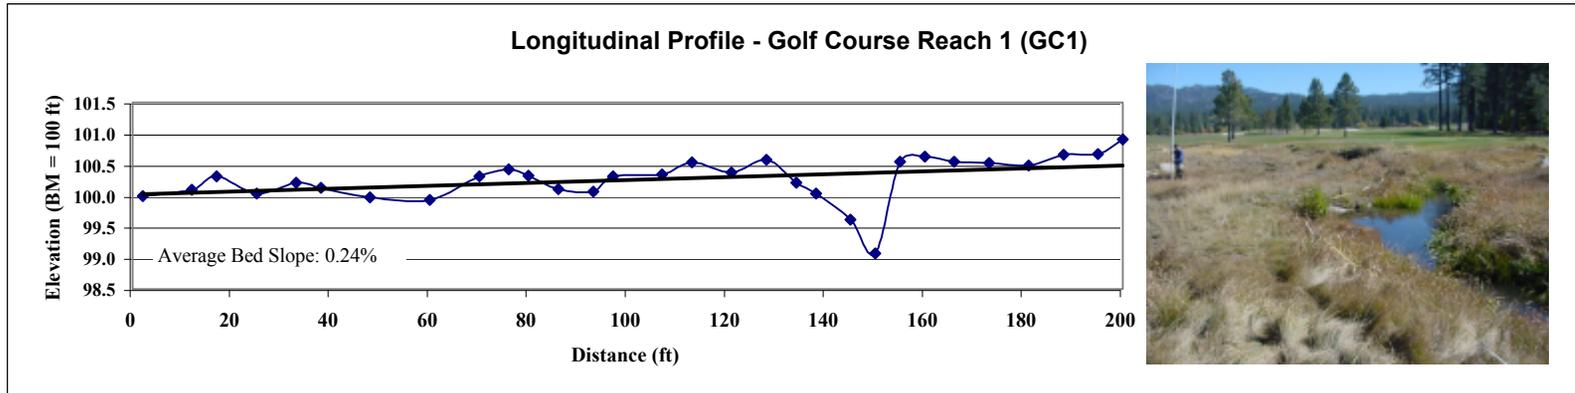
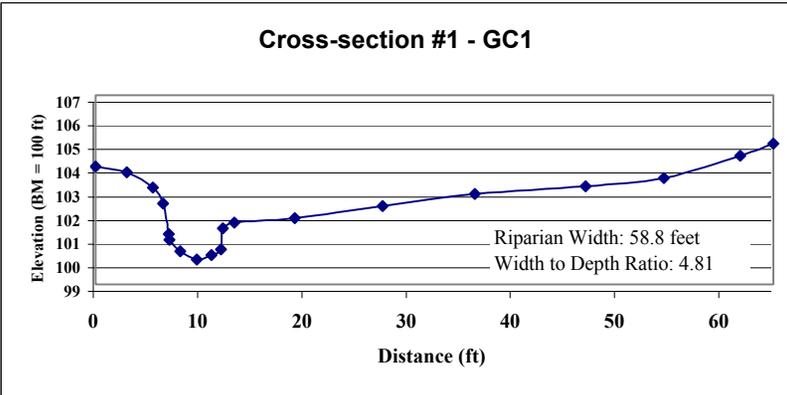
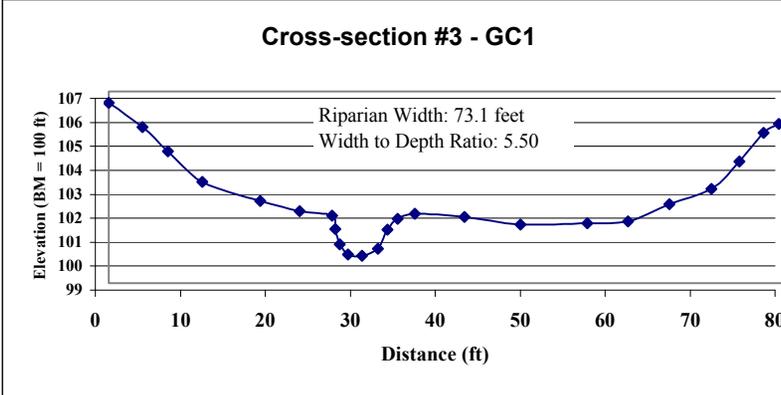
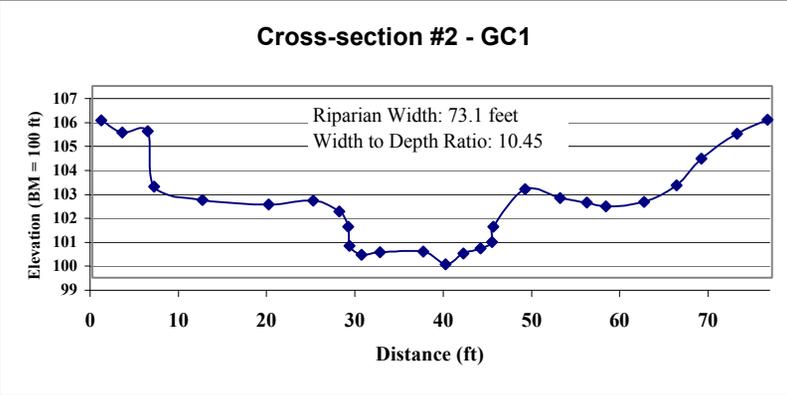
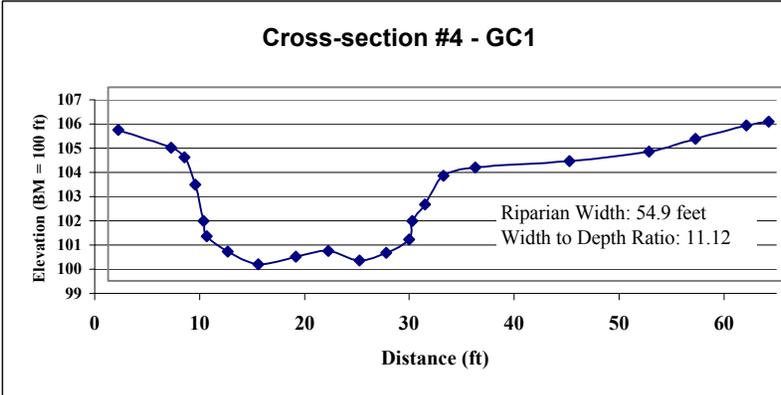
**Figure 2.3:** Long profile and cross-section geometry for a disturbed meadow reach (Golf Course Reach #1) at Edgewood Golf Course. This site consists of a highly modified channel. Riparian width was calculated as the edge of the maintained fairway turf grass. The width to depth ratio was calculated as wetted width to wetted depth since bankfull indicators were not apparent since modifications to this channel were recent.

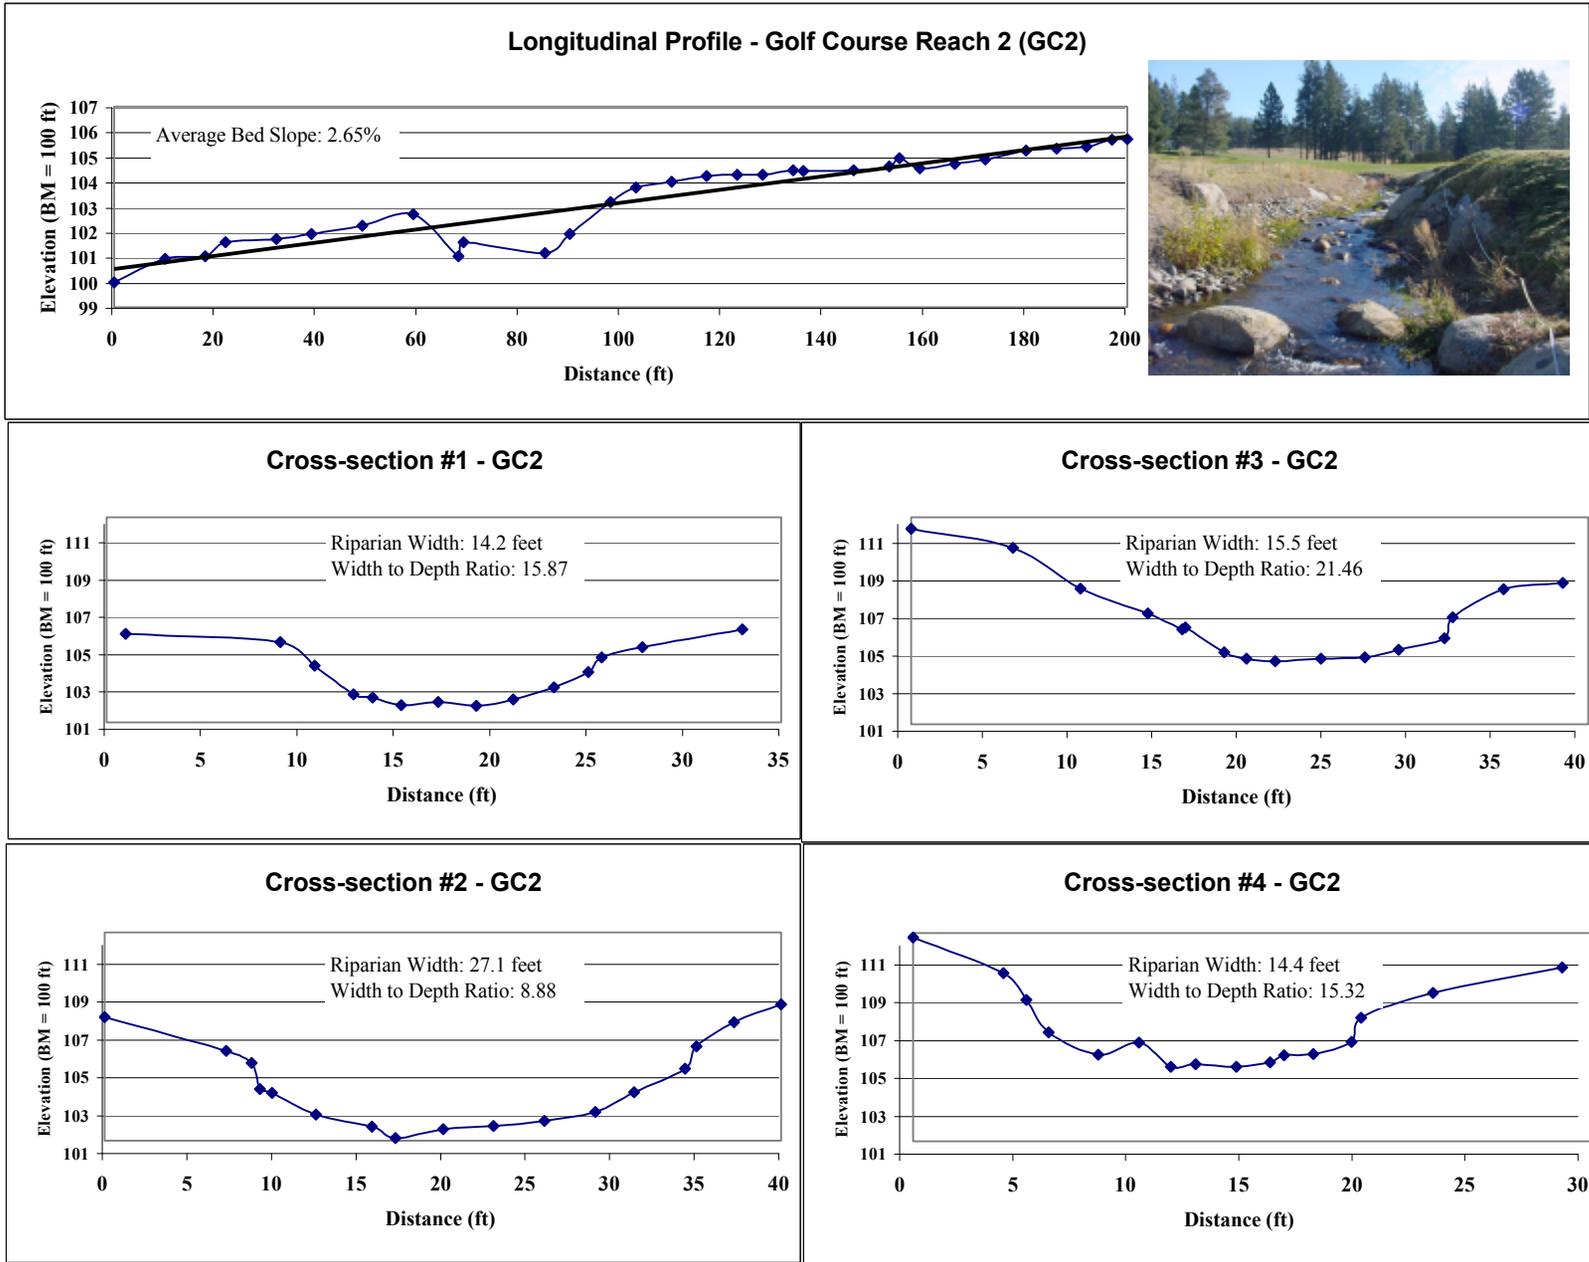
The constructed Golf Course channels do not necessarily replicate the historic conditions and therefore do not provide the appropriate function that creates habitat for terrestrial and aquatic organisms. Golf Course 2 mimics a Rosgen B channel, which is more characteristic of a narrow, moderately steep valley than a meadow stream. Golf Course 1 is a more appropriate morphology to replicate in a meadow setting though the gradient appears to be too low, potentially resulting in backwatering of important riffle habitat.

**Figure 2.4:** Long profile and cross-section geometry for a disturbed meadow reach (Golf Course Reach #2) at Edgewood Golf Course. This site consists of a highly modified channel. Riparian width was calculated as the edge of the maintained fairway turf grass. The width to depth ratio was calculated as wetted width to wetted depth since bankfull indicators were not apparent since modifications to this channel were recent.

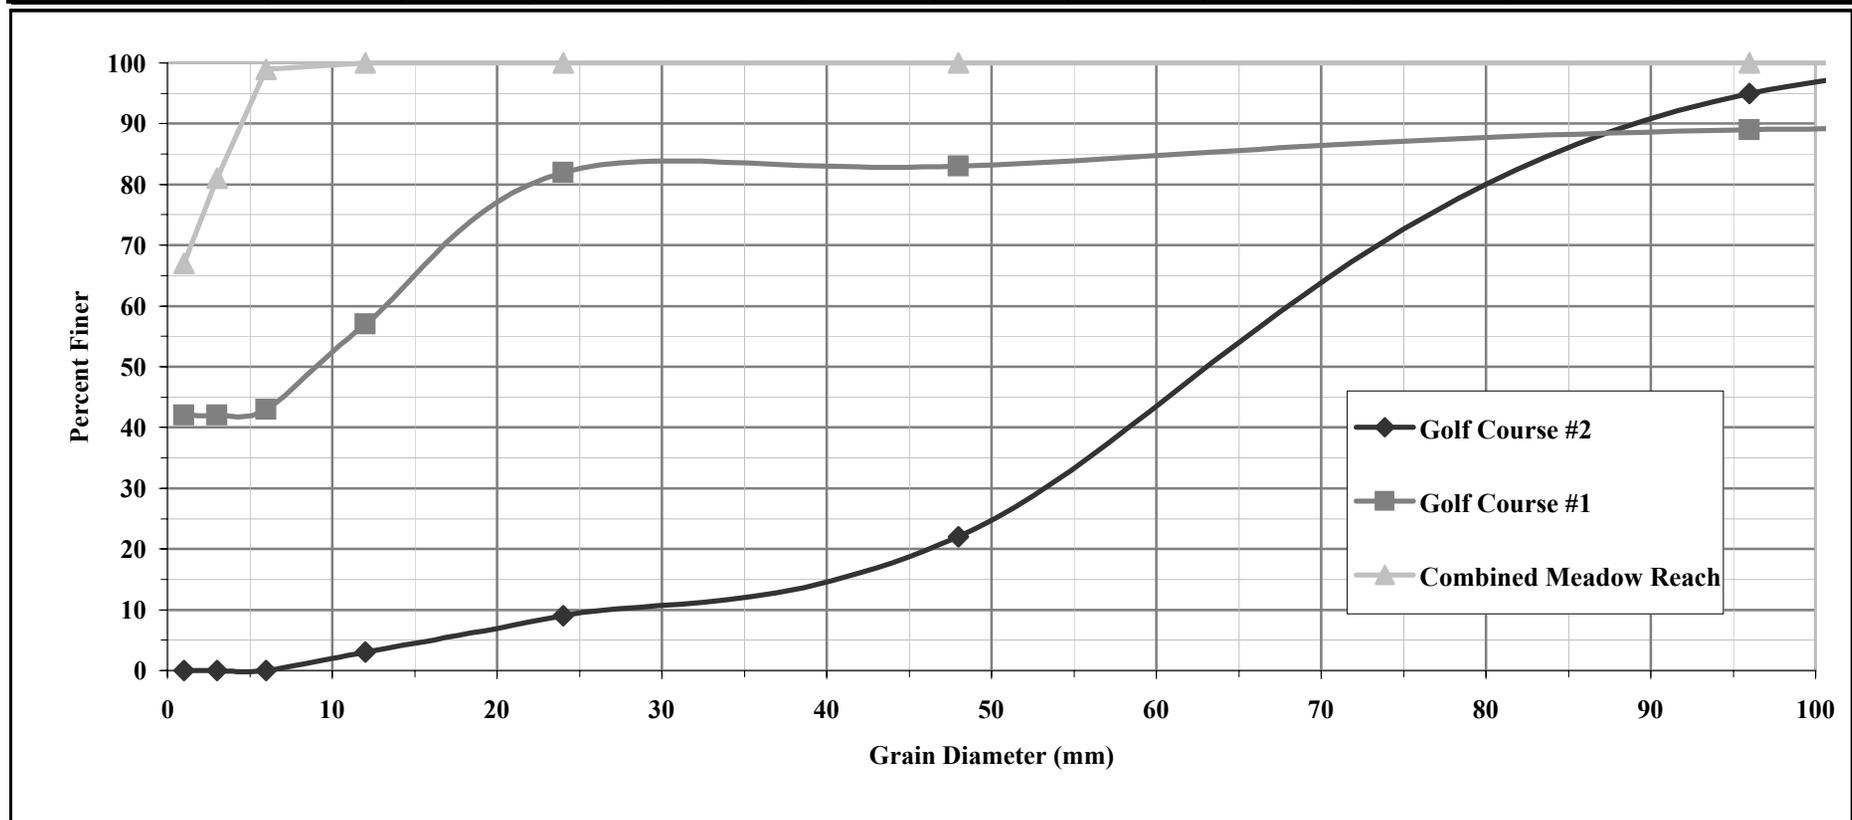
The results observed in the longitudinal profiles and cross-sections are mirrored in the pebble count results. Substrate grain-size distributions in Edgewood Creek are dominated by sand-sized particles. At Golf Course 2, cobble dominates the bed. Though this may benefit aquatic insect production, a lack of gravel sized bed material may inhibit fish spawning potential.

**Figure 2.7:** Pebble count results for Edgewood Golf Course and Park Cattle Company study reaches. Constructed channels on the golf course have coarser bed material due to importation of material and reductions in bedload due to the Friday Station Pond.

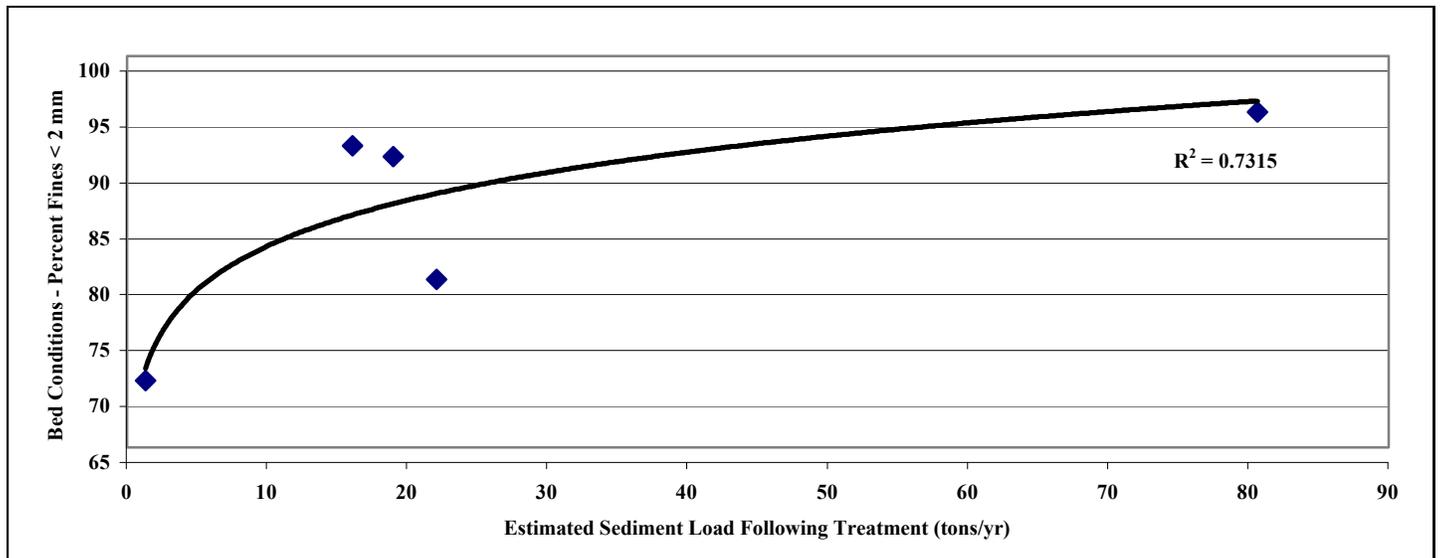
The historic USGS data and our 2002 sediment sample results are summarized in Figure 2.9. At all sampling sites the percent of material less than 2 millimeters has not changed considerably since the mid-1980s with the exception of sites E7 and E9. At these two sites, the percentage of fine sediment less than 2 millimeters has increased. Site E7 is located downstream of the Mainstem and North Fork confluence. This site captures road drainage impacts from the poorly maintained access road as well as untreated road drainage from the middle portion of Kingsbury Grade. In 1983, 1984, and 1987, the USGS reported percent fine material to be 43, 34, and 38 percent of the sample, respectively, whereas in 2002, percent fines accounted for 91 percent of the sample. Though the changes can be partially attributed to differences in the sampling method, the magnitude of the change points to increased sediment delivery and the poor condition of the dirt road. Site E9 is located just downstream of the Boulder Lodge Parking Lot. In 1983 and 1984, fine material less than 2 millimeters was estimated to be 55 and 41 percent of the sample respectively. In 2002, the portion less than 2 millimeters was estimated to be 70 percent of the sample. The difference between these two sample results may be due to differences in the sampling method and not necessarily an increase in fine sediment delivery.

Bed conditions at selected sediment sampling sites were then compared to estimated delivery amounts, the results of which are shown in Figure 2.9. A total of 5 sediment and stream intersection sites were compared. The results suggest a positive correlation exists between percent fine sediment less than 2 millimeters and estimated sediment delivery from untreated roads. Though this suggests that treatment of road runoff will reduce sediment delivery to stream channels and improve bed conditions, the magnitude of the improvement may not significantly change the quality of the habitat for aquatic organisms given the natural production of sand-sized sediment in the watershed. The benefit may relate more directly to sediment delivery to Lake Tahoe, an issue of great importance in the Tahoe Basin.

**Figure 2.9:** Bed material pebble count and grain-size analysis for selected USGS monitoring sites and sediment basins in the Edgewood Creek Watershed. Pebble count and grain-size data from the 1980's was taken from a USGS study published in 1990 (Hill et. al.) where bulk samples (1987) and pebble counts (1983 and 1984) were conducted. The 2002 data were collected by project team members in the vicinity of the USGS cross-section groups using a grab sample method on bar features in the channel. Samples were then sieved to determine percent material within each size class by volume. Also listed is the stream intersection ID from Figure 2.2 that corresponds the best with the sample location. The scatter diagram at the bottom is the result of plotting the sediment load delivered to the channel at each stream intersection point against the percent fine sediment measured at sampling locations. The correlation suggests a positive relationship exists between estimated sediment delivery from stream channels and the percent of fine sediment occurring in the bed samples.

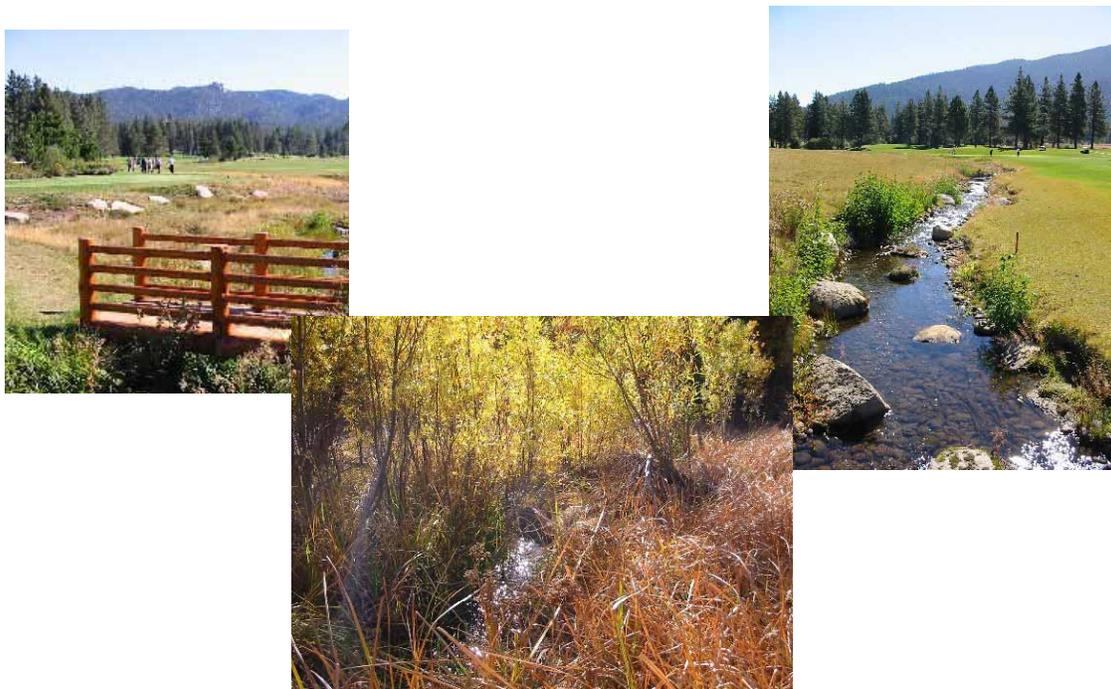
Riparian areas are also significantly different in the two areas. The lower reach on the golf course has riparian buffers, composed mainly of sedges. The upper reach on the golf course has little riparian buffer. The two reaches in the undisturbed meadow, however, have large expanses of riparian vegetation on either side of the channel, composed of both grasses and woody shrubs. The following photographs show the extent of riparian vegetation in each of the reaches surveyed.

Figure 4.1 Riparian vegetation on the reaches surveyed. The top two photographs are the reaches on the golf course. The photograph in the bottom center is of the upper reach in the undisturbed meadow.

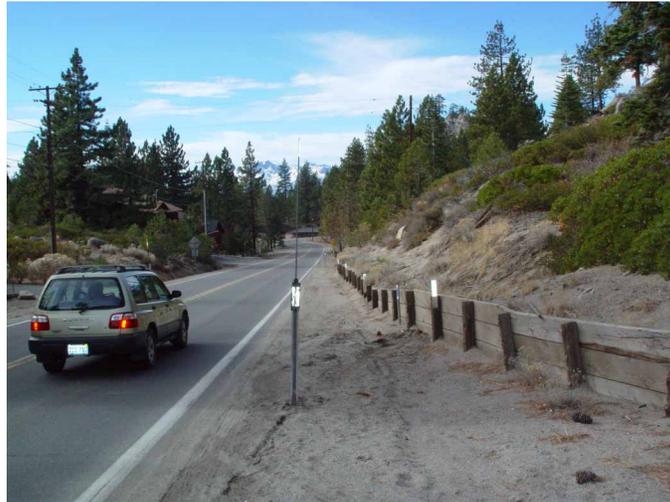
Significant volume of the sediment is being conveyed within and from roadway areas as a result of roadway de-icing operations, it is therefore important to note the differences within the project area. Roadways that experience the heaviest traffic loads, receive the greatest level of roadway de-icing material application. The material applied to the roadways for de-icing include two major constituents; sand/cinders for providing abrasive to reduce skid potential and salt (sodium chloride) to melt ice build-up on the roadway surface. Within the Edgewood Creek watershed, US50 and SR207 (Kingsbury Grade) receive the greatest volume of applied roadway de-icing material. The subdivision streets receive less de-icing application which is readily observable in the field. Usually major intersections and bus stops within the developments receive additional abrasive and salt for safety reasons. However, in this case we did not observe any significant signs of additional road abrasive deposition in the vicinity of major intersections or bus stops. This may mean that the road abrasives are either being transported downhill to a different location or the sediment collection features in the vicinity are large enough to accommodate the additional de-icing material.

SR207 – December 2002 – Roadway De-Icing Material Build-Up in Road Shoulder

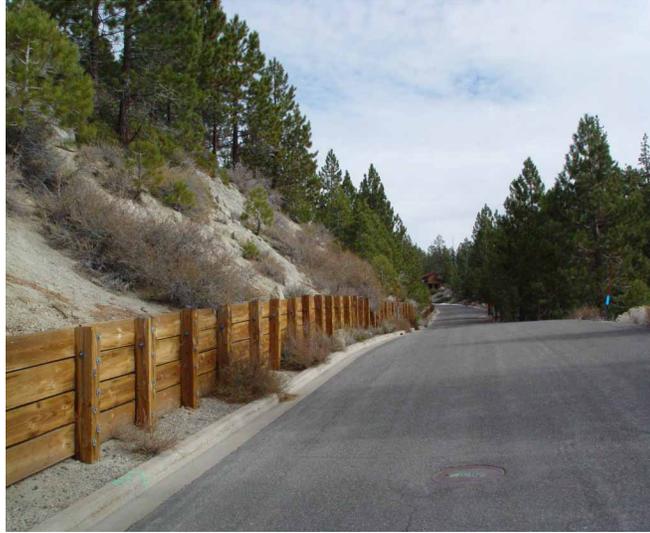
Typical Subdivision Street – December 2002 – Little De-Icing Material and More Extensive Slope Treatments

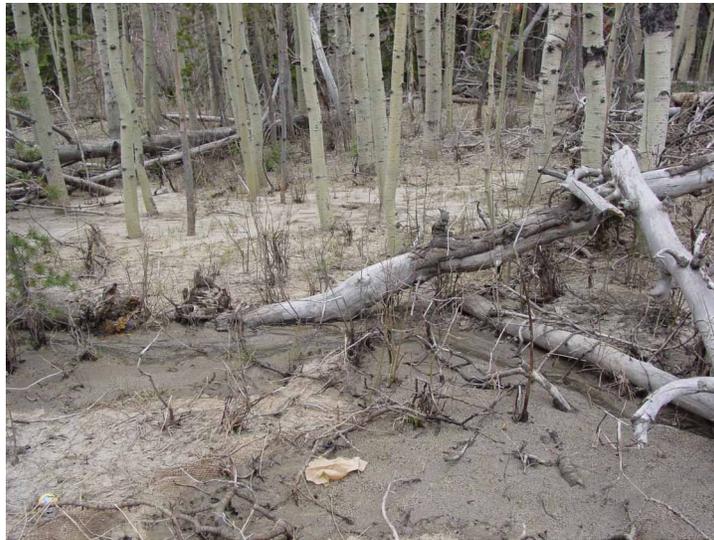
Sediment accumulation in the SEZ below North Benjamin Drive north of Aspen Way. May 2003

Large accumulations of sediment in the SEZ off of North Benjamin Drive just north of Aspen Way should be attenuated by the placement of a sediment basin at the base of the steep grade above the SEZ (Figure 7.1 – Recommended BMPs - sediment basin). Large amounts of roadway deicing material move down the steep grade into the sediment can near the corner, passing through and eventually being deposited in the SEZ. Flows also appear to move overland, bypassing the sediment can completely.

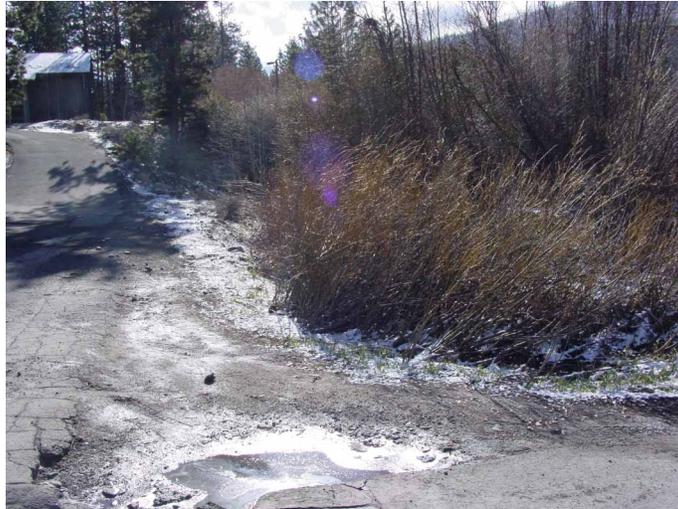
In the lower Kingsbury area adjacent to the Post Office, the parking lot is not equipped with BMPs and it appears that during the winter the SEZ is used for snow storage. East of this location, two drop-inlets appear to be directly connected to the creek without any water quality features (Figure 7.1 – EIP area “J” – Lower Kingsbury).

Willows deformed from snow storage in the SEZ behind the Post Office parcel. April 2003
