2018 Lake Tahoe Nearshore Aquatic Plant Status Report

March 29th, 2019

Tahoe Regional Planning Agency
128 Market St.
Stateline, NV 89449

Marine Taxonomic Services, Ltd.

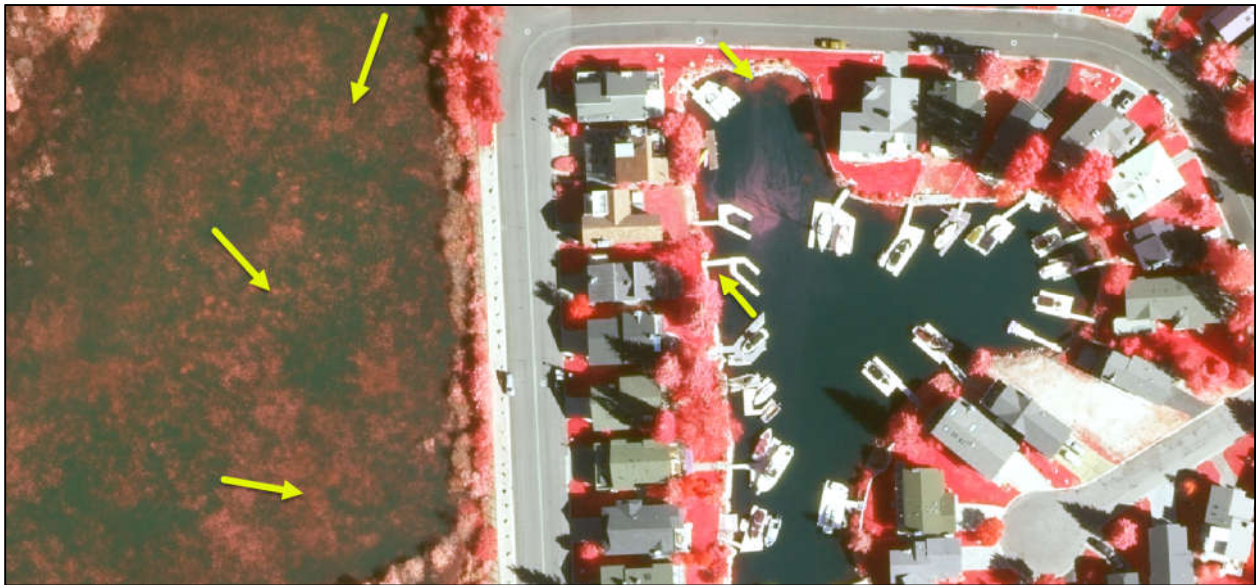
Figure 2. Example of aquatic surface vegetation observable in the 2018 aerial imagery displayed as a color infrared composite. Location: Pope Marsh (left) Tahoe Keys Homeowner's Lagoon (right).

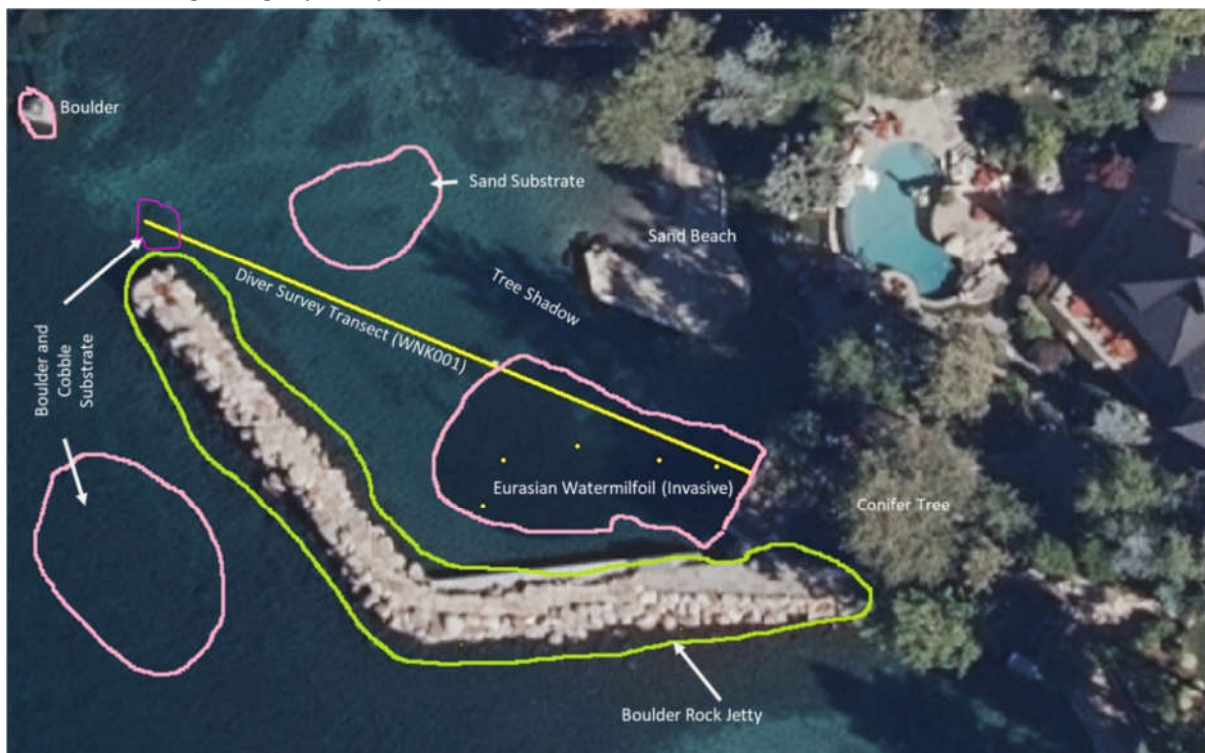
Figure 5. Sample data interpretation key for aquatic vegetation mapping. Location: Wovoka near Pine Point Drive, east shore of Lake Tahoe.

Data interpretation keys were developed to guide the feature extraction process (Figure 5). These keys were developed using a combination of field diver data and local knowledge. They served as the foundation for guiding aquatic plant feature identification.

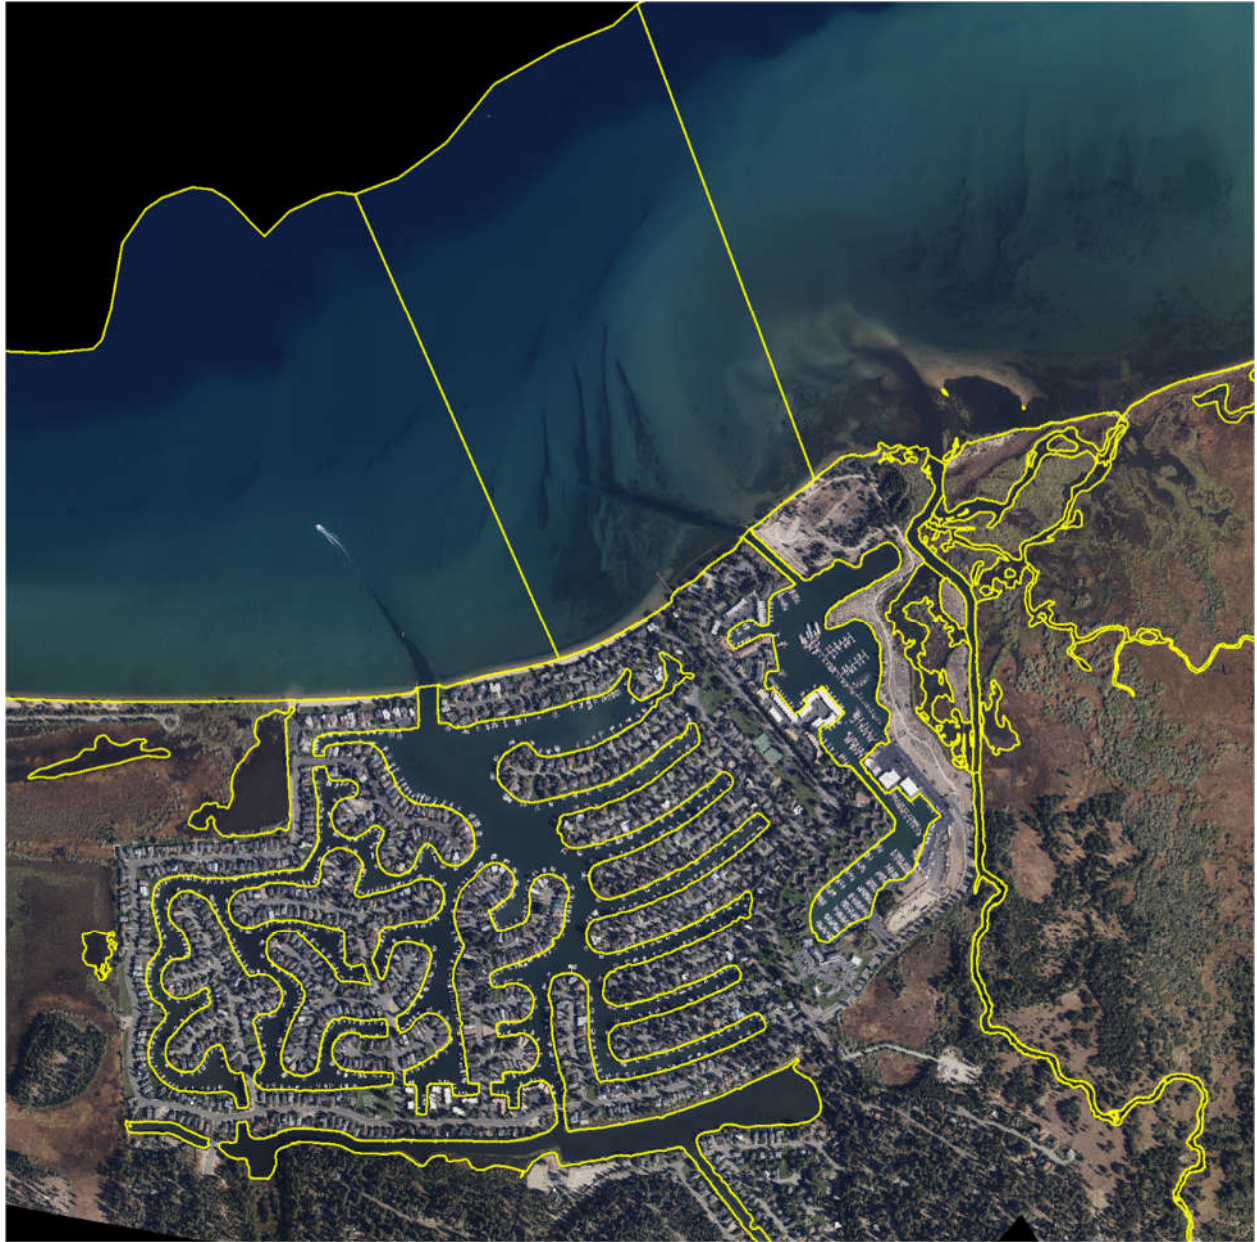
Figure 11. An example area (overlooking Tahoe Keys area) showing 'survey zones' used to quantify different aquatic plant indicators.

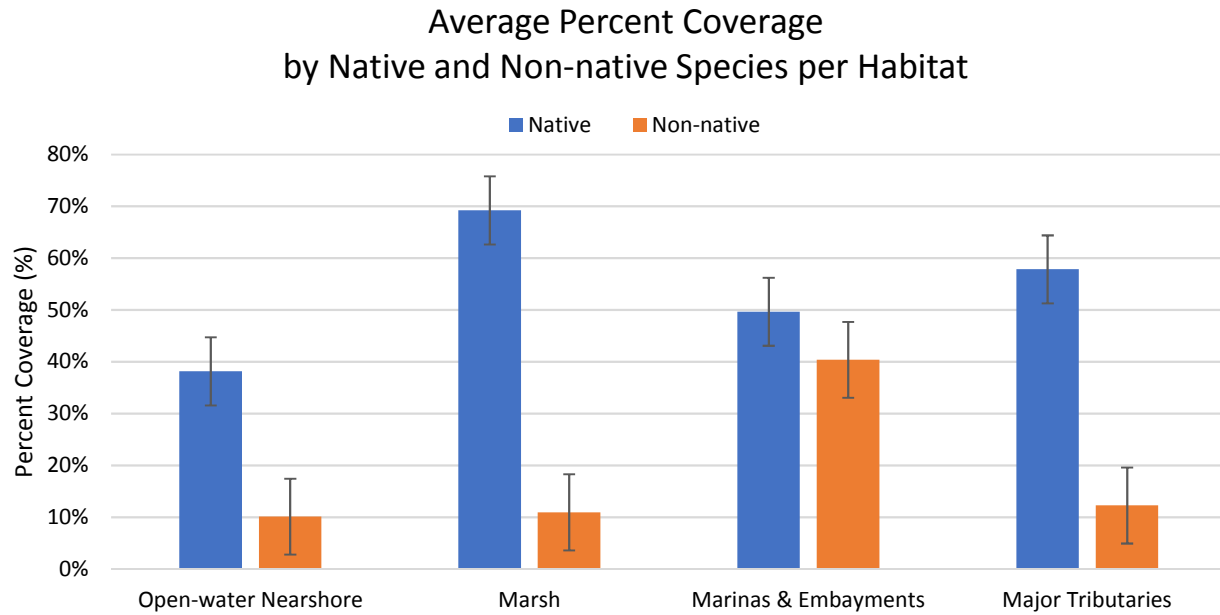
Figure 12. Average percent of native and non-native plants among vegetated transects per strata. Error bars represent one standard deviation from the mean.

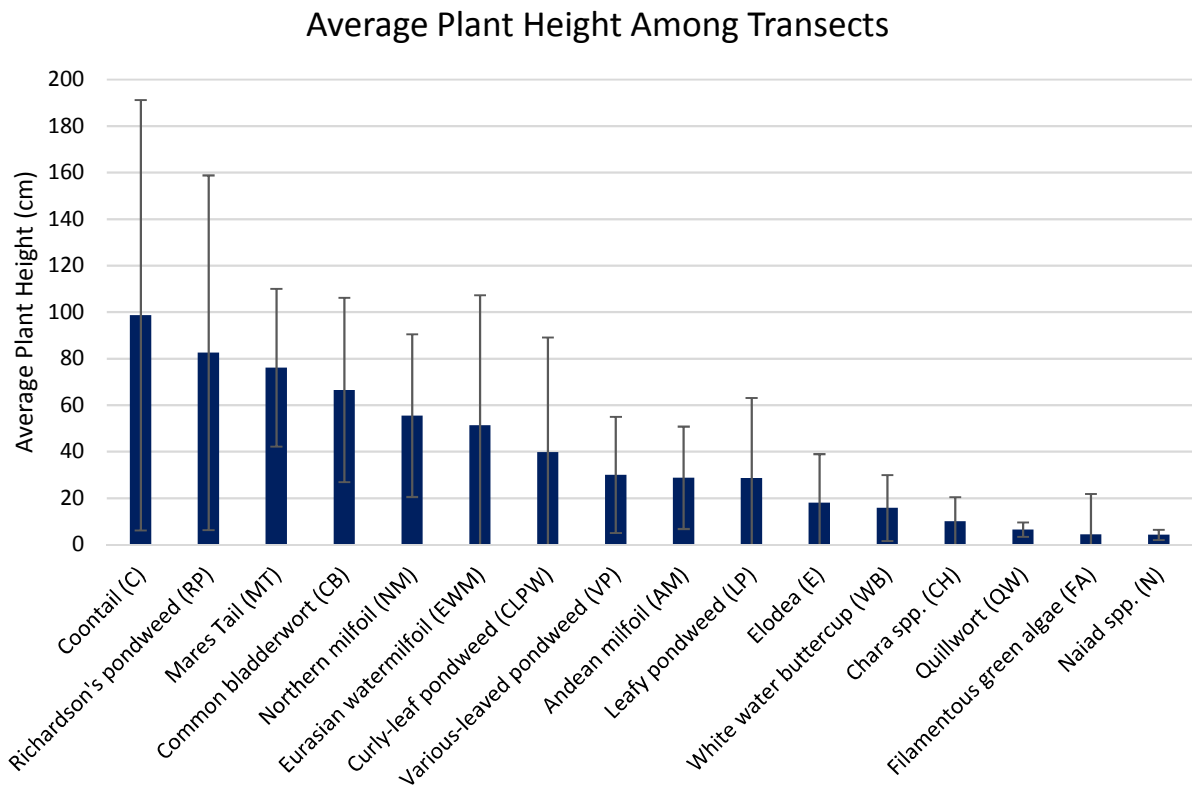
Figure 13. Average plant height across transects. Error bars represent one standard deviation from the mean.

Table 2. Observed species average plant height ranged from 4 cm (*Naiad spp.*) to 100-cm tall (coontail) (Figure 13).

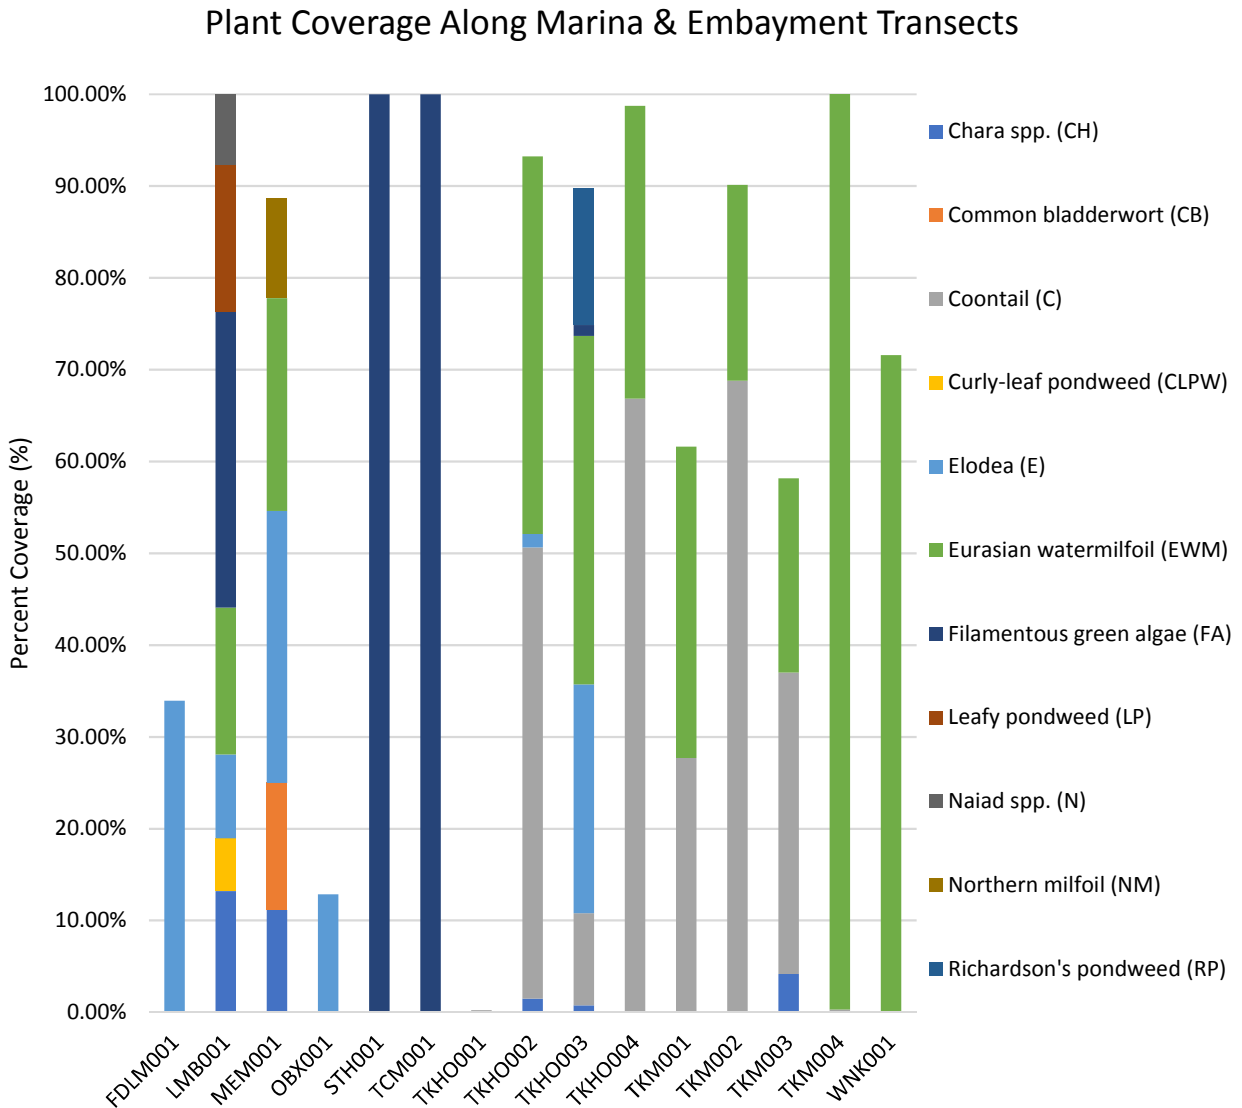
Figure 17. Stacked bar graph of species presence within marinas and embayments transects. Only transects with plants present are displayed in the above chart. Low values are not visible for TKHO001.

A total of 30 marinas and embayments transects were surveyed across 23 marinas and embayments (Appendix B, Table 6). One of the transects was an opportunistic transect. Of the 29 planned transects surveyed for plant coverage, 15 contained aquatic plants. Elk Point and Lakeside Marinas were not surveyed due to ongoing invasive aquatic plant mitigation installations (marina areas were covered with bottom barriers). Eurasian watermilfoil and coontail were observed to contribute to most of the plant cover along marina and embayment transects within the Tahoe Keys Homeowner's Lagoon (TKHO) and Tahoe Key Marina (TKM) (Figure 17). Two transects were observed to be entirely covered with filamentous green algae. Elodea was present on occasion along a few transects and was observed to be the only species contributing to plant cover in Fleur Du Lac Marina (FDL001). Percent cover by species are included in Appendix C. Animals observed while conducting marina and embayment field surveys included Asian clam, bluegill, brown trout, crayfish, minnows, rainbow trout, Lohontan redbreast shiner, and speckled dace (Appendix D).

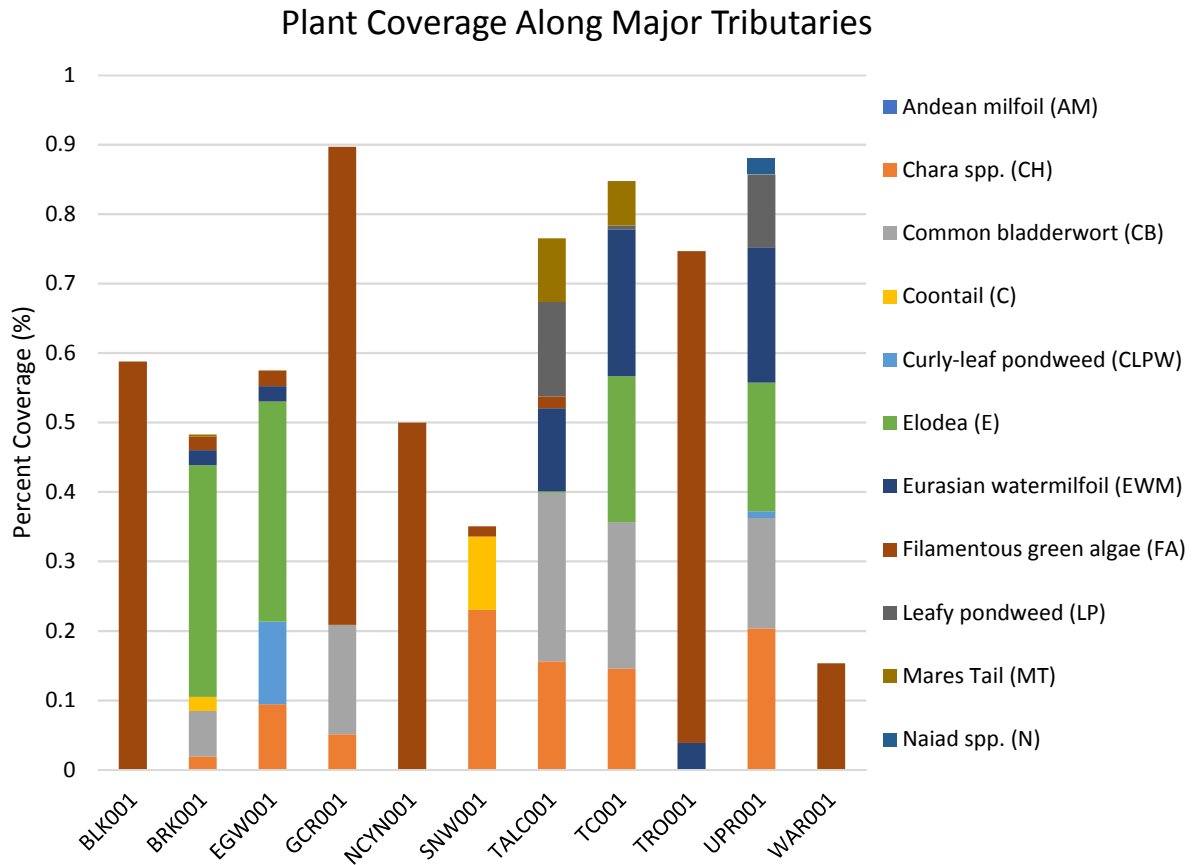
Figure 18. Stacked bar graph of species presence within Stream transects. Only transects with plants present are displayed in the above chart.

A total of 12 transects were surveyed in the major tributaries' stratum (Appendix B, Table 7) - plants were detected on all transects. Filamentous green algae dominated coverage along five transects (Figure 18). Many of the other transects were observed to include at least three species, much of the coverage contributions were attributed to *Elodea* and *Chara* spp., with lesser but still notable coverage by common bladderwort and curly-leaf pondweed. Percent plant coverage for stream data is included in Appendix C. Edgewood Creek had the highest cover of the curly-leaf pondweed (AIS); the Upper Truckee River had the highest cover of Eurasian watermilfoil (AIS).

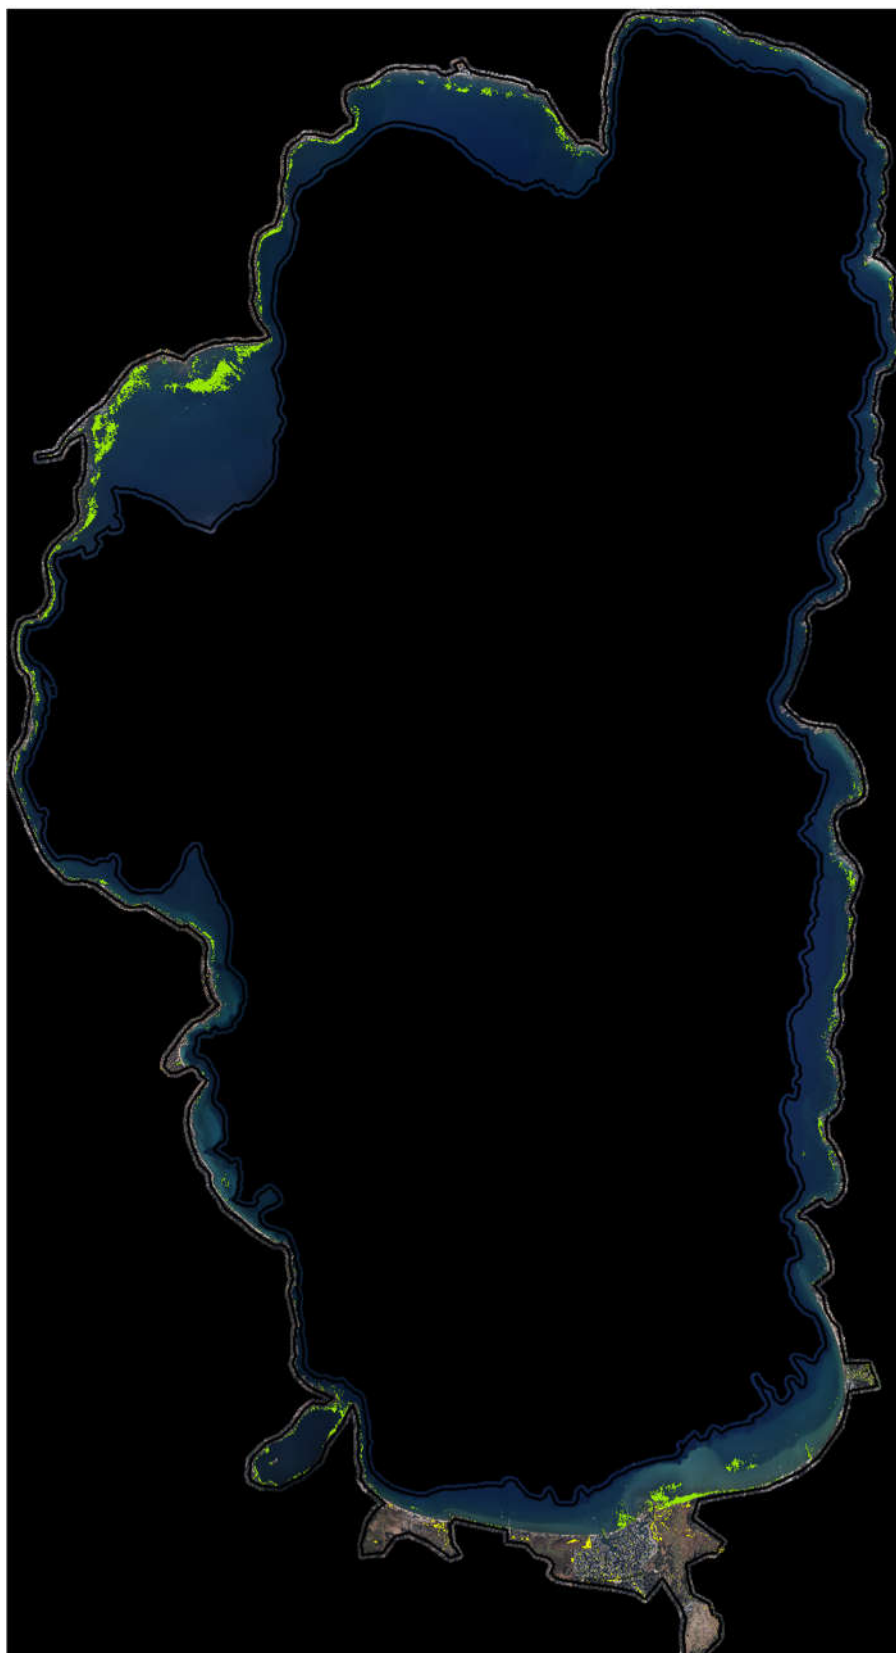
Figure 29. Modeled presence of submerged (green) and surface (yellow) vegetation in Lake Tahoe's nearshore and surrounding suitable habitats.

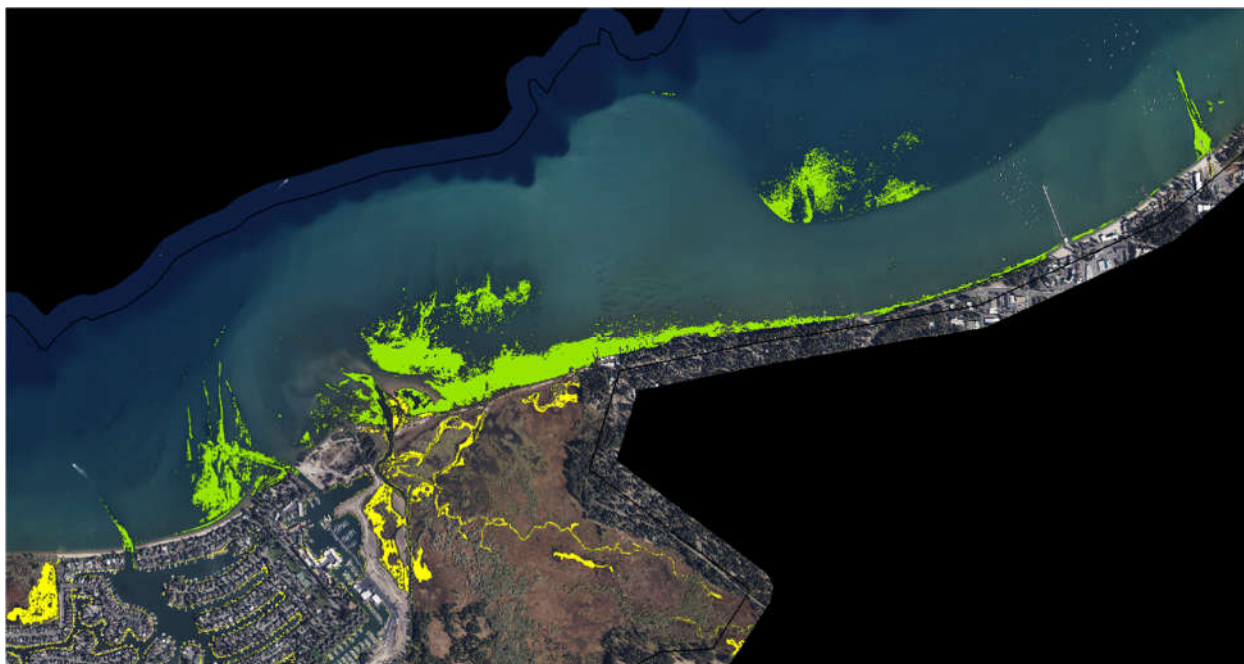
Figure 30. Modeled presence of submerged (green) and surface (yellow) vegetation in Lake Tahoe's nearshore and surrounding suitable habitats.

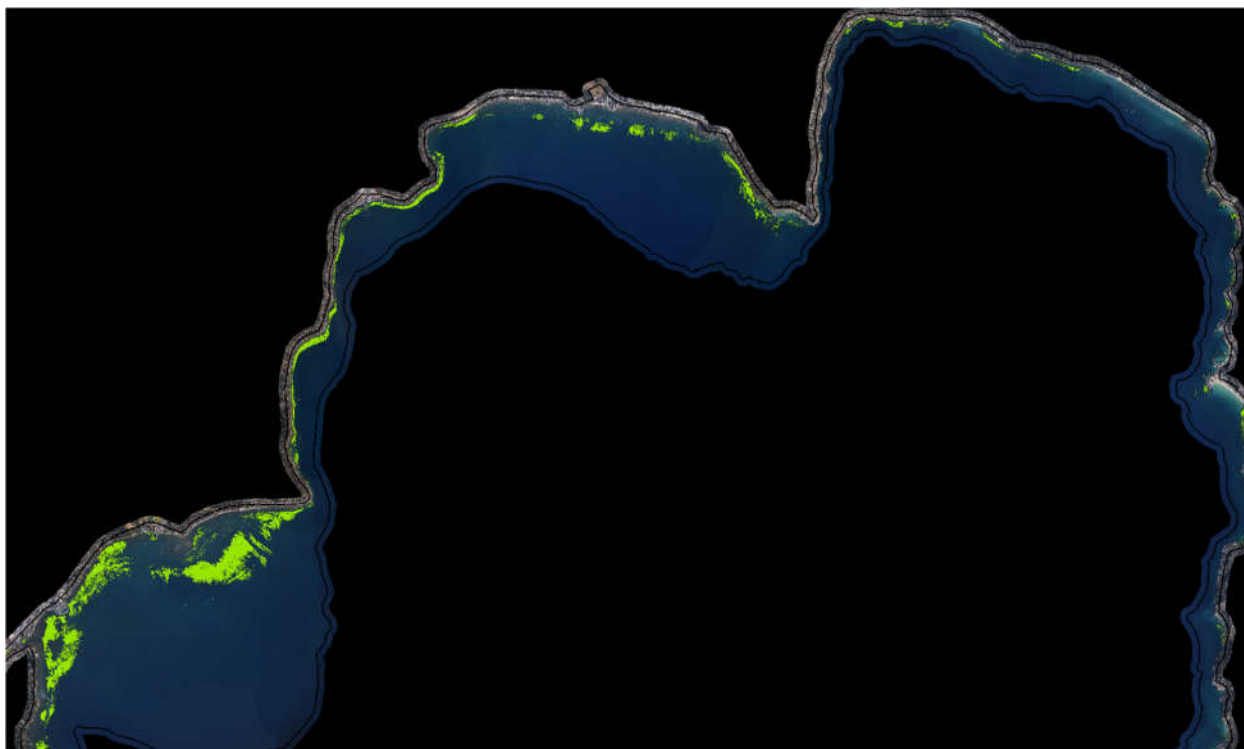
Figure 31. Modeled presence of submerged (green) and surface (yellow) vegetation in the northern region of Lake Tahoe.

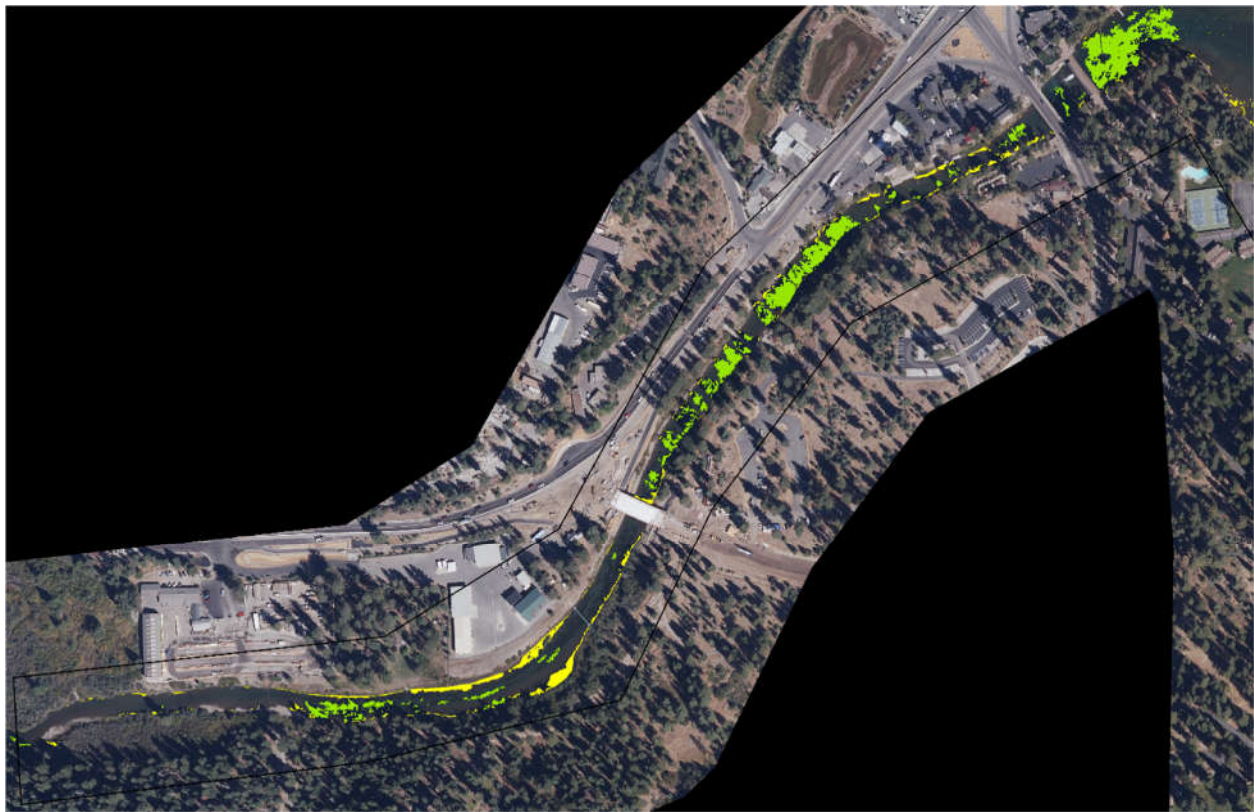
Figure 32. Modeled presence of submerged (green) and surface (yellow) vegetation in the Truckee River Corridor near Tahoe City, CA.

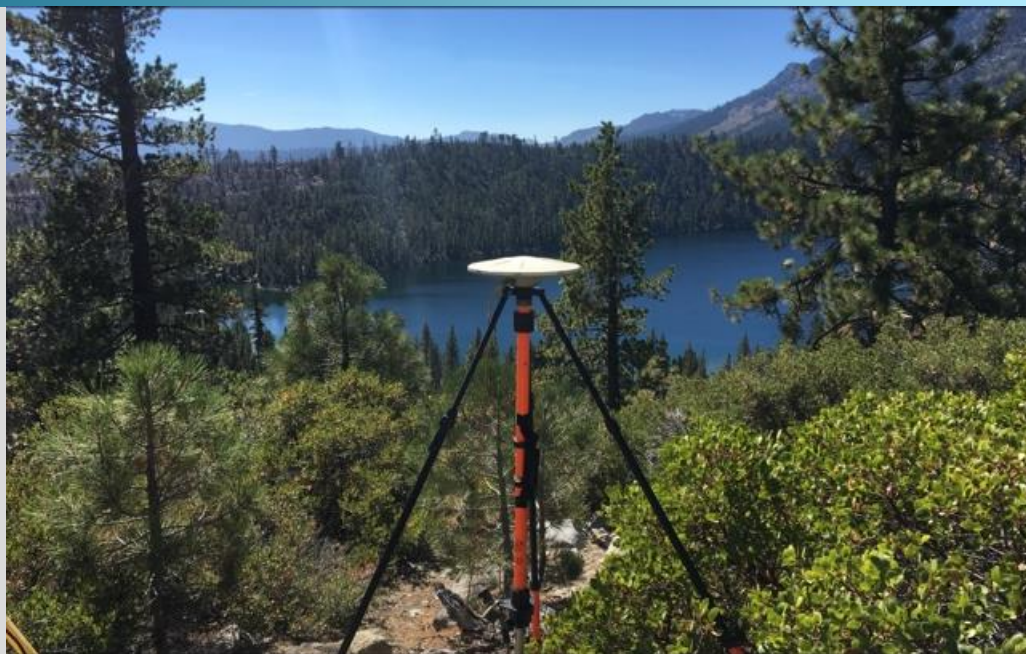
This photo taken by QSI acquisition staff shows a view of GNSS Equipment set up over monument VLECK_1 to the southwest of the Lake Tahoe project site.

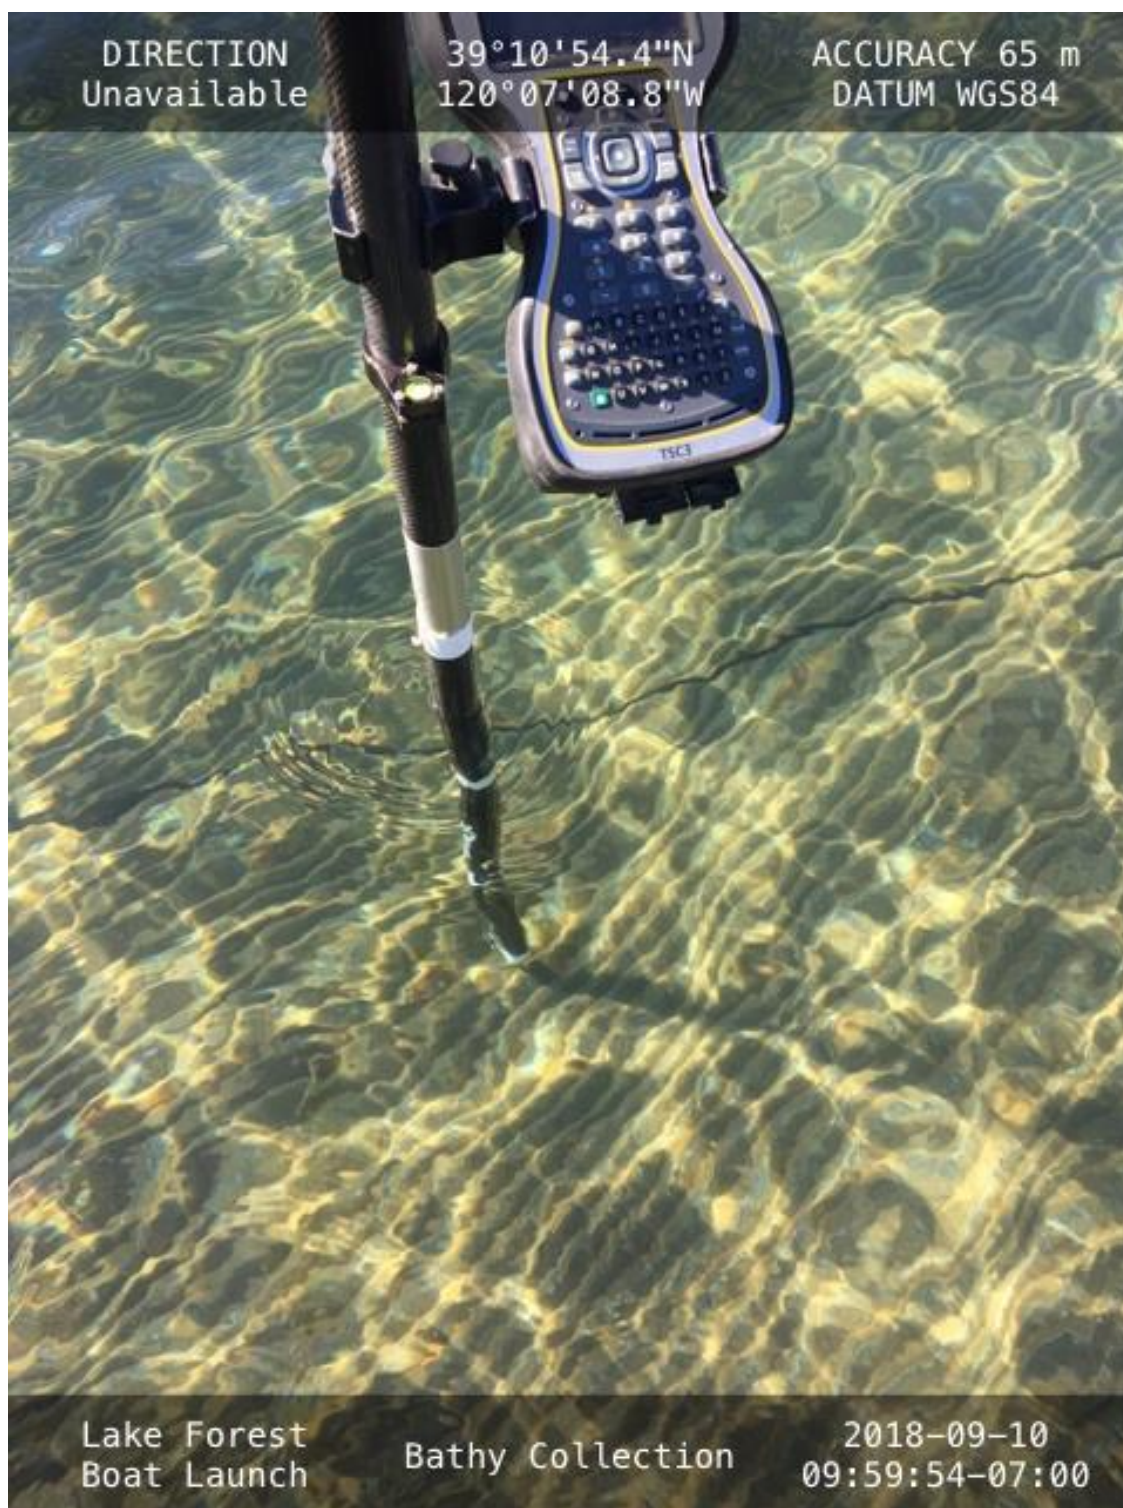
This photo taken by QSI acquisition staff shows a view of the water clarity conditions observed at the time of LiDAR acquisition.

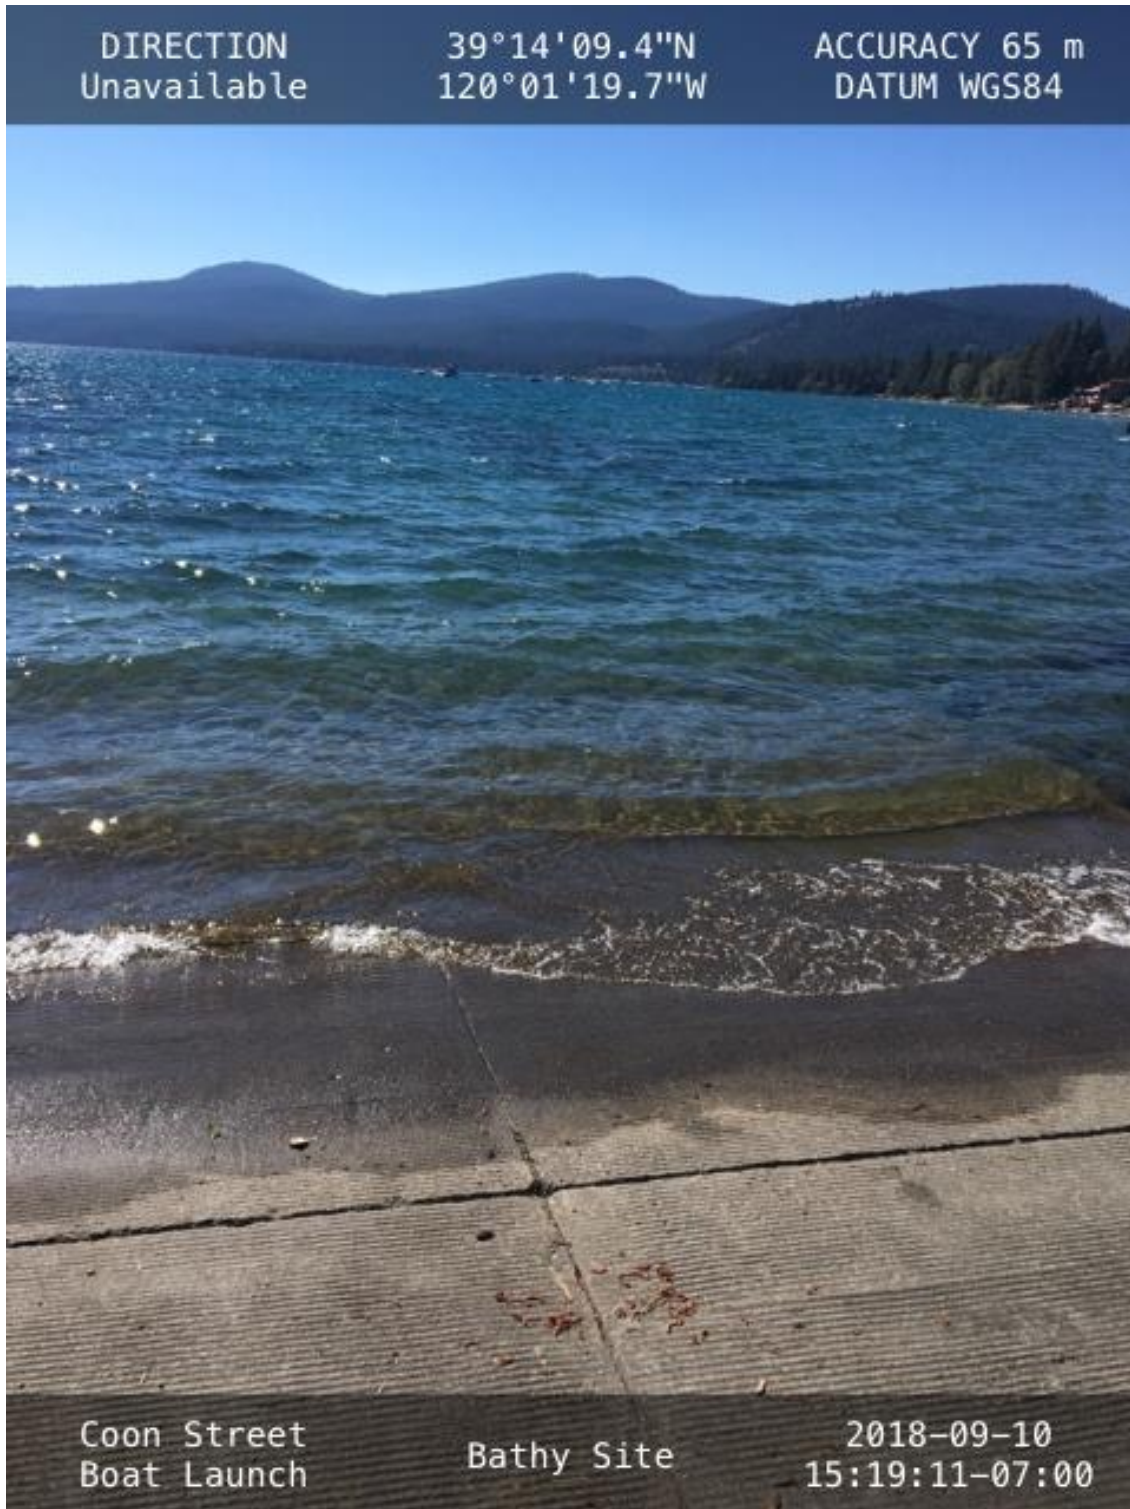
Another photo taken by QSI acquisition staff showing wave conditions observed on September 10th, 2018, during LiDAR acquisition.

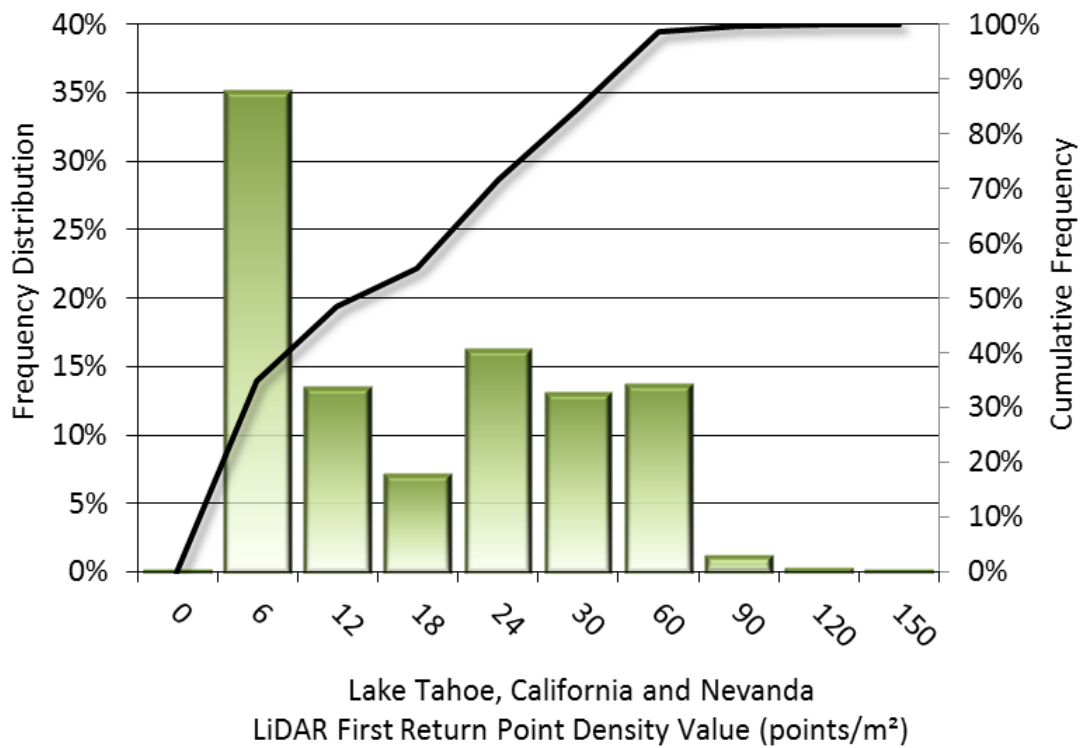
Figure 6: Frequency distribution of first return densities per 100 x 100 m cell

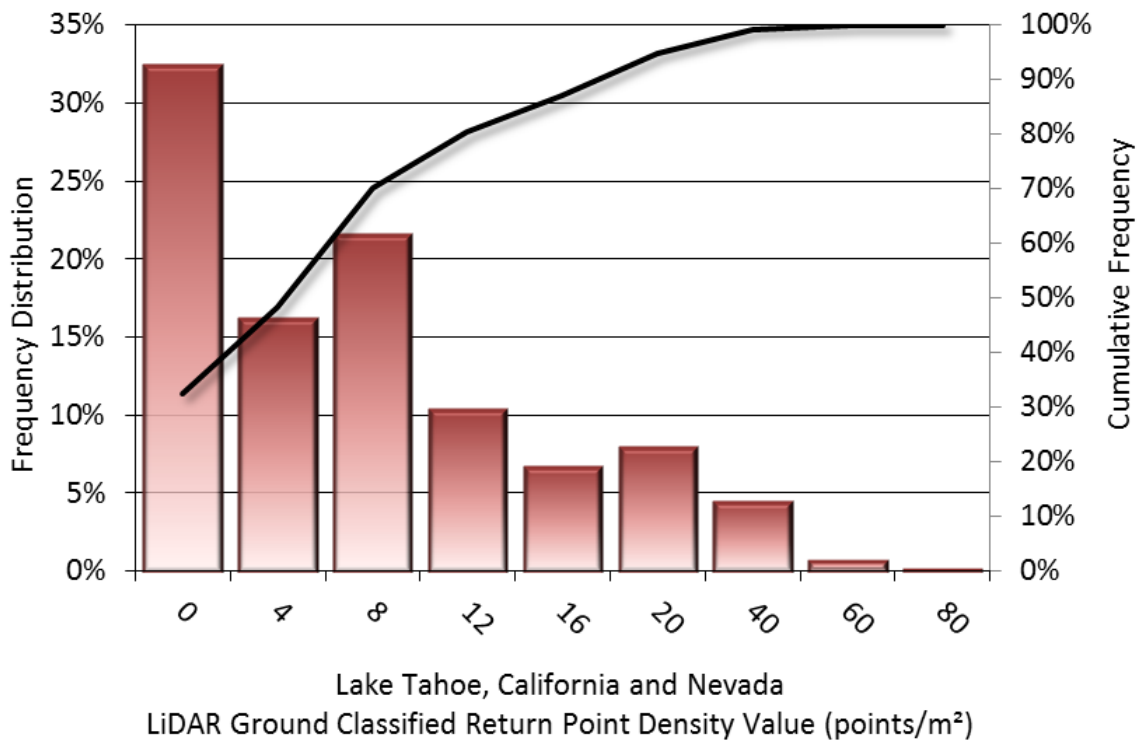
Figure 7: Frequency distribution of ground and bathymetric bottom classified return densities per 100 x 100 m cell
