# *Nearshore Water Quality Monitoring Buoy at Lake Tahoe*

Brian Fitzgerald  
Richard B. Susfalk  
Todd Mihevc

***Prepared by***  
Desert Research Institute, Reno, NV

***Prepared for***  
Nevada Division of State Lands  
Contract Award LTLP 10-06

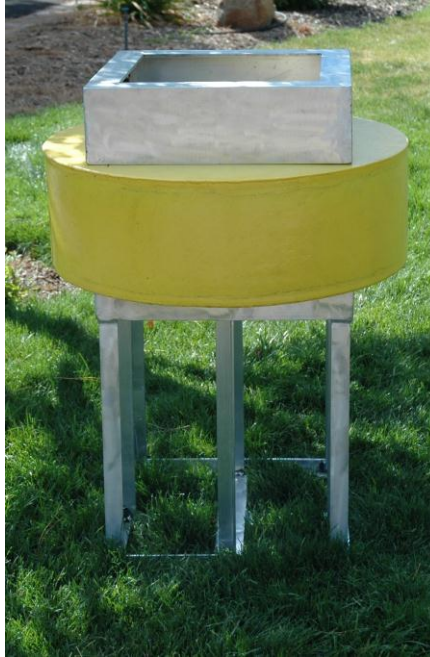
Figure 1. Structural portion of the buoy without sensors or sensor mounts.

The buoy platform was based on a closed cell Softlite ionomer foam float (Gilman Corporation). An equipment cage for mounting the water clarity sensors was positioned underneath the float while an electronics compartment was mounted on top of the float (Figure 1). The cage and electronic compartment were constructed from aluminum alloy 6061 and welded together with a mig welder.

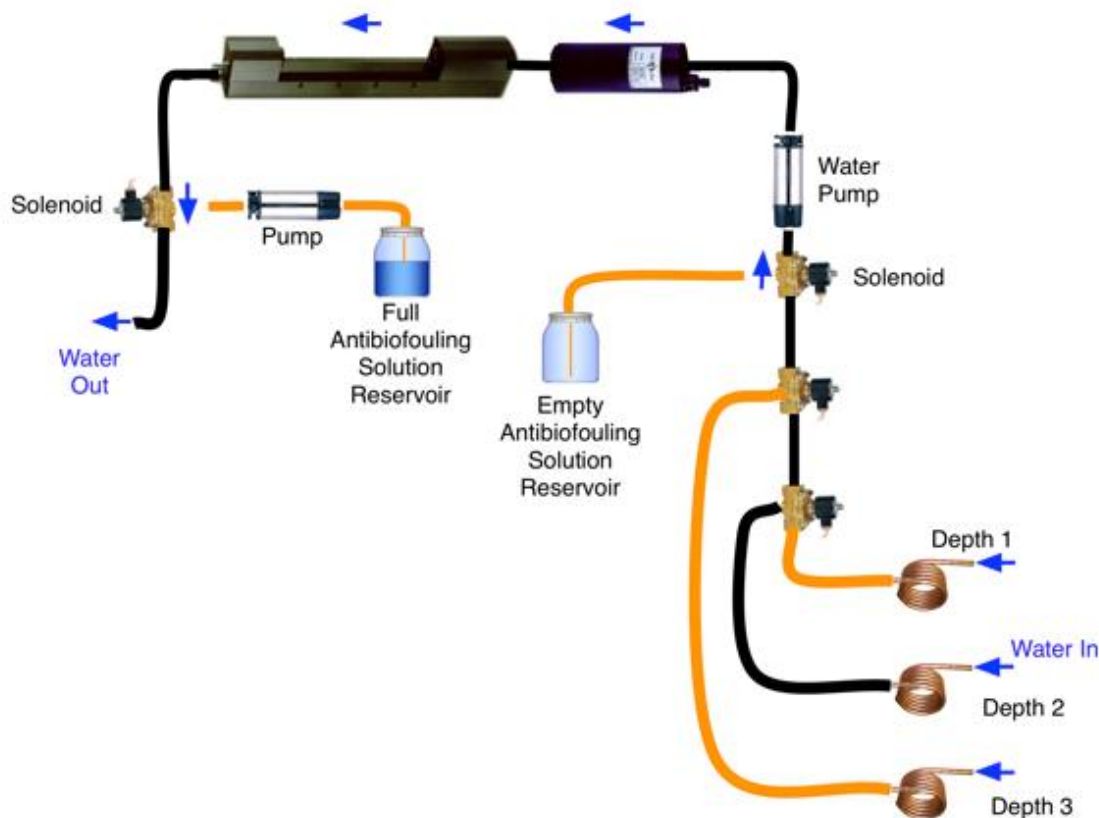
Figure 2. Schematic of “internal” water quality sensors on the buoy. Turbidity and water temperature (not shown) sensors were open to the lake whereas all others were part of a closed system requiring a pump to push water through the system.

Water clarity sensors were installed on the buoy either as an “external” sensor that measured the bulk water column or as an “internal” sensor that required water to be passed through a cuvette or internal chamber. The turbidimeter and thermocouple-based water temperature sensors were external while light transmissometer and chlorophyll fluorescence sensors were internal (Figure 2). Water was pushed through the internal sensors by a pump that was driven by a relay operated by the data logging system.

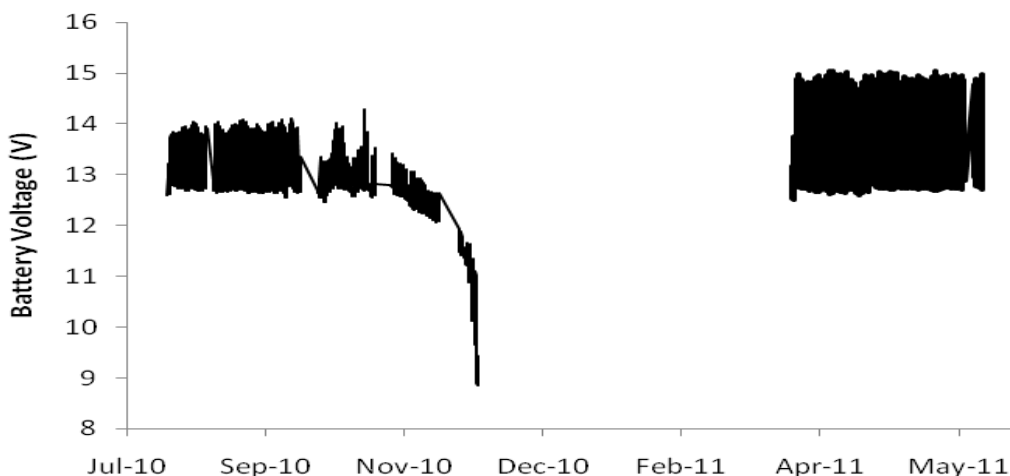
Figure 4. Average hourly battery voltage.

Beginning on November 18, 2010, the buoy exhibited an uncharacteristic increase in power use as evidenced by the large decrease in battery voltage at night when the system could no longer rely on solar panel inputs (See Figure 4). By December 2, 2010, the battery voltage was less than 8.5 volts and could no longer support the electronics package. The buoy was left in the water to assess if a series of subsequent sunny days could supply enough solar power to revive the buoy. After no communication for three days the buoy was removed from the water to assess the failure and conduct repairs, ending the fourth deployment.

Potential causes for these power issues on the buoy would be either too much drain, or not enough solar recharge. We postulated that the root cause of this power issue was: 1) the rate of power recharge, i.e., the new solar panel, solar regulator, and battery configuration, or 2) the drawdown of power from overuse of the high power-draw cellular modem or pumps. To assess the drawdown of the new solenoid driven pumping and cleaning systems, testing occurred in the laboratory of DRI; while testing of the recharge systems was conducted in DRI's parking lot to ascertain the solar panel charging capacity and battery recovery. Testing of the two systems, drawdown and recharge, did not reveal any deficiencies. Not until after this indeterminate testing and the logger and power control

device systems were re-wired did we discover a short in one of the four solenoids, which would have slowly drained the system of power while the solenoid was fully submerged in water over the course of a few days. It was concluded that this electrical short was the sole cause of the power issues during the fourth deployment. The buoy was fixed and redeployed to Round Hill Pines on March 22, 2011, for the fifth deployment.

Initial battery performance was good, as evidenced by the initial flat slope in battery voltage (Figure 4). After a solenoid short in late November 2010, however, battery power dropped below 8.5 volts and the station failed. While these power losses were unexpected, they provided learning experiences and pointed to specific issues that can be improved upon for future deployments.

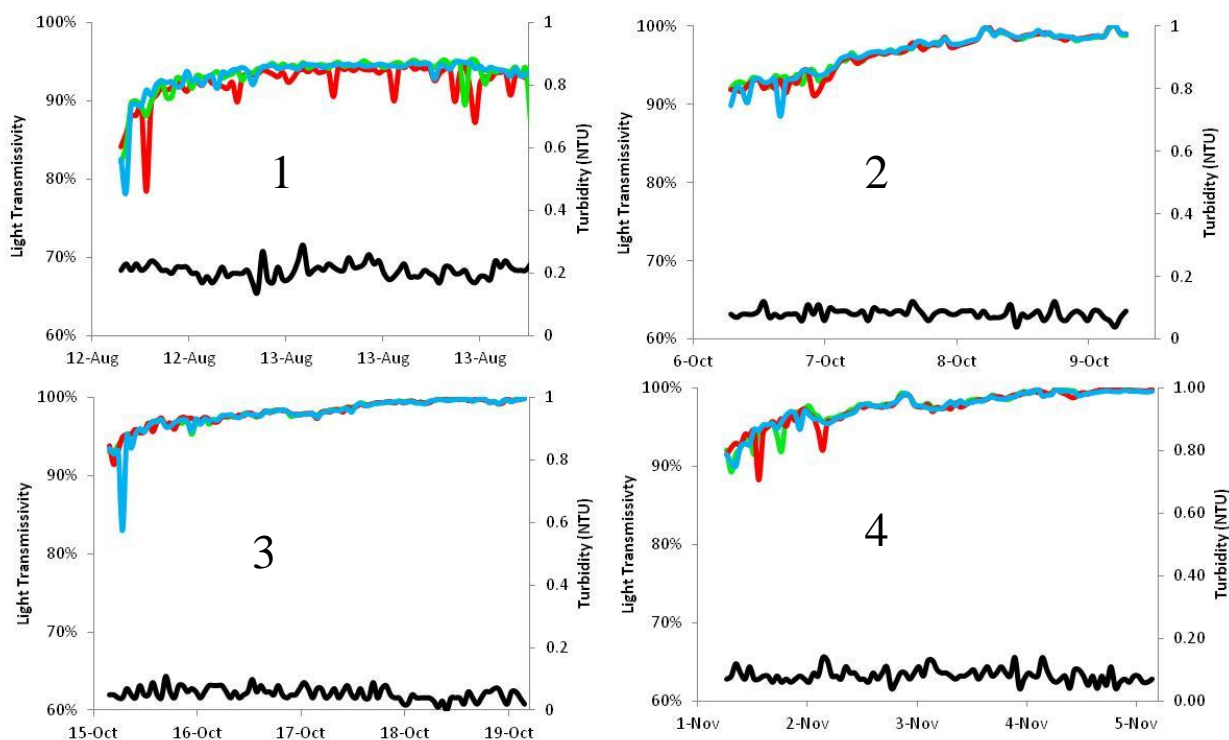
Figure 5. Comparison of observed turbidity and light transmissivity at the outset of each deployment period. Number labels refer to deployment number (Table 1). Black lines are turbidity; blue lines are 0.23 meter depth light transmissivity; green lines are 0.46 meter depth light transmissivity; red lines are 0.92 meter depth light transmissivity. Turbidity data presented are average hourly data and light transmissivity are raw hourly measurements. Note that deployment 5 is not included because the sampling interval was only once per day for light transmissivity at that time.

The light transmissometer sensor experienced a slow equilibration to baseline readings each time it was cleaned and/or deployed, even though the sample lines were completely purged of air when the buoy is put in to place (Figure 5). Upon each of the five separate deployments of the buoy, the light transmissometer showed variability in its baseline reading, i.e., the maximum transmittance of light for a deployment period was significantly different, ranging from 3300 to 4400mV. Natural causes, like real clarity degradation, were deemed to not be the cause as there was not a similar *in situ* response with either the turbidimeter nor chlorophyll meter. In addition, other studies on Lake Tahoe employing the same instruments did not observe such baseline shifts (Taylor et al., 2004, Susfalk et al., 2009). The equilibration problem resolved itself within 12 to 48 hours after being deployed.

It was suggested by the manufacturer of the instrument, WETLabs Inc, that very small air bubbles stuck to the walls of the sample cell by surface tension may cause refraction of the passing light beam, affecting the readings. A potential reason that the Taylor et al. (2004) and Susfalk et al. (2009) studies were not similarly impacted was because vibrations present on the Research Vessel Mount Rose may have helped to dissipate air bubbles. Alternatively, the light transmissometer on the boat was placed in warmer water before sampling began, allowing for air bubbles to overcome surface tension. The baseline and equilibration problems were not seen in 2008, potentially, because the buoy was not removed from the water for the entire study period. For 2010, the problem occurred despite careful purging of the sample lines of air, while the intake was submerged in the lake at the time of each deployment. It was hypothesized that flushing a surfactant through the system may clean the light transmissometer cell of any residual bubbles. This theory was not tested *in situ* and would be essential prior to another buoy deployment to prevent these baseline shifts. Surfactant could be pumped through the plumbing system as part of the purging process at the beginning of each deployment. Another solution may be to calibrate the light transmissometer to a known, ultra-clear medium such as deionized water at the outset of each deployment.

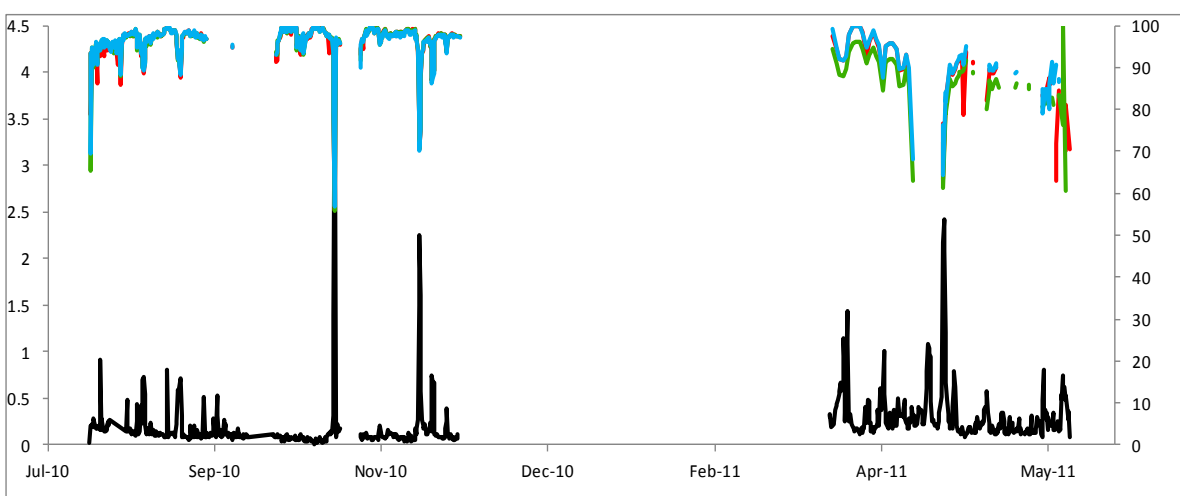
Figure 6. Comparison of observed turbidity and light transmissivity for the period of record, August 2010- June 2011. Black line is turbidity. Blue, green, and red lines are 0.23, 0.46, and 0.92 meter depth light transmissivity, respectively. Turbidity data and light transmissivity are 6-hour average measurements.

The full data set for the 2010 study are presented in Figure 6. During the fall season, only modest fluctuations are noted in both turbidity and light transmissivity. In the spring, more variability is observed in both of these water quality parameters. The sampling interval for light transmissivity was only three times per day in March & April, then once per day in May and June, which may contribute to the irregularity of results. The turbidity during this spring sampling had similar fluctuation, which indicates real water clarity loss. These observations are explored in greater detail in the deployment graphs and event graphs later in this chapter.

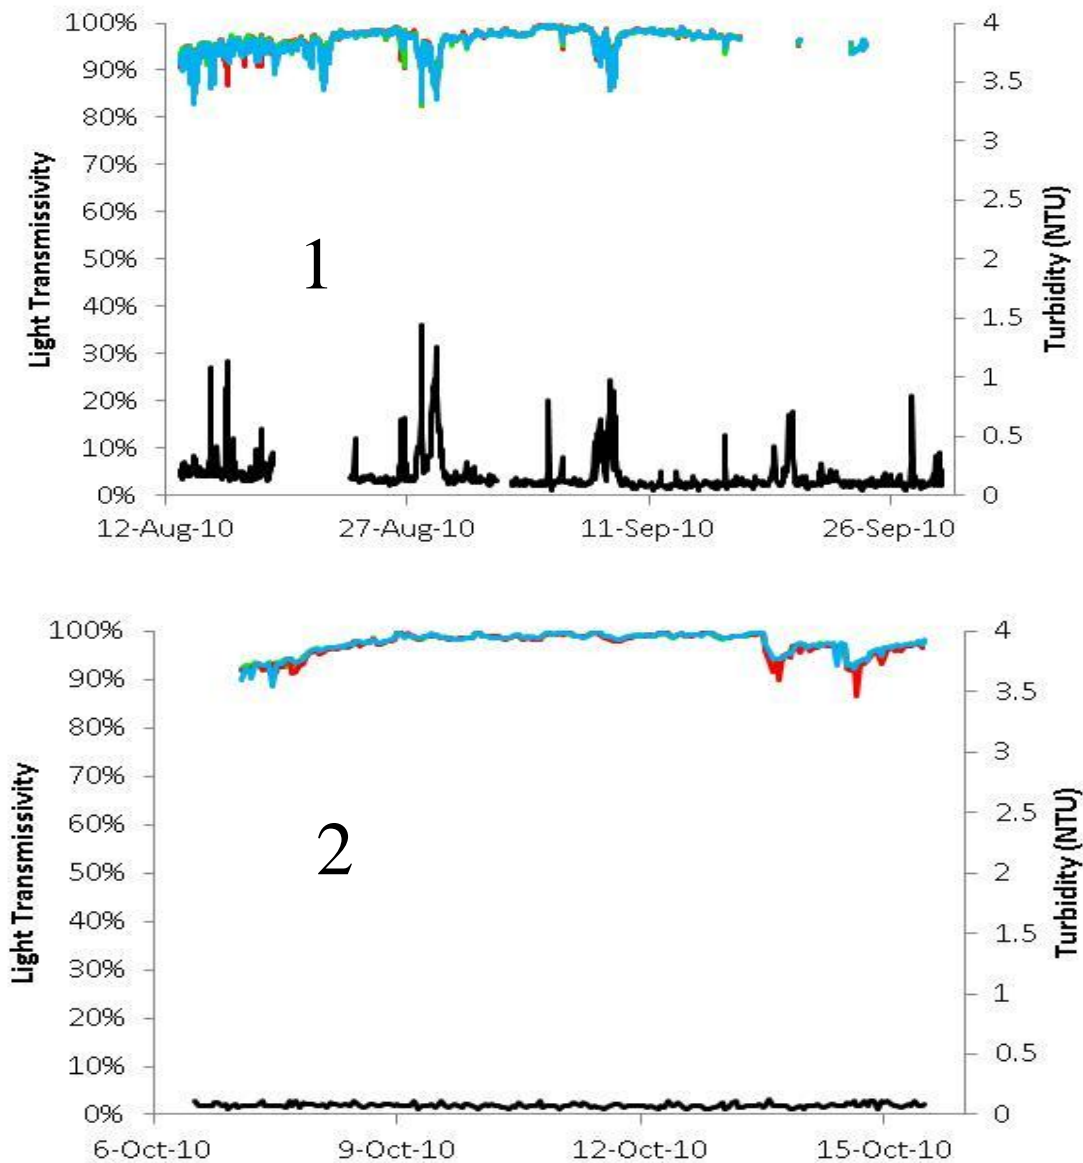
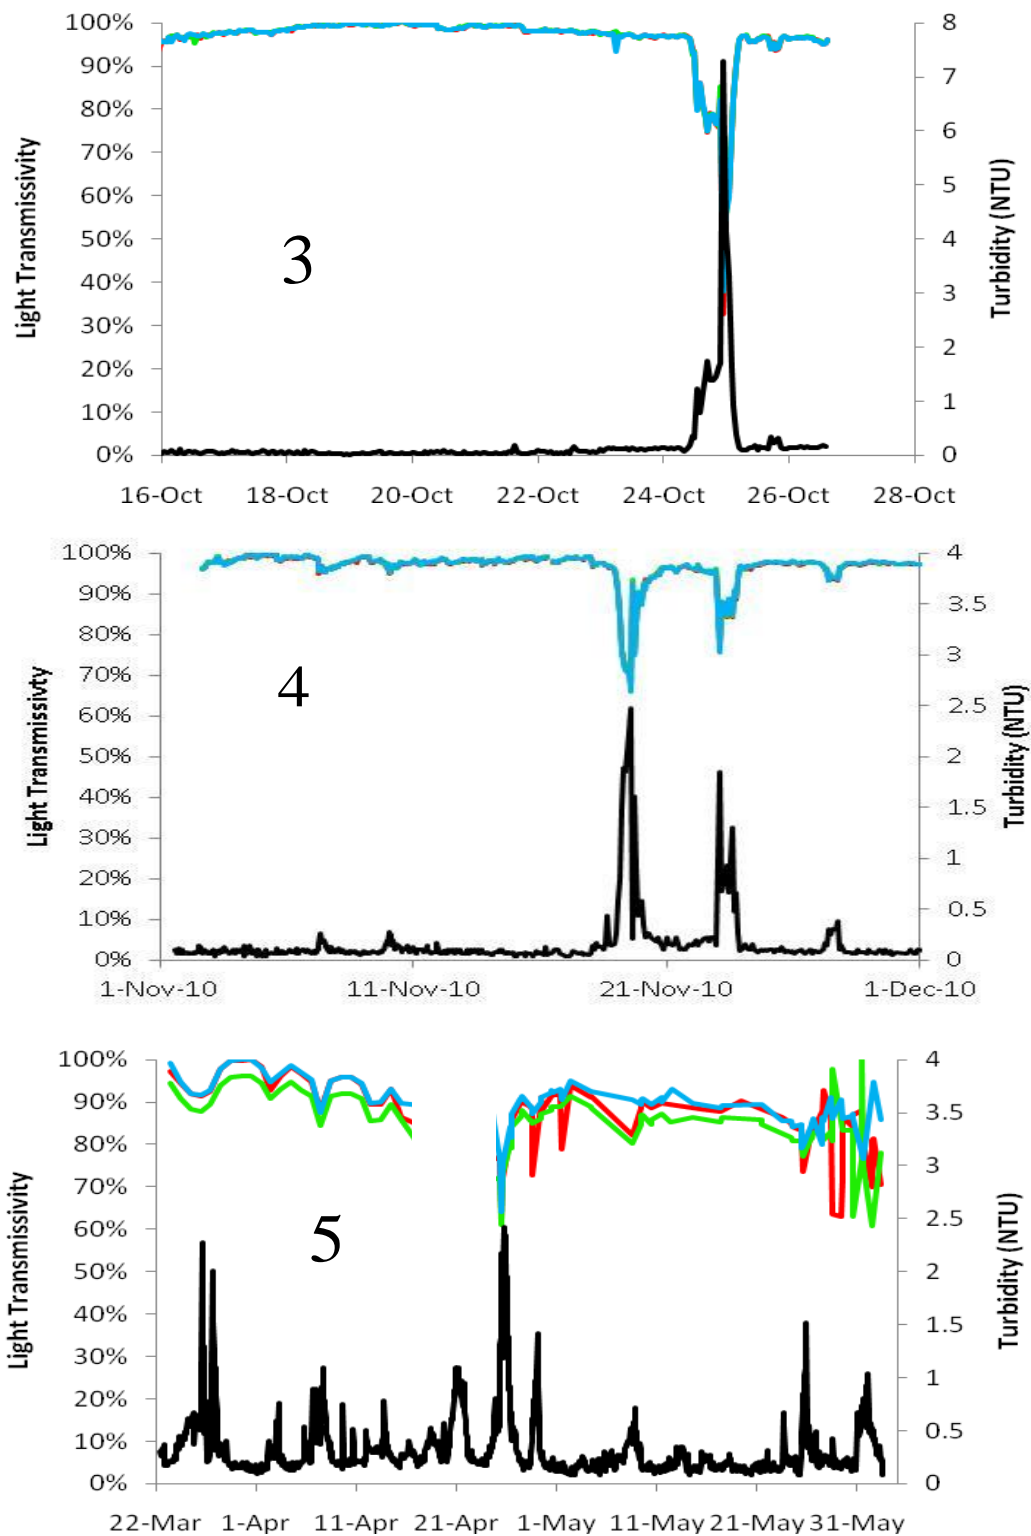
Figure 7. Comparison of observed turbidity and light transmissivity between August 12, 2010 and June 2, 2011. Each graph represents one deployment period. Graph “1” is deployment 1, graph “2” is deployment 2, etc. Black lines are turbidity, blue lines are 0.23 meter depth light transmissivity, green lines are 0.46 meter depth light transmissivity; red lines are 0.92 meter depth light transmissivity. Turbidity data presented are average hourly data and light transmissivity are raw hourly measurements. Note that the turbidity scale on secondary y-axis in graph 3 is twice that of the other graphs.

Figure 7. Comparison of observed turbidity and light transmissivity between March 22, 2010 and June 2, 2011 (continued).

Over the five deployments, turbidity and light transmission both mirrored changes in water clarity (Figure 7). Daily minimum turbidity levels were approximately 0.15 to 0.35 NTU during the snowmelt season (deployment 5), or two or more times greater than that of background measurements (0.06 NTU) conducted in late summer. Average daily values of greater than 0.5 NTU were not uncommon during snowmelt, with instantaneous measurements of up to approximately 2.2 NTU. The Marla Bay area was chosen as a location for the project because of its proximity to large Asian clam beds. Asian clam deterrent tarps had been in place and would be removed during the course of the buoy deployment by Wittman et al (2012), providing an opportunity to observe water quality before, during, and after the disturbance (Section 5.1.3). Turbidity measurements were deemed to not be significantly impacted by runoff. The only tributary to Marla Bay is

It should also be noted that the internal sensor data for deployment 5 is irregular and blocky because of the extended sampling interval. The perceived benefits to power savings did not outweigh the costs to data collection and interpretation by sampling once per day for this study. Later, in April, sampling of light transmissivity and relative chlorophyll was conducted three times per day during the daylight hours. This schedule may provide insight towards both long-term baseline reference clarity data, but also observe shorter-term hydrologic events that would be missed with once-per-day sampling. Light transmissivity and relative chlorophyll samples should be taken once per hour if the intent is monitoring of short-term hydrologic events. Alternatively, this once-per-hour sampling scheme could be rotated through the three depths, so that each depth is sampled every three hours for a total of three or four samples per day, if needed. If the goal of buoy monitoring of the nearshore is long-term threshold exceedances and management thereof, then once-per-day sampling may suffice.

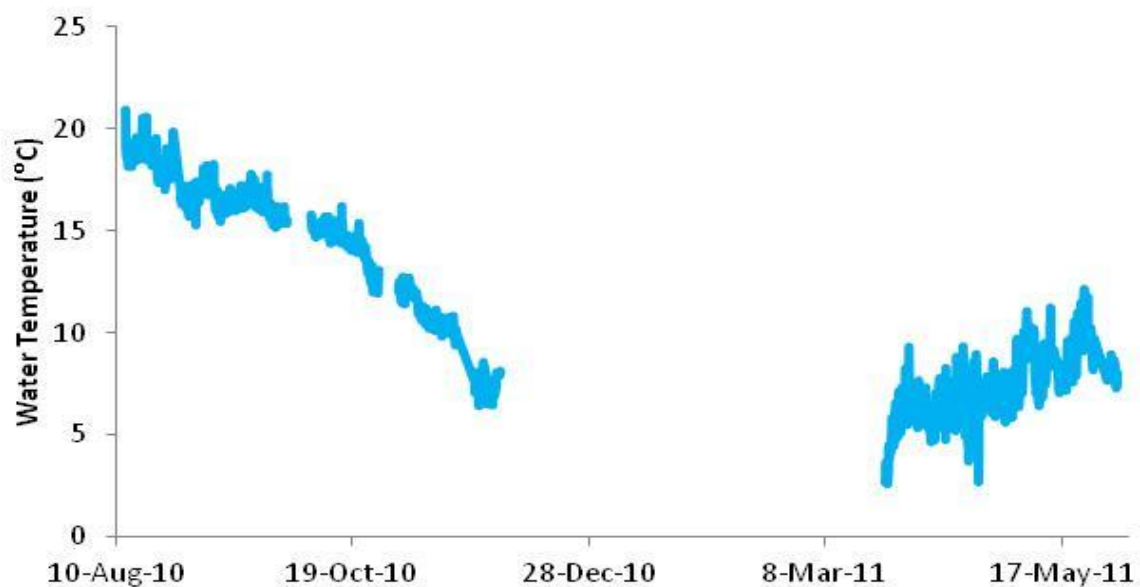
Figure 8. Temperature for the period of record, between August 12, 2010 and June 2, 2011. Only the middle depth (0.46 meters below water surface) is shown, but deviation from upper (0.23 meters) and lower (0.92 meters) depths over this scale were negligible.

The water temperature results for the period of record are shown in Figure 8. The upper and lower thermocouples are not shown in this long-term graph, as they provide little added information. The depth profile of temperatures provided more distinctive opportunity for interpretation of short-term changes in air versus water temperature (Section 4.2.2). Water temperature changed from a daily average high of 19.7 °C on August 18, 2010, to a daily average low of 2.7 °C on March 25, 2011.

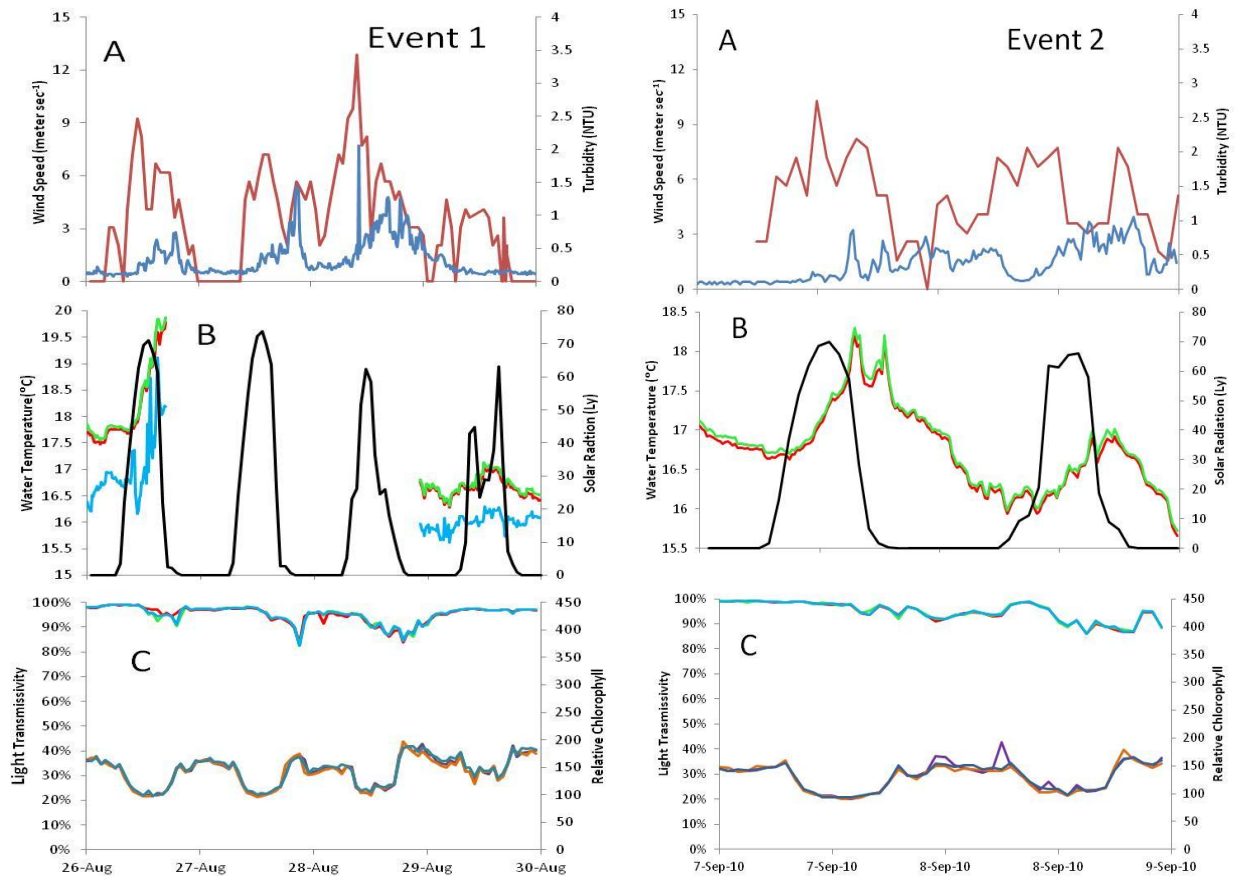
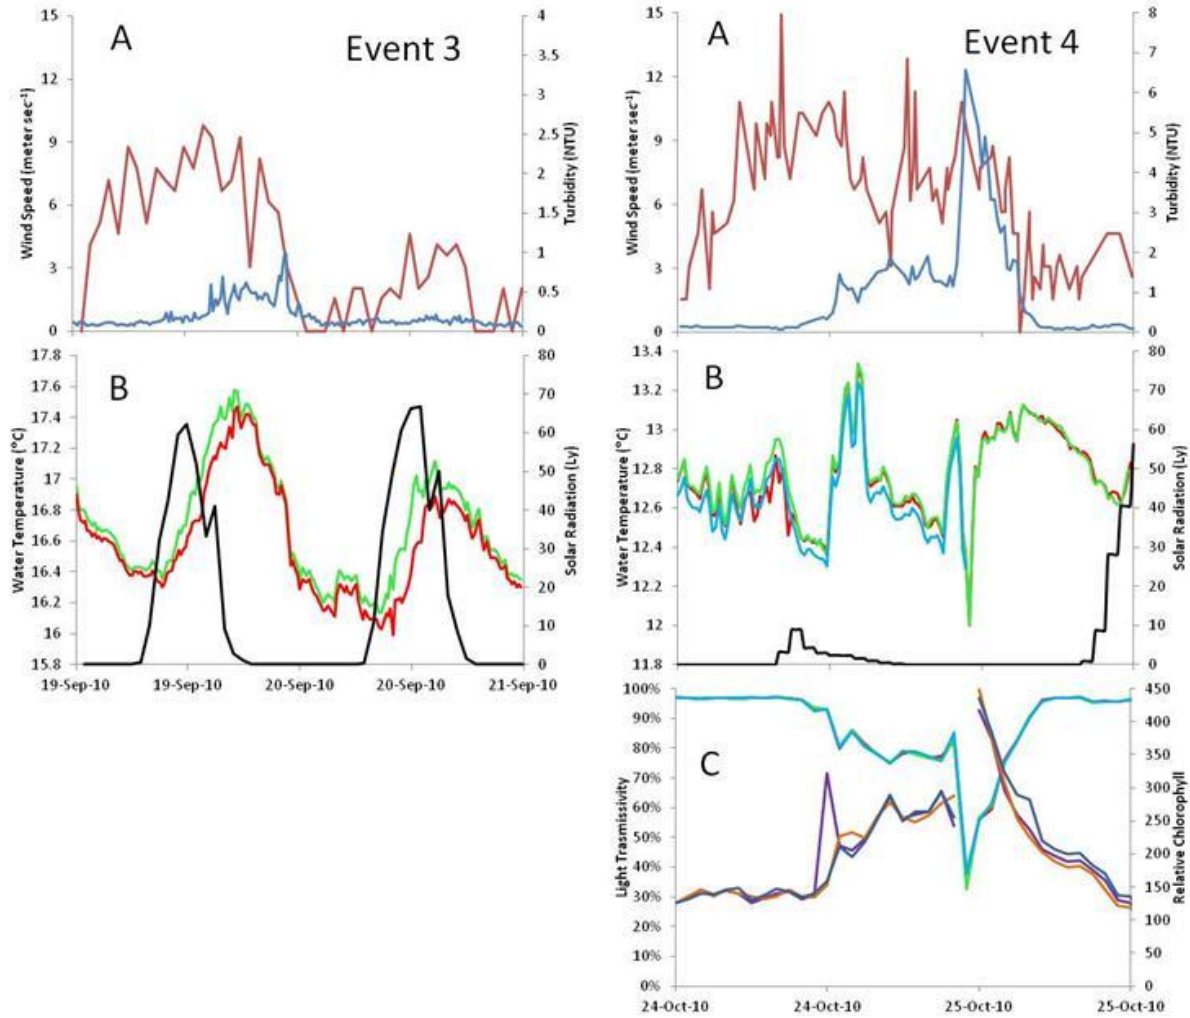
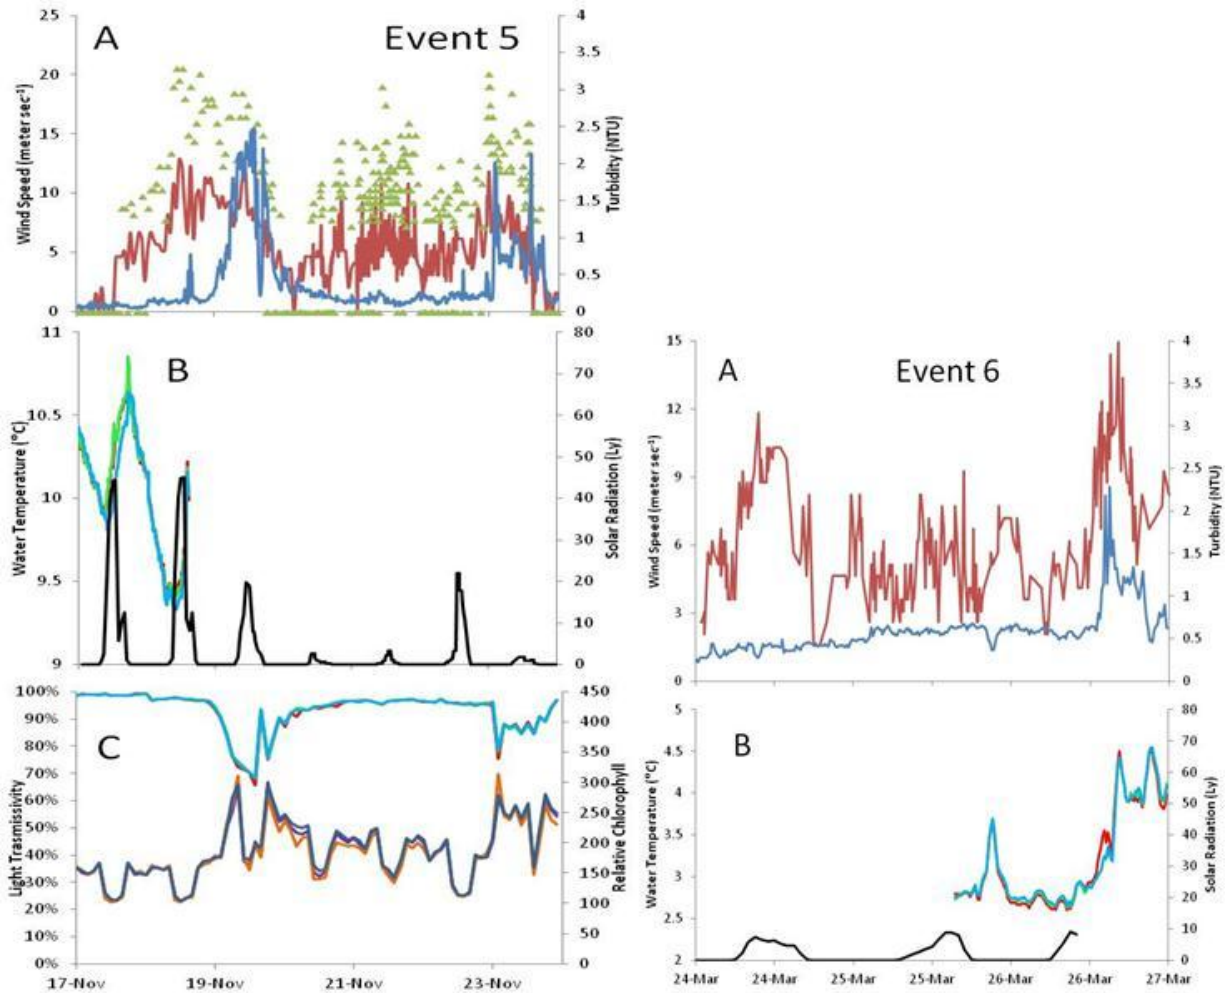
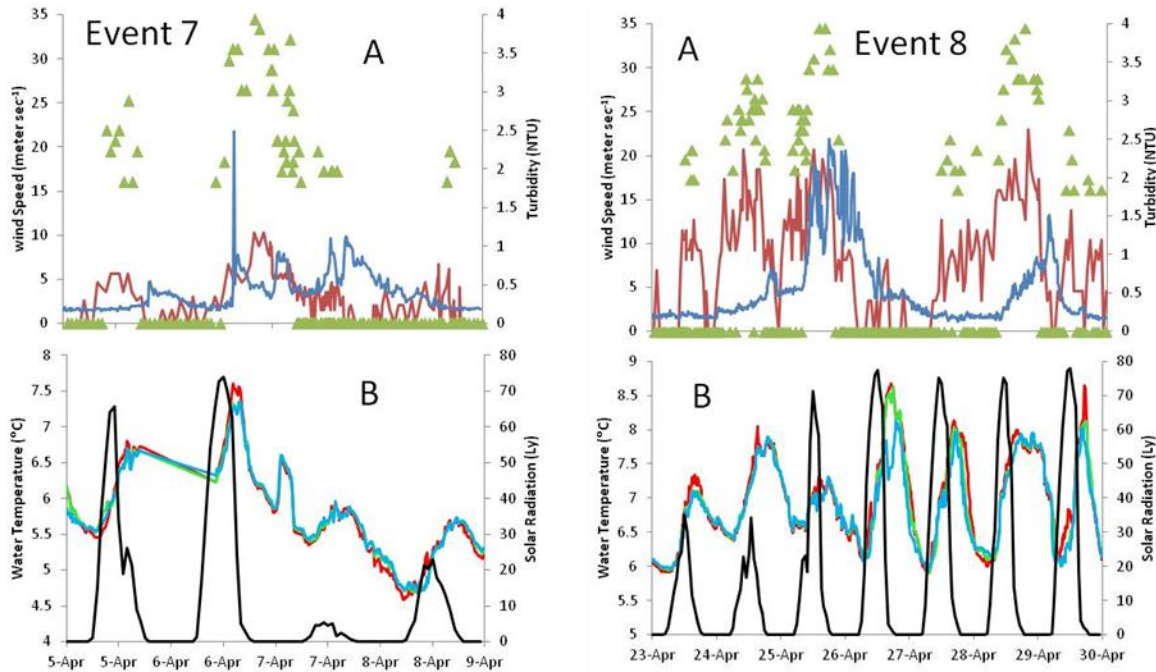
Figure 9a Events 1 and 2. For “A” graphs: Turbidity (dark blue) and wind speed (purple). For “B” graphs: Water temperature profile, light blue = shallow (0.23 meters), green = middle (0.46 meters), red = deep (0.92 meters) and, solar radiation (black), comparison. For “C” graphs: Light transmissivity profile, light blue = shallow (0.23 meters), green = middle (0.46 meters), red = deep (0.92 meters), and Chlorophyll profile, navy blue = shallow (0.23 meters), purple = middle (0.46 meters), orange = deep (0.92 meters). All values are reported as hourly averages.

Figure 9b. Events 3 and 4. For “A” graphs: Turbidity (dark blue) and wind speed (purple). For “B” graphs: Water temperature profile, light blue = shallow (0.23 meters), green = middle (0.46 meters), red = deep (0.92 meters) and, solar radiation (black), comparison. For “C” graphs: Light transmissivity profile, light blue = shallow (0.23 meters), green = middle (0.46 meters), red = deep (0.92 meters), and Chlorophyll profile, navy blue = shallow (0.23 meters), purple = middle (0.46 meters), orange = deep (0.92 meters). All values are reported as hourly averages.

Figure 9c. Events 5 and 6. For “A” graphs: Turbidity (dark blue) and wind speed (purple). Olive triangles are wind gust speed. For “B” graphs: Water temperature profile, light blue = shallow (0.23 meters), green = middle (0.46 meters), red = deep (0.92 meters) and, solar radiation (black), comparison. For “C” graphs: Light transmissivity profile, light blue = shallow (0.23 meters), green = middle (0.46 meters), red = deep (0.92 meters), and Chlorophyll profile, navy blue = shallow (0.23 meters), purple = middle (0.46 meters), orange = deep (0.92 meters). All values are reported as hourly averages.

Figure 9d. Events 7 and 8. For “A” graphs: Turbidity (dark blue) and wind speed (purple). Olive triangles are wind gust speed. For “B” graphs: Water temperature profile, light blue = shallow (0.23 meters), green = middle (0.46 meters), red = deep (0.92 meters) and, solar radiation (black), comparison. All values are reported as hourly averages.

There were eight significant nearshore clarity reducing events during the study period (Figures 9a through 9d). These events were largely unexplained phenomena, as one of the probable causes, wind, was not directly measured at or near the buoy location. Events were chosen based on a finding of turbidity above 1 NTU, which meant that clarity loss was an order of magnitude above normal, baseline readings.

The temperature profile can be more easily viewed in the event figures (Figure 9, events 1 through 8) than in the long-term period of record graphs (Figure 7). During the fall and winter, the shallowest temperature (light blue) is colder than the deeper two temperatures. The cold air above resulted in lower water temperatures at the surface than temperatures seen at the 0.92 meter depth thermocouple (red). Then, the colder air temperatures were driven down the water column. The concept of diel temperature cycles reinforces this observation because the amplitude of the shallowest temperature cycle is greater and responds to changes in air temperature before the lower two water temperatures. In Figure 11, there is good definition of a diel temperature swing, whereby the sinusoidal curve of daily air temperature and solar radiation drive warmer air temperatures vertically down the water column during the day and cold air down in to the water column at night. In addition, the temperature profile reveals good mixing during strong wind events, as in event 8, where the temperatures are more uniform when winds are strongest and more divergent

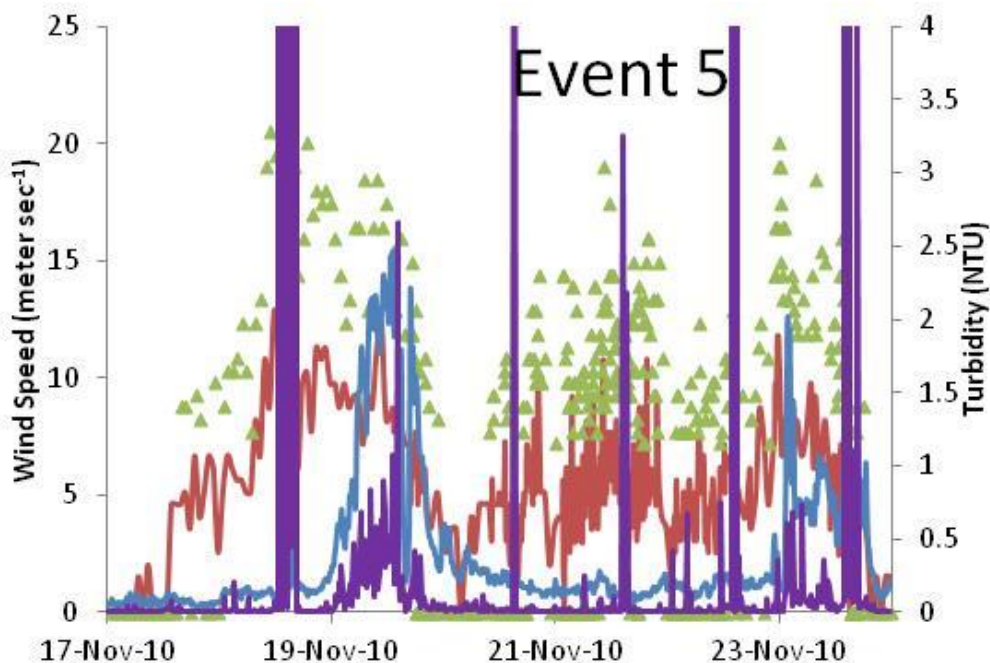
Figure 10. Event 5. Turbidity (dark blue) and wind speed (red). Olive triangles are wind gust speed. Purple line is variance of turbidity (in NTU).

Back and forth buoy movement during wind events may have been the source of bubbles entrained in the water column, affecting turbidity readings. Each turbidity reading reported by the sensor was comprised of an estimated average of 100 readings taken over 10 seconds. To improve instantaneous turbidity readings, the best systematic estimator (BES) of turbidity was utilized rather than a straight arithmetic mean. This approach was chosen because it reduced the impact of spurious high and low readings but also provided some weight to values on either side of the mean. Large standard deviations did not always indicate wind events or unusual turbidity values. The variance term reported by the turbidimeter did not show any significant correlation with wind speed ( $R^2 < 0.005$ ), so was not incorporated in the event graphs. Occasionally, during storms, the turbidity variance became elevated to a large value and may have been a result of wind-energy reaching some threshold, which resuspended bottom sediments or created enough bubble splashing to affect readings. For example, during Event 5, turbidity variance was highly elevated when wind speeds were above  $10 \text{ m s}^{-1}$  and wind gusts were near  $20 \text{ m s}^{-1}$  (Figure 10). The turbidity variance was typically highest at the beginning of an event, which may correspond

to air bubbles from high-gust wind action. In some of the events considered, wind speed appears to elevate turbidity, but not in all cases. Without wind speed and direction measurements on or immediately proximate to the buoy location, it is difficult to determine cause and effect of this phenomenon. Future buoy deployments should incorporate an anemometer at or near the buoy deployment location.

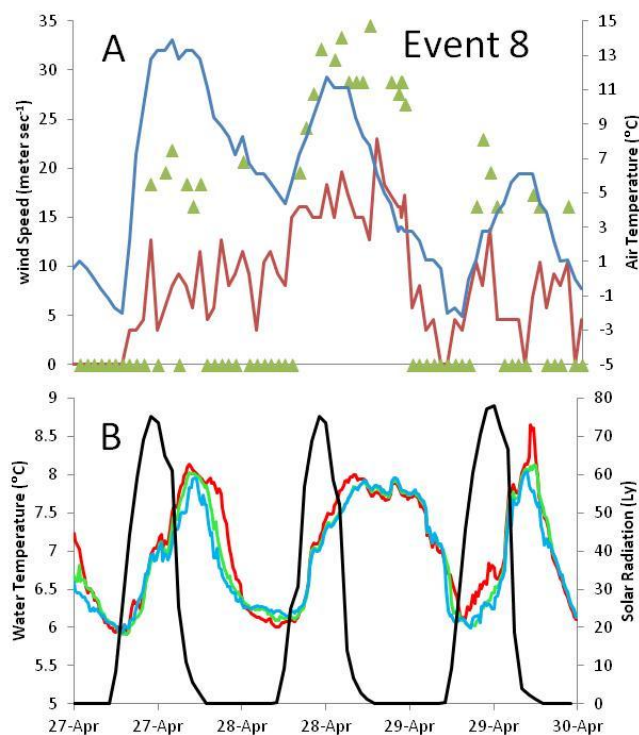
Figure 11. The end of Event 8, April 27, 2011 to April 30, 2011. For “A” graph: Wind speed is red, olive triangles are wind gust speed, the blue line is air temperature. For “B” graph: Water temperature profile, light blue = shallow (0.23 meters), green = middle (0.46 meters), red = deep (0.92 meters) and, solar radiation (black), comparison. All values are reported as hourly averages.

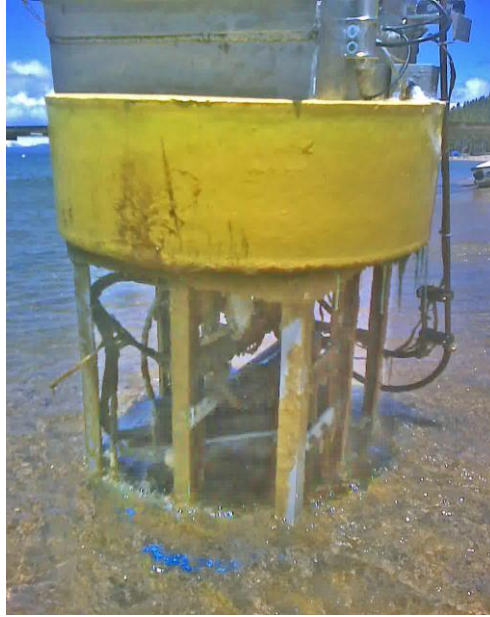
Figure 12. The buoy upon removal on June 2, 2011 showing the amount of algae growth on the aluminum infrastructure. Upright, at the right side of the photo, are the internal sample intake lines, which would hang down in to the water column during normal operation.

The implemented system in 2010 for eliminating biofouling of the light transmissometer and chlorophyll sensors by using a dual bladder system filled with a liquid solution of anti-biofouling compounds worked well. There was no discernible level of biofouling to the internal sensors. The pump and solenoid active anti-biofouling system required minimal maintenance, as the halide biocide fluid did not lose efficacy or significant volume over time. These results indicated that the cleaning cycle frequency can be reduced in winter to give lower power requirements, as biofouling does not readily occur at that time. Cleaning frequency is then increased in summer as the air and water warms, which improves battery performance, and increased sunlight recharges the batteries through the solar panel. Considering the poor anti-biofouling results from the pilot study and the amount of periphyton attached to the undercarriage of the buoy upon removal in June 2011 (Figure 12) the new configuration using an active anti-biofouling approach can be considered successful.

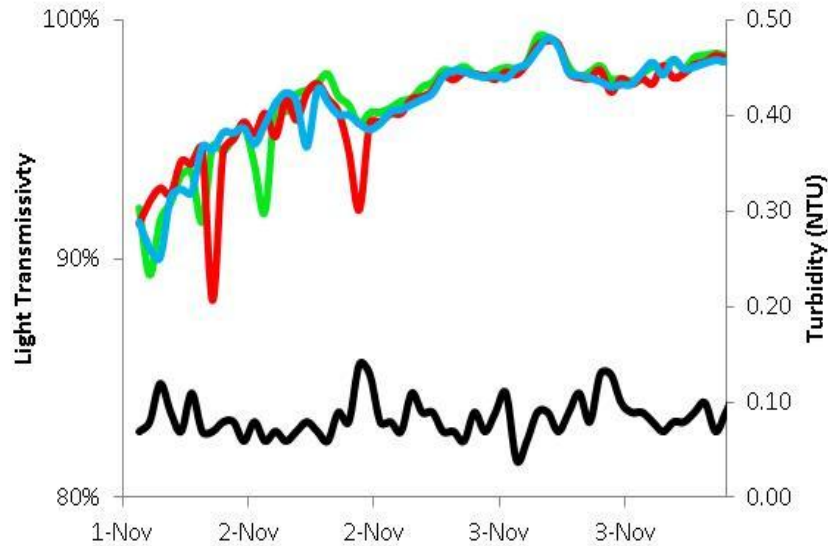
Figure 13. Details of equilibration shift at the beginning of deployment 4, corresponding to the time period of the removal of Asian clam deterrent tarps. Black line is turbidity, blue line is 0.23 meter depth light transmissivity, green line is 0.46 meter depth light transmissivity; red line is 0.92 meter depth light transmissivity.

In the first week of November 2010, the University of California, Davis TERC team removed a tarp from the substrate designed to inhibit Asian clam growth (Wittman et al, 2012). The buoy was placed at the anchor closest to the tarp removal area at the beginning of the fourth deployment on November 1, 2010. The buoy was approximately 200 meters away from the tarps at this time. Although the equilibration of the light transmissometer at the beginning of this deployment occurred at the same time as the tarp removal, small changes in water clarity were observed (Figure 13). The red line shows the 0.92 meter depth light transmissivity, which clearly spikes to less than the middle (0.46m) and upper (0.23m) depth intervals. The clarity reduction for this event was not consistent with timing or depth, as there was a different amount of response at each depth. In addition, the travel time of a potential disturbance from the Asian clam tarps to the buoy location is unknown. Each of the spikes in clarity loss occurs over a period of 3 to 6 hours, lending credence to their interpretation as real phenomena not false readings. That the turbidimeter does not indicate a clarity reducing response may mean that it was not sensitive enough to respond to the modest clarity disturbance. Other nearshore clarity reducing events commonly showed light transmission below 90% during events. The spikes in reduced light transmission are real, if small and short-lived.
