## Monitoring Ecological Functions of Spooner Meadow to Inform Restoration Implementation

Project Number: LTLP 23-01  
Project Period: April 15, 2023 - June 30, 2025

Prepared by Amy Langston, PI  
Assistant Research Professor  
Division of Earth and Ecosystem Sciences, DRI  
Final Project Report  
June 2025

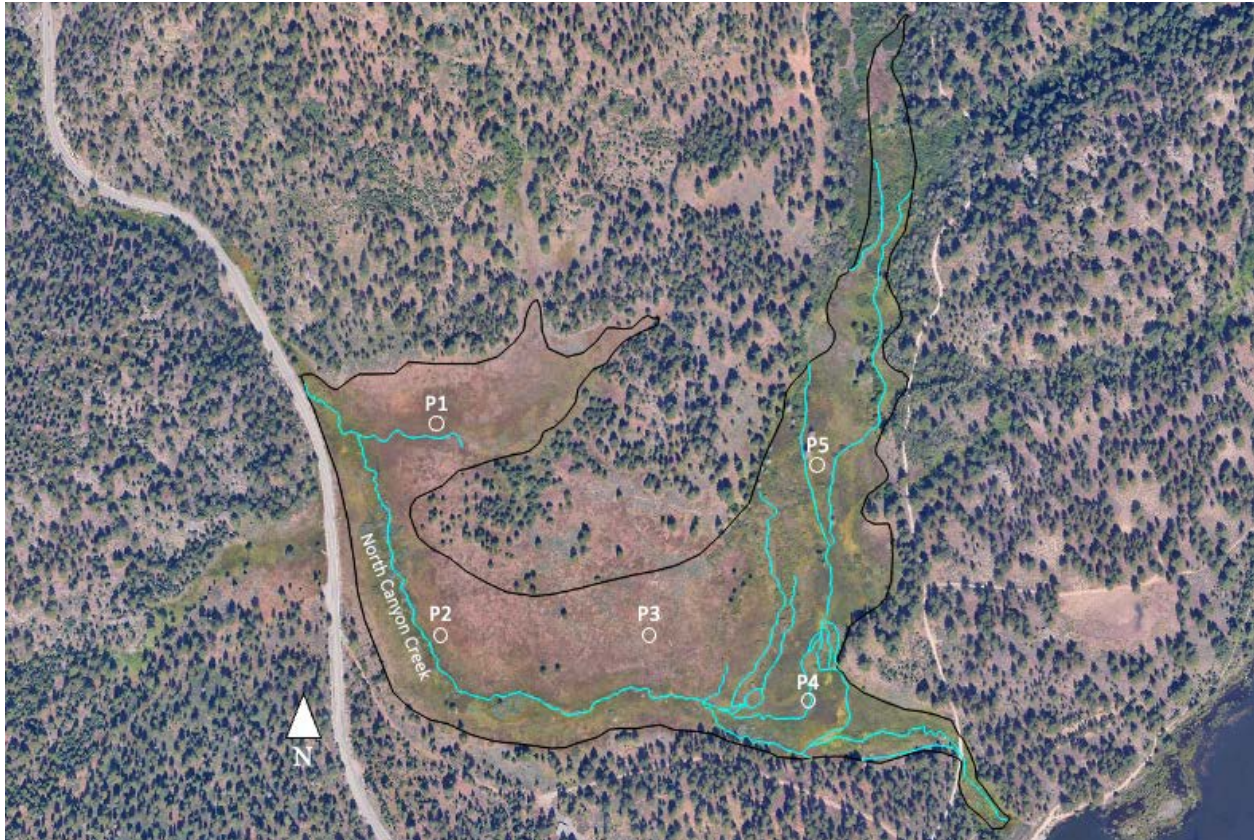
Figure 2. Locations of Study Plots. Plots are shown as circles. North Canyon Creek and tributaries are shown as blue lines. (Note: not all tributaries are shown here; water features shown here are intended to provide general hydrologic context for the study plots and may not match formally delineated features.)

Field data were collected from July 2023 through June 2025 at Spooner Meadow. We collected soil and vegetation data from five 500 m<sup>2</sup> circular plots (Figure 2) and water quality data from North Canyon Creek.

Plots were positioned at various distances from North Canyon Creek to capture conditions representative of the meadow (Table 1). The center of each plot was marked by a PVC post. Plots 1, 2, 4, and 5 were within the bounds of the formally delineated wet meadow, whereas Plot 3 was upslope in a drier area more characteristic of a mesic meadow (Huffman & Carpenter, Inc. 2009).

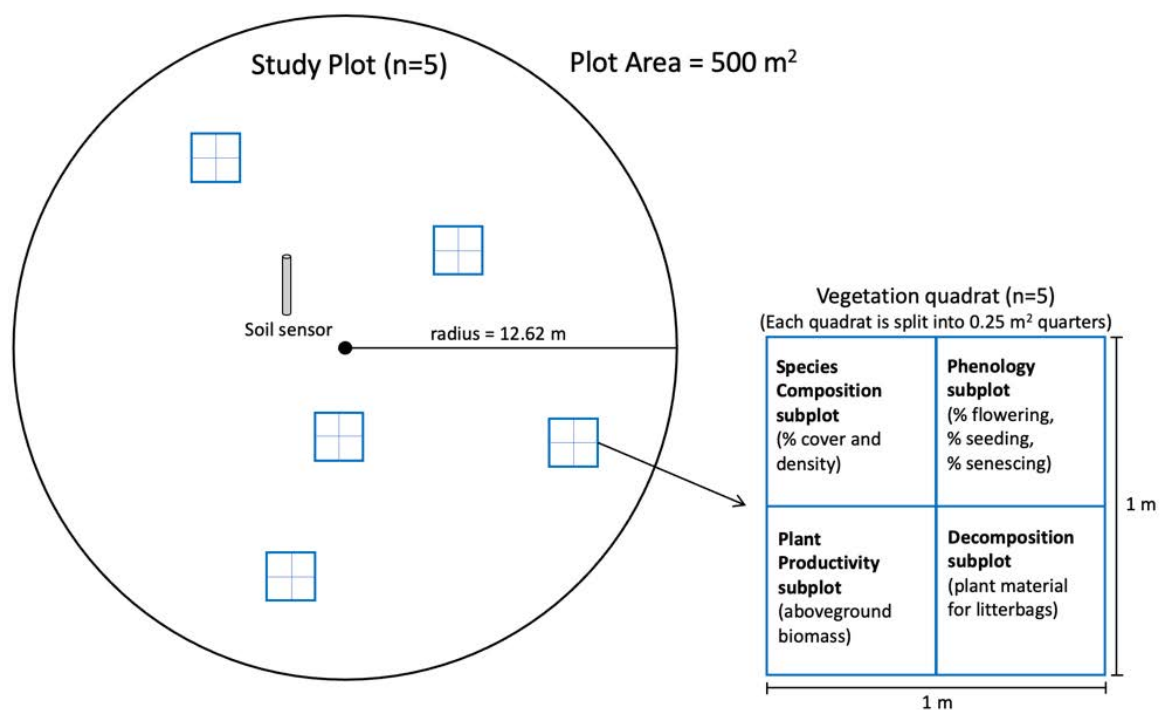
Figure 3. Study Plot diagram and vegetation sampling design. Not to scale.

In each plot, we measured vegetation in five 1-m<sup>2</sup> quadrats to inform habitat, biodiversity, productivity, and decomposition functions and processes. To evaluate these characteristics, we collected data on plant species composition, phenology, aboveground biomass (AGBM), and decomposition rates. Quadrats were randomly positioned in each circular plot. New random quadrat locations were used each year. Each quadrat was divided into 0.25 m<sup>2</sup> quarters; different vegetation measurements were collected in each quarter (Figure 3).

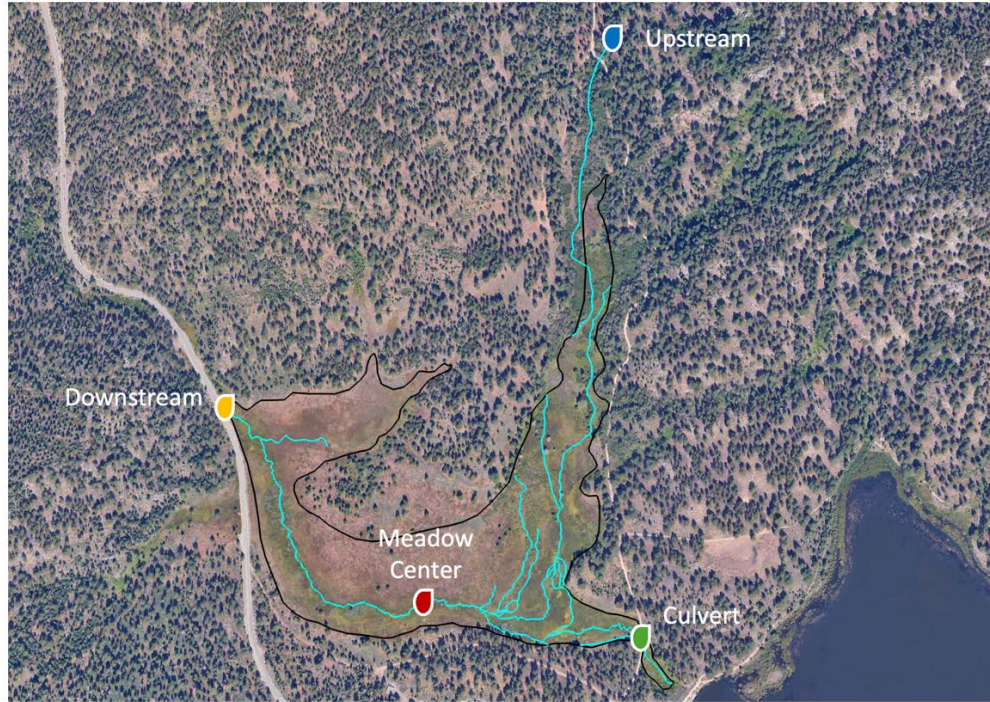
Figure 4. Water quality sampling locations along North Canyon Creek.

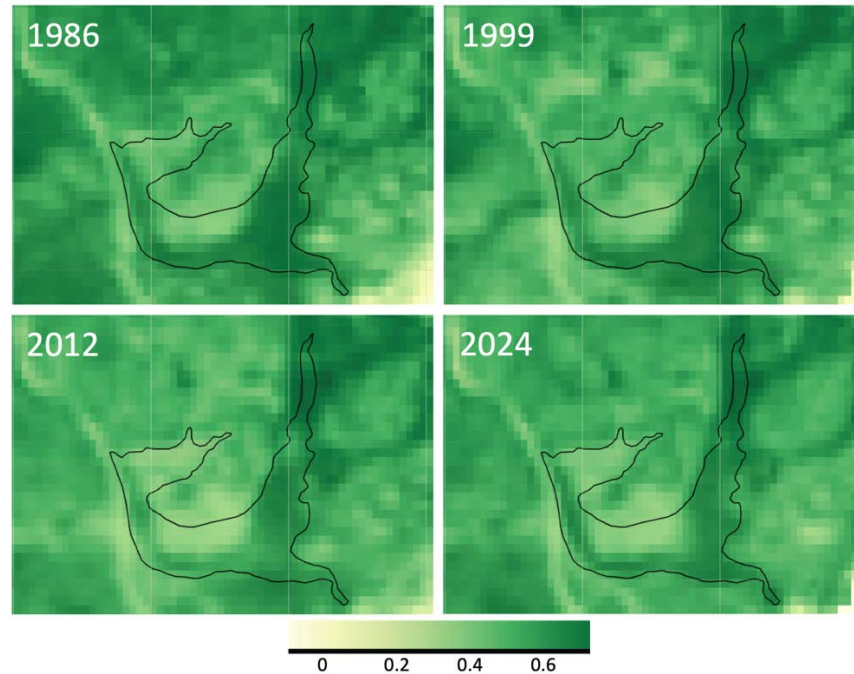
Figure 18. Snapshots of NDVI during the growing season (June to September) in 1986, 1999, 2012, and 2024.

NDVI values for the growing season (June to September) varied within Spooner Meadow but were relatively consistent over time (1986-2024; Figure 18). The western portion and southern edge of the meadow had the highest NDVI values, reaching ~0.7. These green, dense, healthy areas follow the flow of North Canyon Creek. The central portion of the meadow, which is upslope and considered mesic meadow rather than wet meadow, had NDVI values ranging from 0.2 to 0.5. This suggests that the vegetation there was sparser or stressed, likely due to drier, upslope conditions.

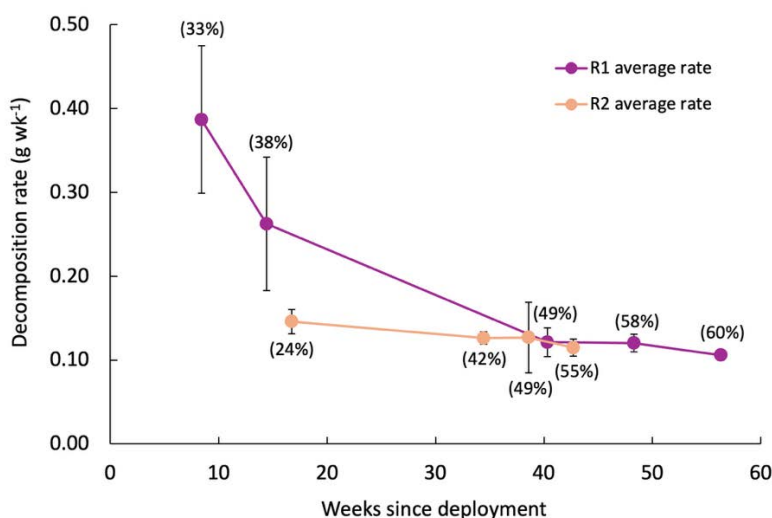
Figure 19. Decomposition rates measured at Study Plots. Average rates (points) and standard deviations (bars) are based measurements from litter bags deployed July 2023-August 2024 (R1) and August 2024-June 2025 (R2). The average percent of decomposed material is shown in parentheses.

We expected to see the fastest rate of decomposition at Plot 3, which was more exposed and drier, and slowest decomposition rates at Plots 4 and 5, which were most frequently saturated. However, there was no clear trend between plots. During the decomposition study, several bags went missing or showed signs of damage, particularly litter bags deployed at Plot 3 where there were many rodent burrows (potentially from pocket gophers). Missing and damaged litter bags were not included in data analysis, which makes it difficult to draw conclusions on temporal and spatial decomposition trends in the meadow.

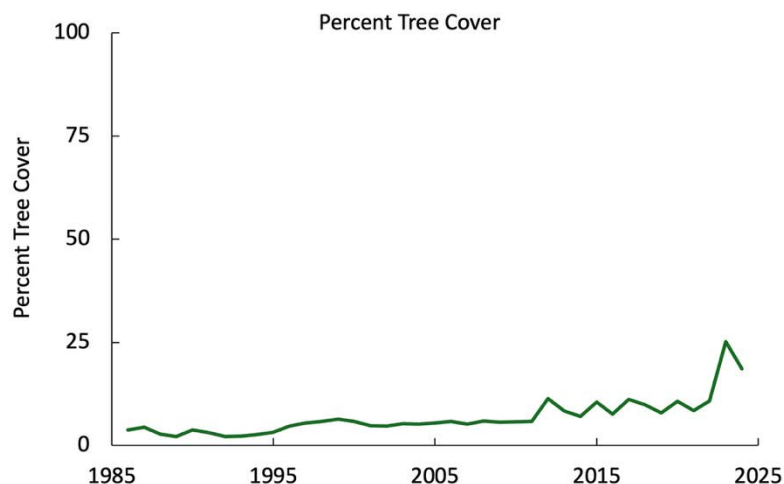
Figure 21. Percent tree cover (1986-2024). Tree cover estimated from remote sensing analysis using the RAP Tree Cover dataset.

Forest surrounding Spooner Meadow is dominated by lodgepole pine (*Pinus contorta*) and North Canyon Creek supports patchy riparian corridors dominated by willows (*Salix* spp.) and quaking aspen (*Populus tremuloides*). Based on remote sensing RAP Tree Cover data (Table 2), percent tree cover increased from ~4% to 25% since 1986. Tree cover increased steadily from 1986 to 2011 (Figure 21). Since 2012, tree cover has fluctuated and sharply increased to 25% in 2023. However, given the coarse spatial resolution of the dataset (30 m), a more detailed field study with high-resolution imagery would be necessary to accurately evaluate tree encroachment trends into Spooner Meadow.

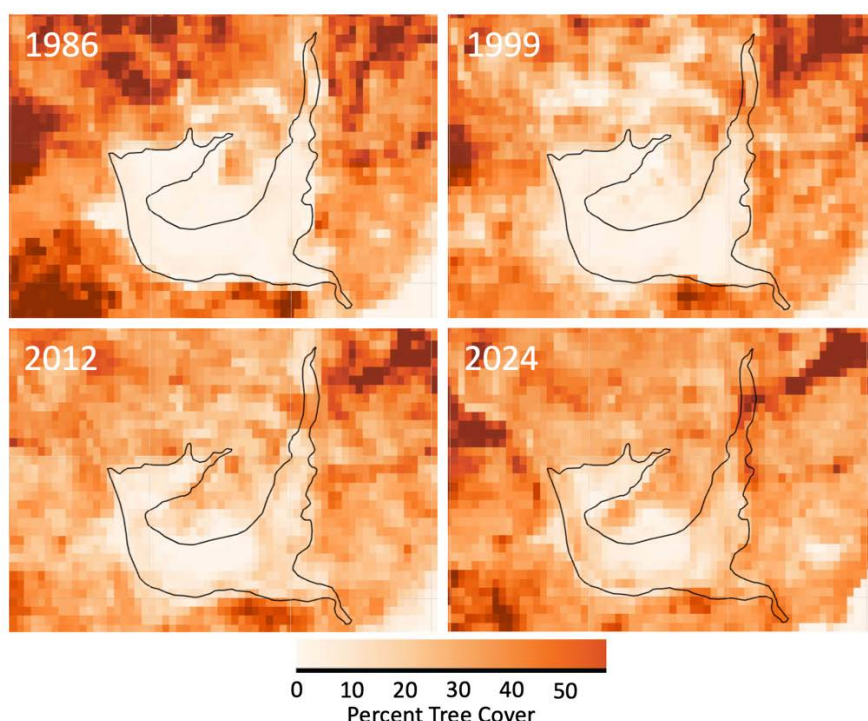
Figure 22. Snapshots of percent tree cover in 1986, 1999, 2012, and 2024.

pronounced riparian corridor forming from increased willow cover, especially in the western region of the meadow, rather than from encroaching conifers.

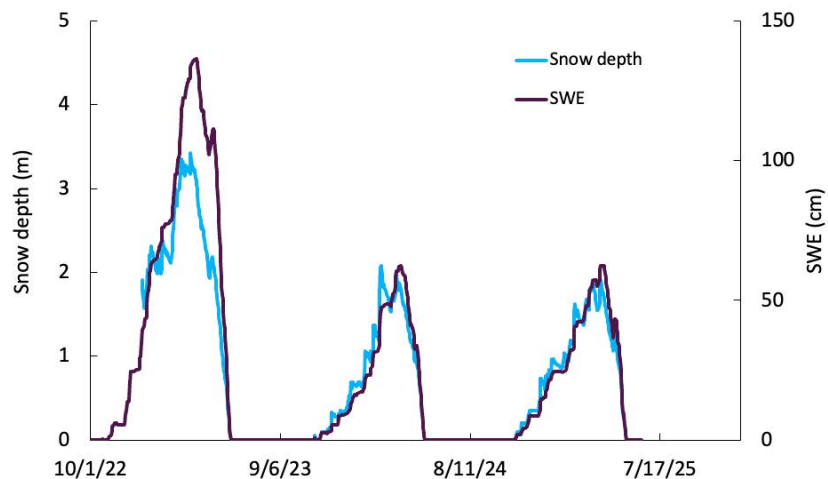
Figure 27. Snowpack at the Marlette Lake SNOTEL Monitoring Site (2023-2025). Snowpack was measured as snow depth (left y-axis) and snow water equivalent (SWE; right y-axis).

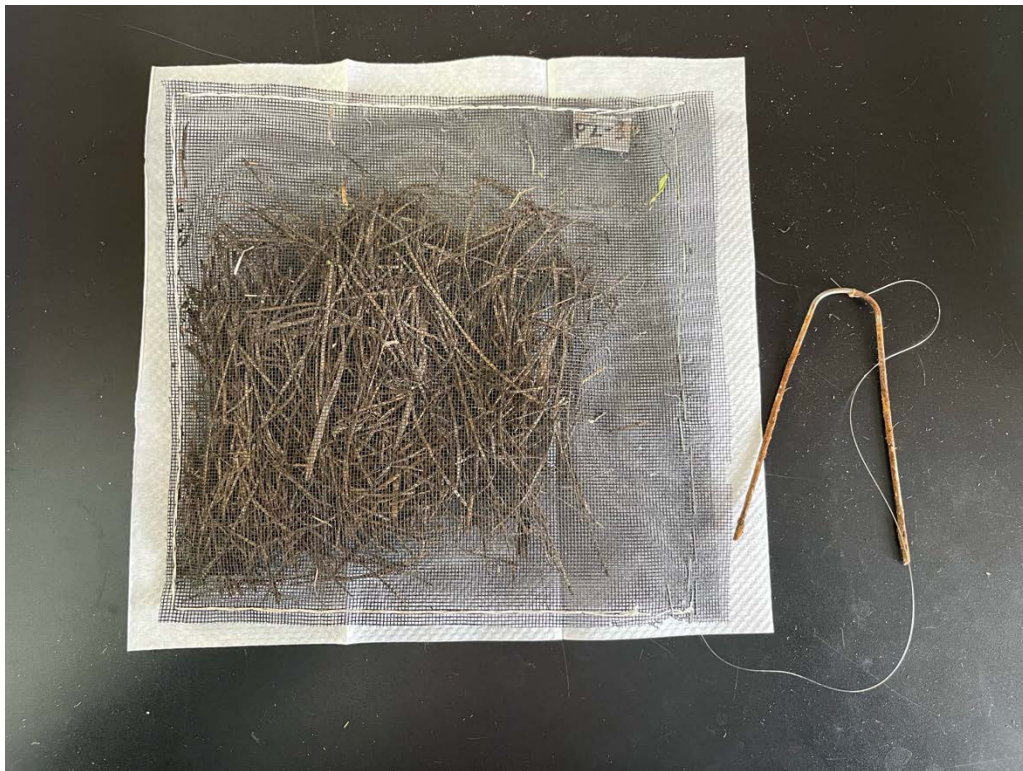
Photo 27. Litterbag collected from Study Plot 3.
