EDGEWOOD CREEK  
WATERSHED ASSESSMENT

TECH MEMO II  
**FINAL DRAFT**

December 12, 2002  
Revised April 23, 2003  
Revised June 10, 2003

**EDGEWOOD CREEK INTEGRATED WATERSHED ASSESSMENT TEAM**

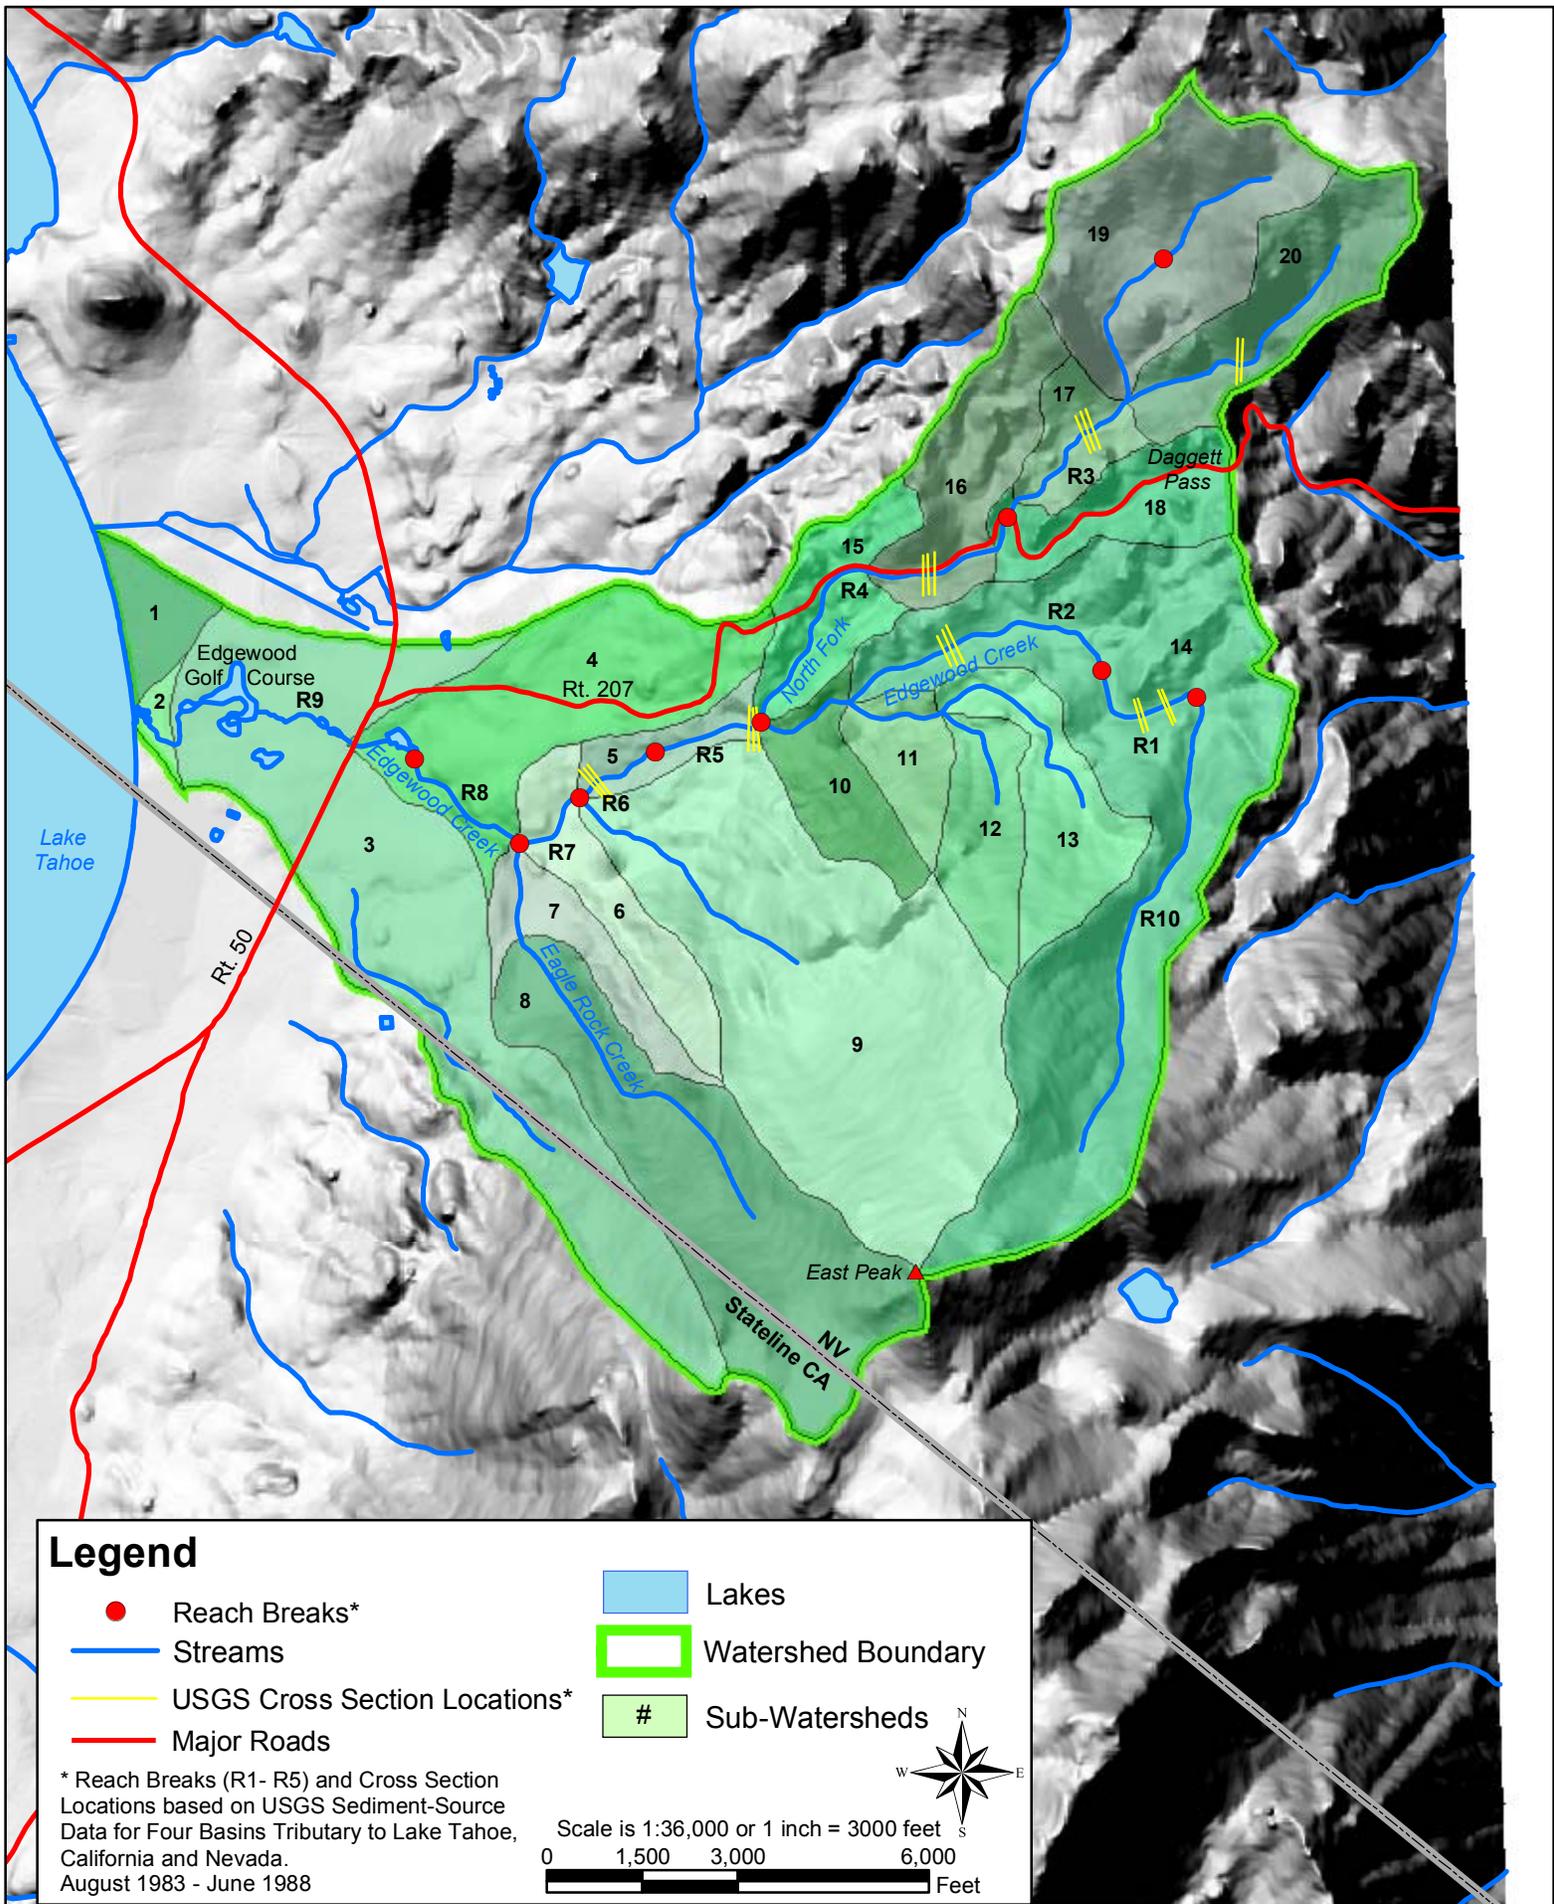
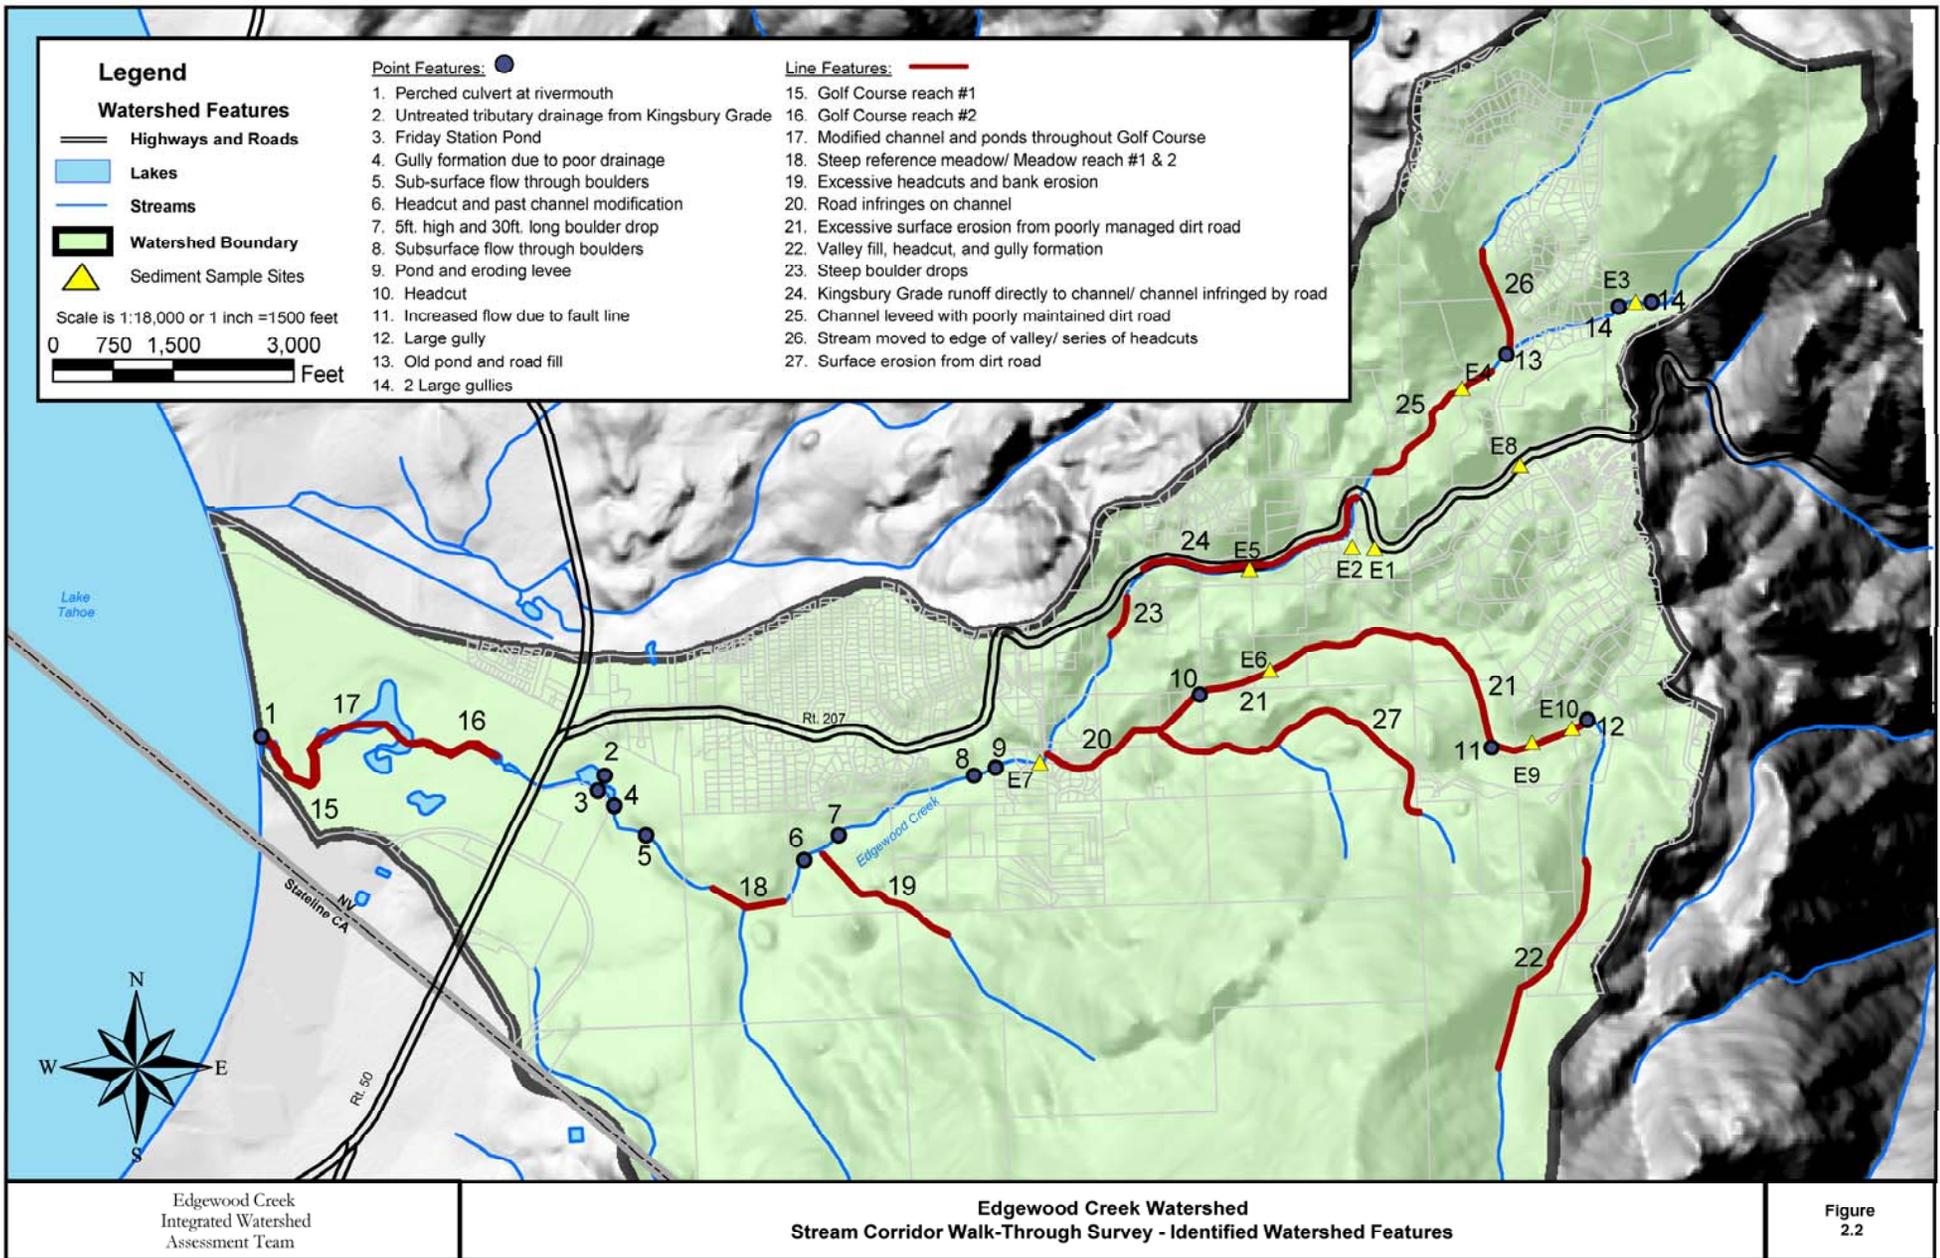
Approximately 500 feet upstream of the Highway 50 crossing an earthen dam impounds approximately 500 lineal feet of Edgewood Creek and a small tributary entering from the vicinity of lower Kingsbury. The earthen dam has a valve release at the bottom. Recent beaver activity in the pond, known as Friday Station Pond, has blocked the outlet works, prompting Park Cattle Company (PCC) staff to close the release valve and allow water to go over the spillway. Although there are large rocks in the spillway channel, it is a potential erosion area in the event of high winter or spring flows.

Given the size of Friday Station Pond and its location in the lower watershed of Edgewood Creek and at the confluence of the mainstem and a tributary draining Lower Kingsbury, it is likely that all of the bedload and a portion of the suspended load are trapped within the impoundment. Consequently, Friday Station Pond acts as a large sediment basin that reduces the overall sediment load that is delivered to Lake Tahoe. The degree to which the Pond is a sediment trap for finer-grained material that may be impacting water clarity in Lake Tahoe would need to be studied further. Such a program should focus on suspended material entering and leaving the Pond. The trap efficiency of the Pond may differ depending on whether water is released through the release valves or the spillway.

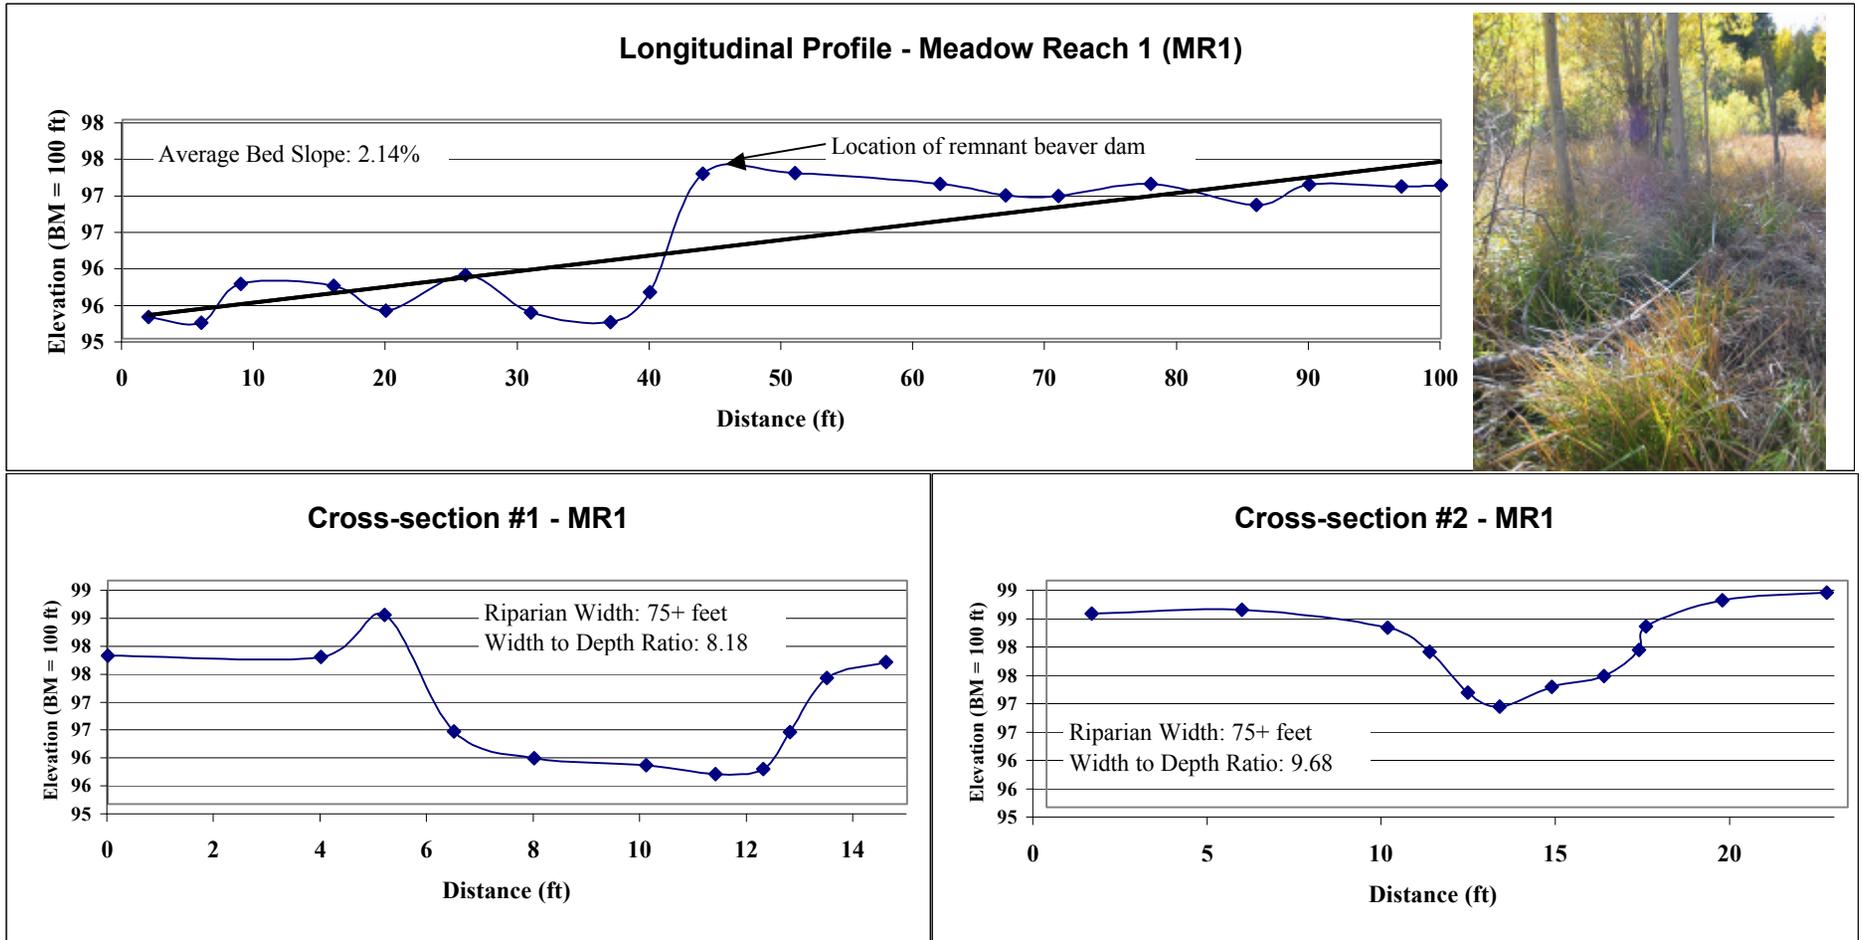
**Figure 2.5:** Long profile and cross-section geometry for a reference meadow reach (Meadow Reach #1) located at the upstream end of Park Cattle Company property. This site consists of a steep meadow in good condition. Riparian width was estimated based on vegetation type (i.e. - edge of coniferous forest). The width to depth ratio was calculated as wetted width to wetted depth to maintain consistency with the Edgewood Gold Course reaches.

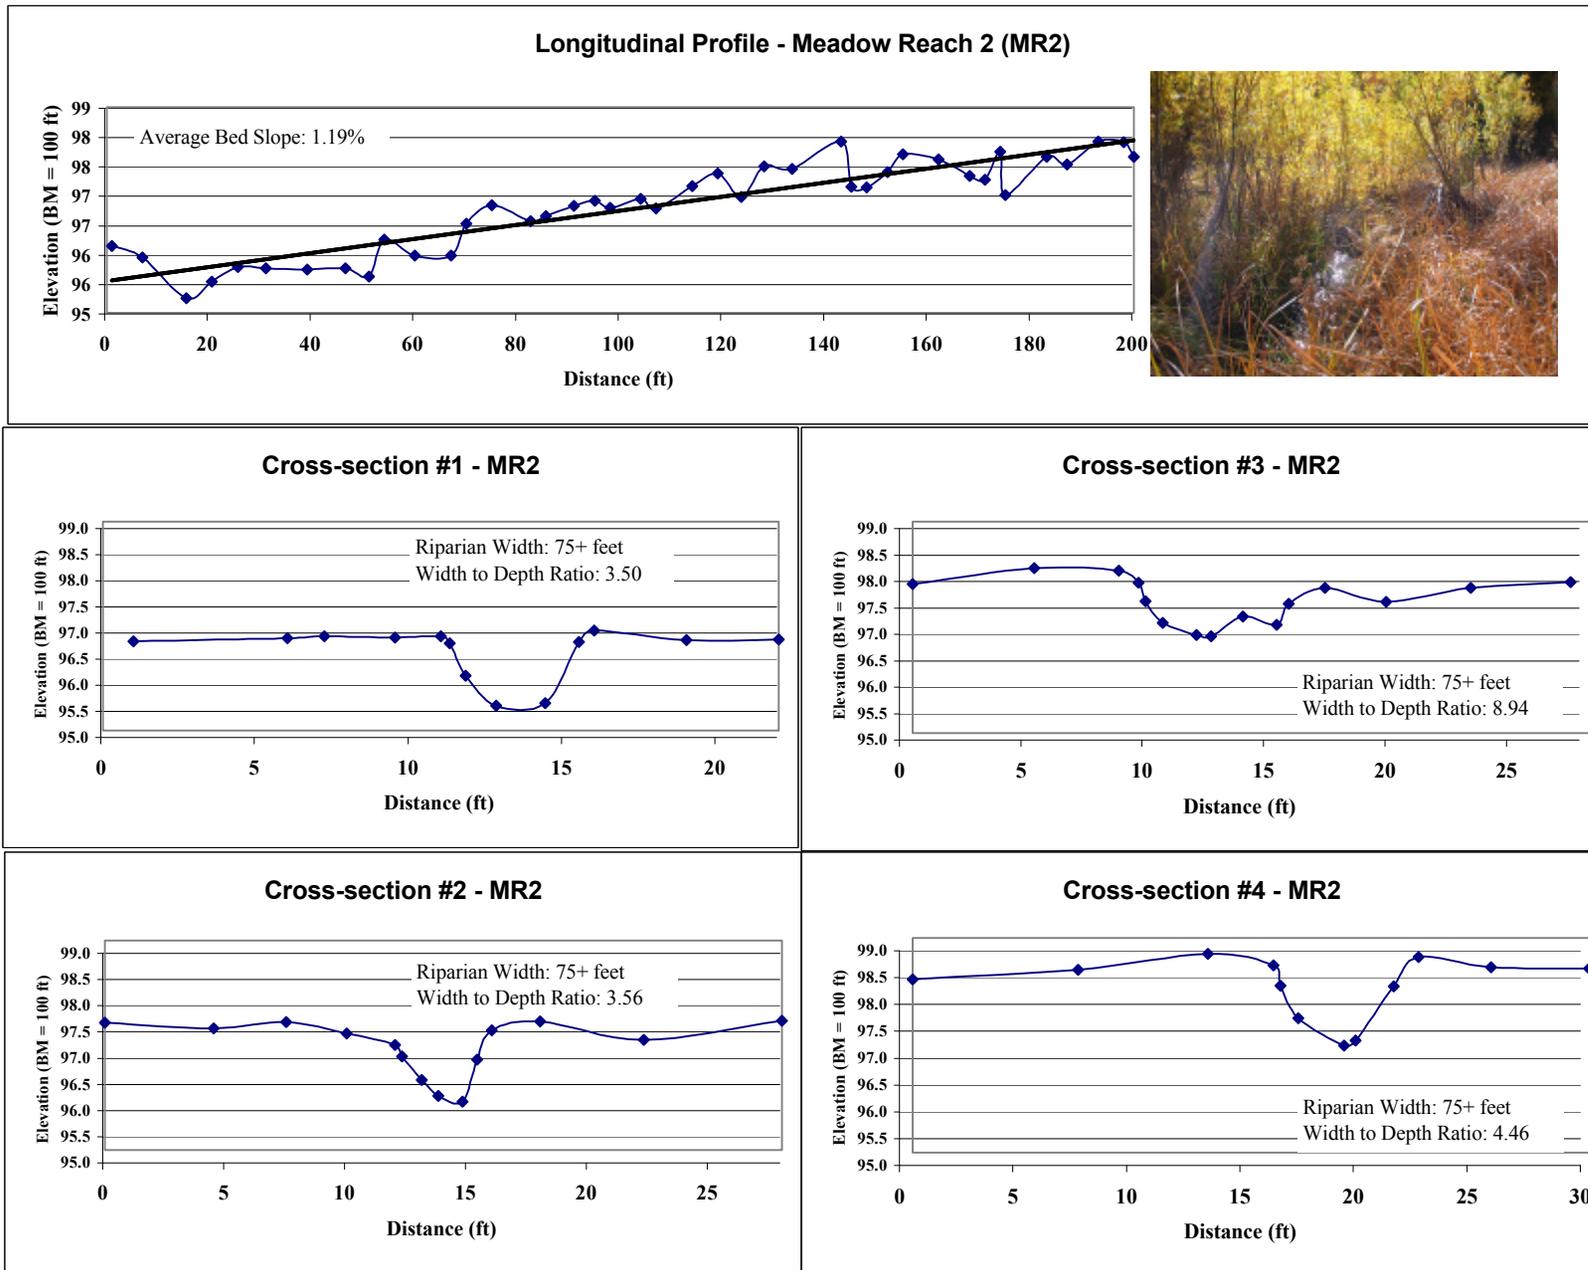
**Figure 2.6:** Long profile and cross-section geometry for a reference meadow reach (Meadow Reach #2) located at the upstream end of Park Cattle Company property. This site consists of a steep meadow in good condition. Riparian width was estimated based on vegetation type (i.e. - edge of coniferous forest). The width to depth ratio was calculated as wetted width to wetted depth to maintain consistency with the Edgewood Gold Course reaches.
