# **Stormwater System Operation and Maintenance Handbook**

**Nevada Division of Environmental Protection**

**Nevada Tahoe Conservation District  
400 Dorla Court  
Zephyr Cove, NV 89448**

**November 2009**

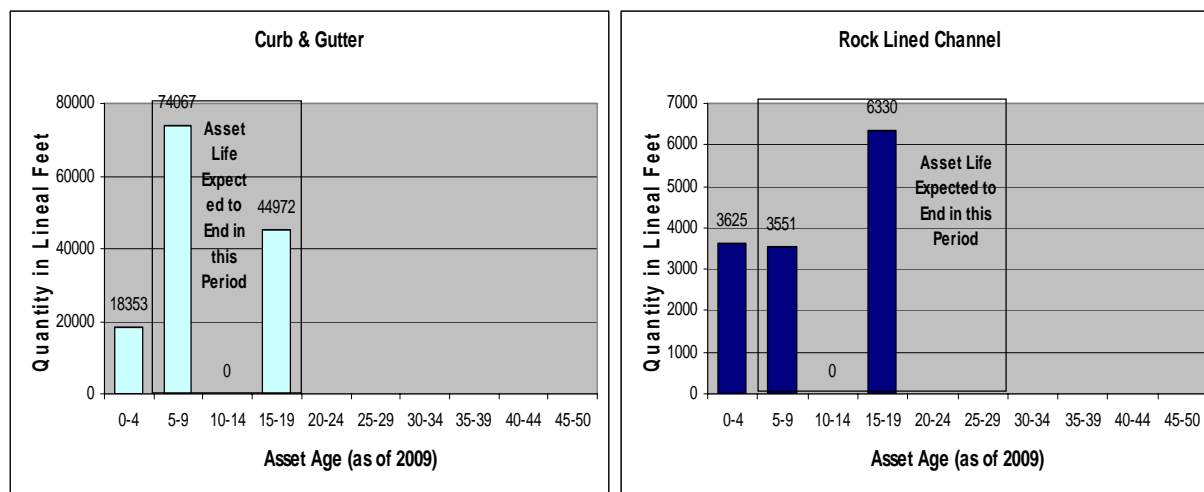
**Figure 3: Douglas Tahoe Asset Age vs. Design Life – Curb & Gutter and Rock Lined Channel**

Examples of Douglas Tahoe asset age vs. design life are shown in Figure 3, representing life cycles and actual age of assets for curb & gutter and rock lined channel. Note in these examples, the asset age has in all cases begun to enter the design life range and thus some of these assets may be found to require major maintenance or need to be scheduled for replacement in the next few years.

The identification of asset age with expected design life as shown in the examples provides a quick reference to asset owners of the need to verify asset conditions and performance as well as planning for major maintenance work.

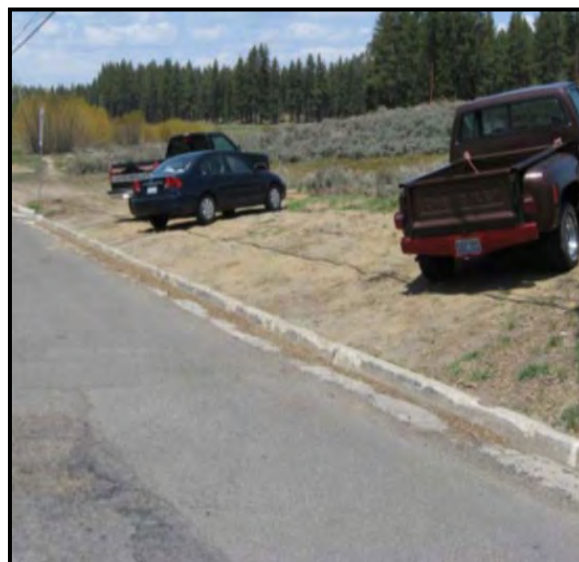
**Bare Soil Cover Example of Need to Prevent Vehicle Use**

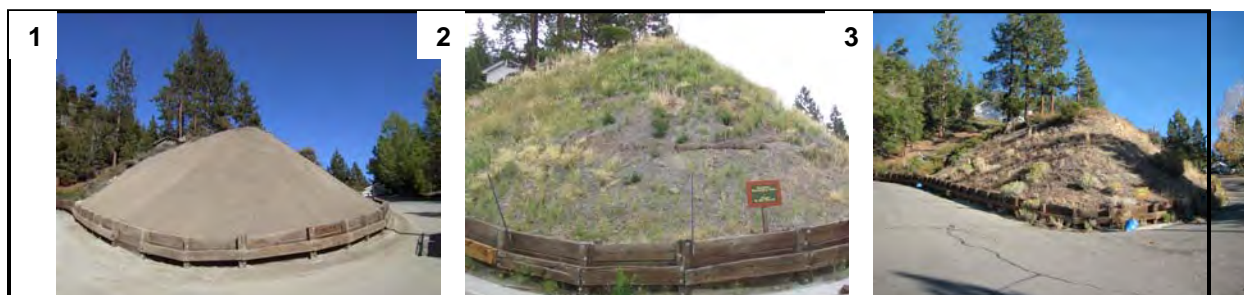
**Bare Soil Cover Example: L to R 1) 2001 Cleared 2) 2003 Vegetation 3) 2009 Vegetation**

Vegetation controls erosion by protecting bare soil surfaces from displacement by raindrop impacts and by reducing the velocity and quantity of overland flow.

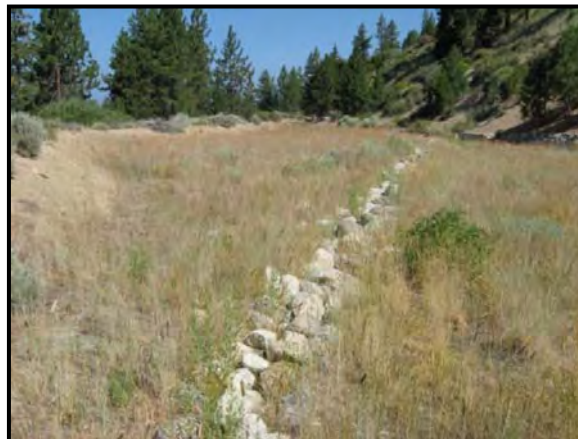
A bed filter is a shallow basin that is designed to treat stormwater. Bed filters use the natural filtering ability of the soil to remove pollutants in stormwater runoff. A bed filter is hydraulically similar to infiltration basins except the runoff is filtered through the bed (soil), collected into an underdrain, and discharged to an outlet rather than being infiltrated to the local unsaturated zone. Little to no stormwater volume is lost, yet sediment and pollutants are captured via filtration through the bed material. Bed filters function as long as infiltration capacity is upheld and vegetation is kept at a minimum (not usually a problem in the Tahoe Basin, since getting vegetation to grow can be a challenge).

Bed Filter: This basin looks like a dry basin but has an underdrain to carry flows back to the surface

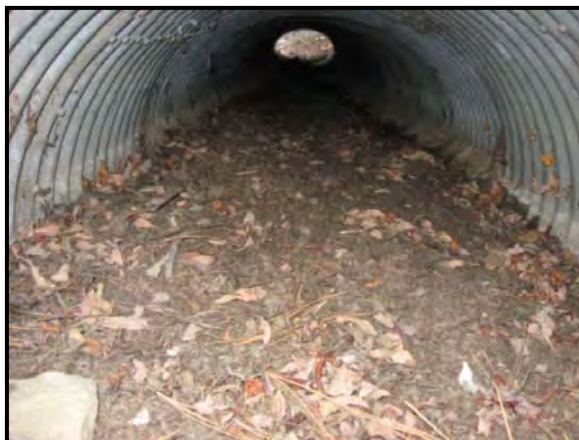
Conveyance Piping: Example of need for cleaning

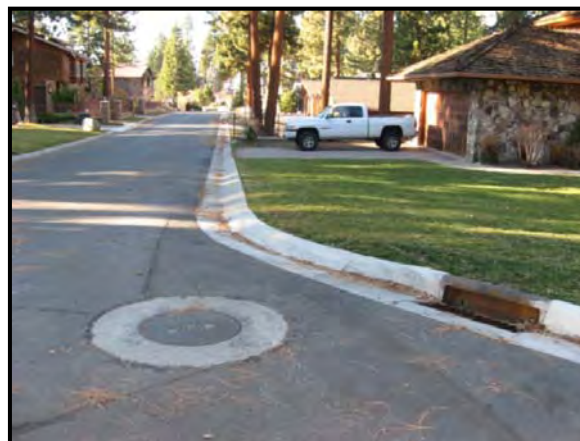
Curb & Gutter: Good example

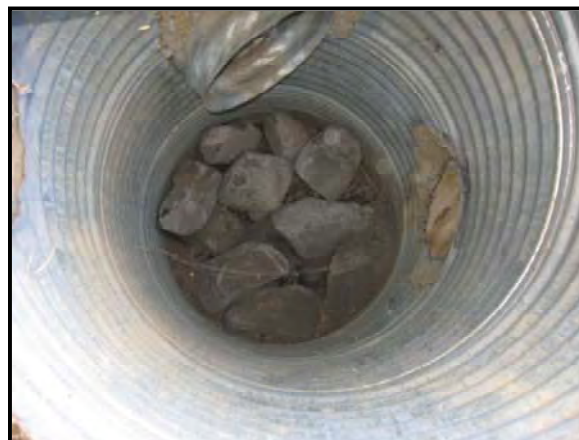
Drainage Inlet: typical with rock bottom

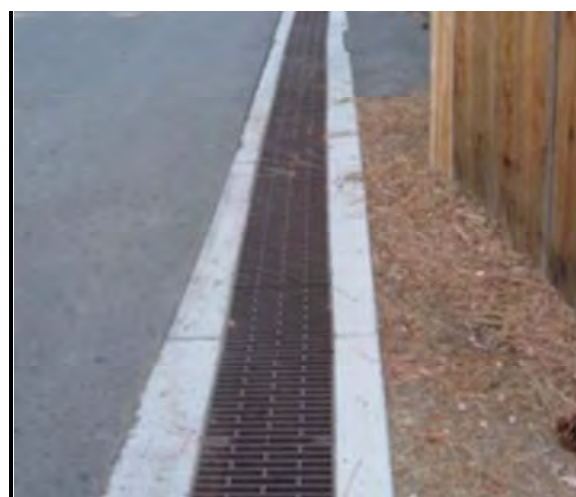
Drainage Inlet: includes slotted drains

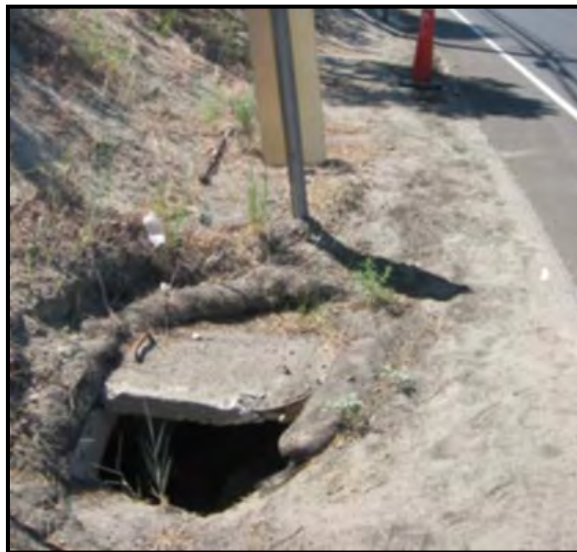
Drainage Inlet: Needs improvements

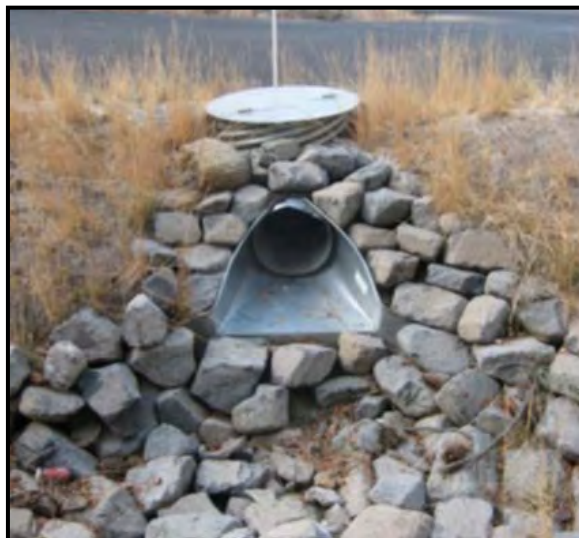
Drainage Outlet: This one is outlet from a basin

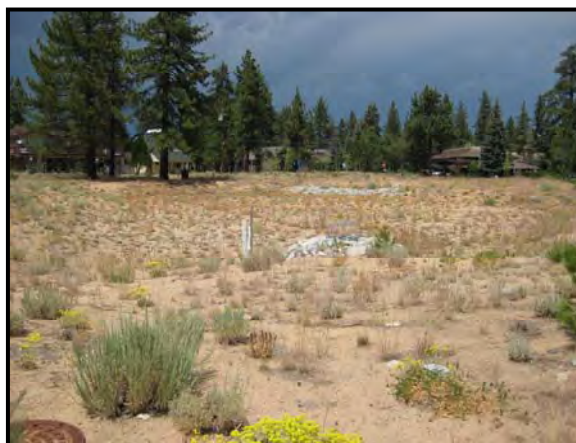
Dry Basin: This basin has an outlet to control sedimentation and a gauge to measure depth of sediment accumulation

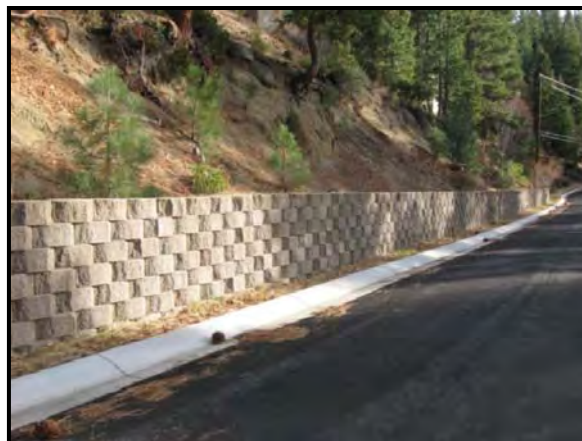
Retaining Wall: Block structure in good condition.

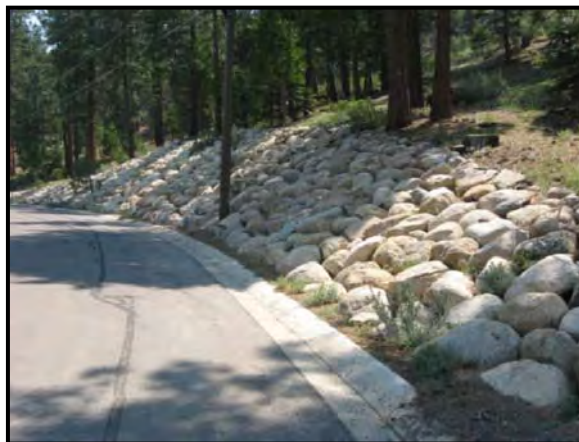
Vegetation is often incorporated with riprap slope stabilization as an additional source control BMP.

Riprap Slope Stabilization: Good example

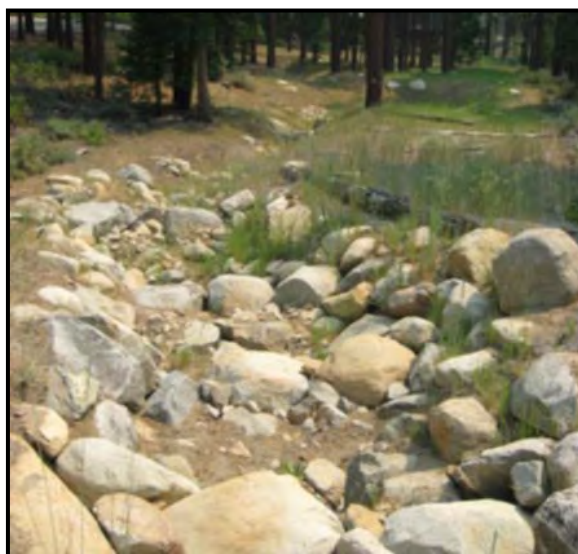
Rock Lined Channel

Rock lined channels do allow infiltration and some are built with step-pool combinations or check dams, thus allowing stormwater to infiltrate and particles to settle.

Vegetation is often incorporated with rock lined channels as an additional source control BMP.

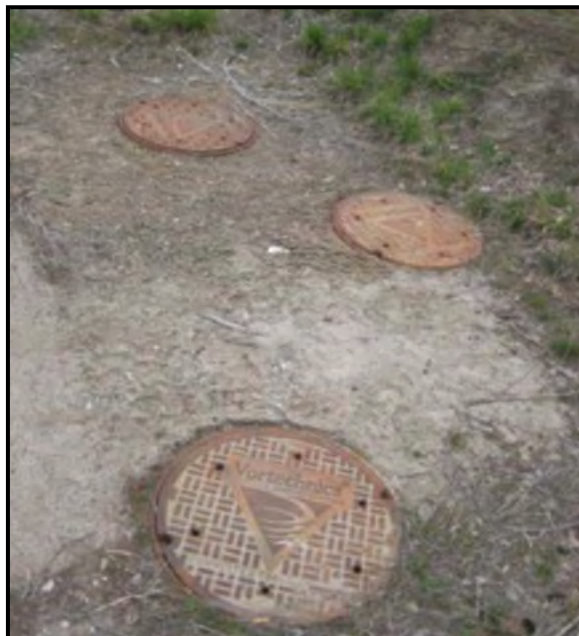
Treatment Vault: Vortechtechnics

Because treatment vaults are designed to attenuate flow, some particles and nutrients do settle out. There is much concern that resuspension will occur during the next runoff event and the settled particles and nutrients will be transported downstream into Lake Tahoe.

However, depending upon the design, many treatment vaults have high flow stormwater runoff bypasses, which help prevent resuspension of settled particles.

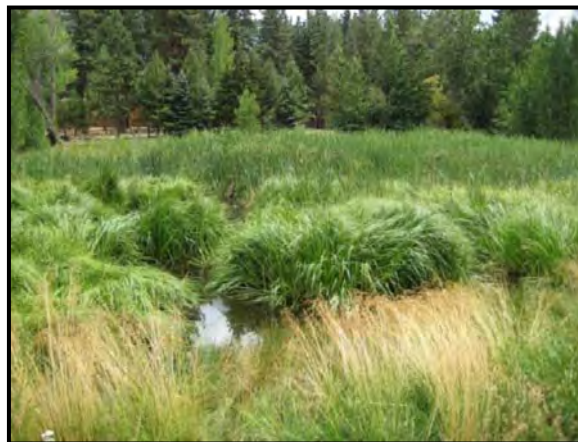
Wet Basin: Good condition. Note vegetative growth

Wet basins (a.k.a. stormwater ponds, retention ponds, wet extended detention ponds) are constructed basins that have a permanent pool of water throughout the year (or at least throughout the wet season) and differ from constructed wetlands primarily in having a greater average depth. These basins treat incoming stormwater runoff by settling and biological uptake. The primary removal mechanism is settling as stormwater runoff resides in this pool, but pollutant uptake, particularly of nutrients, also occurs through biological activity in the basin.
